Subject: Supplement No. 2
Geotechnical and Geologic Investigation
Lots 11, 19, and 20, Block 15, Tract No. 7803
1749 and 1751 Malcolm Avenue and 1772 Glendon Avenue
Los Angeles, California

FINAL GEOLOGIC MAP		PROJECT No:	
DESCRIPTION: Proposed Multifamily Building		15-363-26	
FOR: Sinanian Development		DATE:	01 / 15 / 2016
ADDRESS: 1749 & 1751 Malcolm Avenue, Los Angeles, CA 90024		DRAWN BY:	ZS
		CHECKED BY:	SM
  Applied Earth Sciences		GEOTECHNICAL . GEOLOGY . ENVIRONMENTAL ENGINEERING CONSULTANTS	www.aessoil.com (818) 552-6000
DRAWING No: 1		SUPP. No: 2

FINAL GEOTECHNICAL SITE PLAN

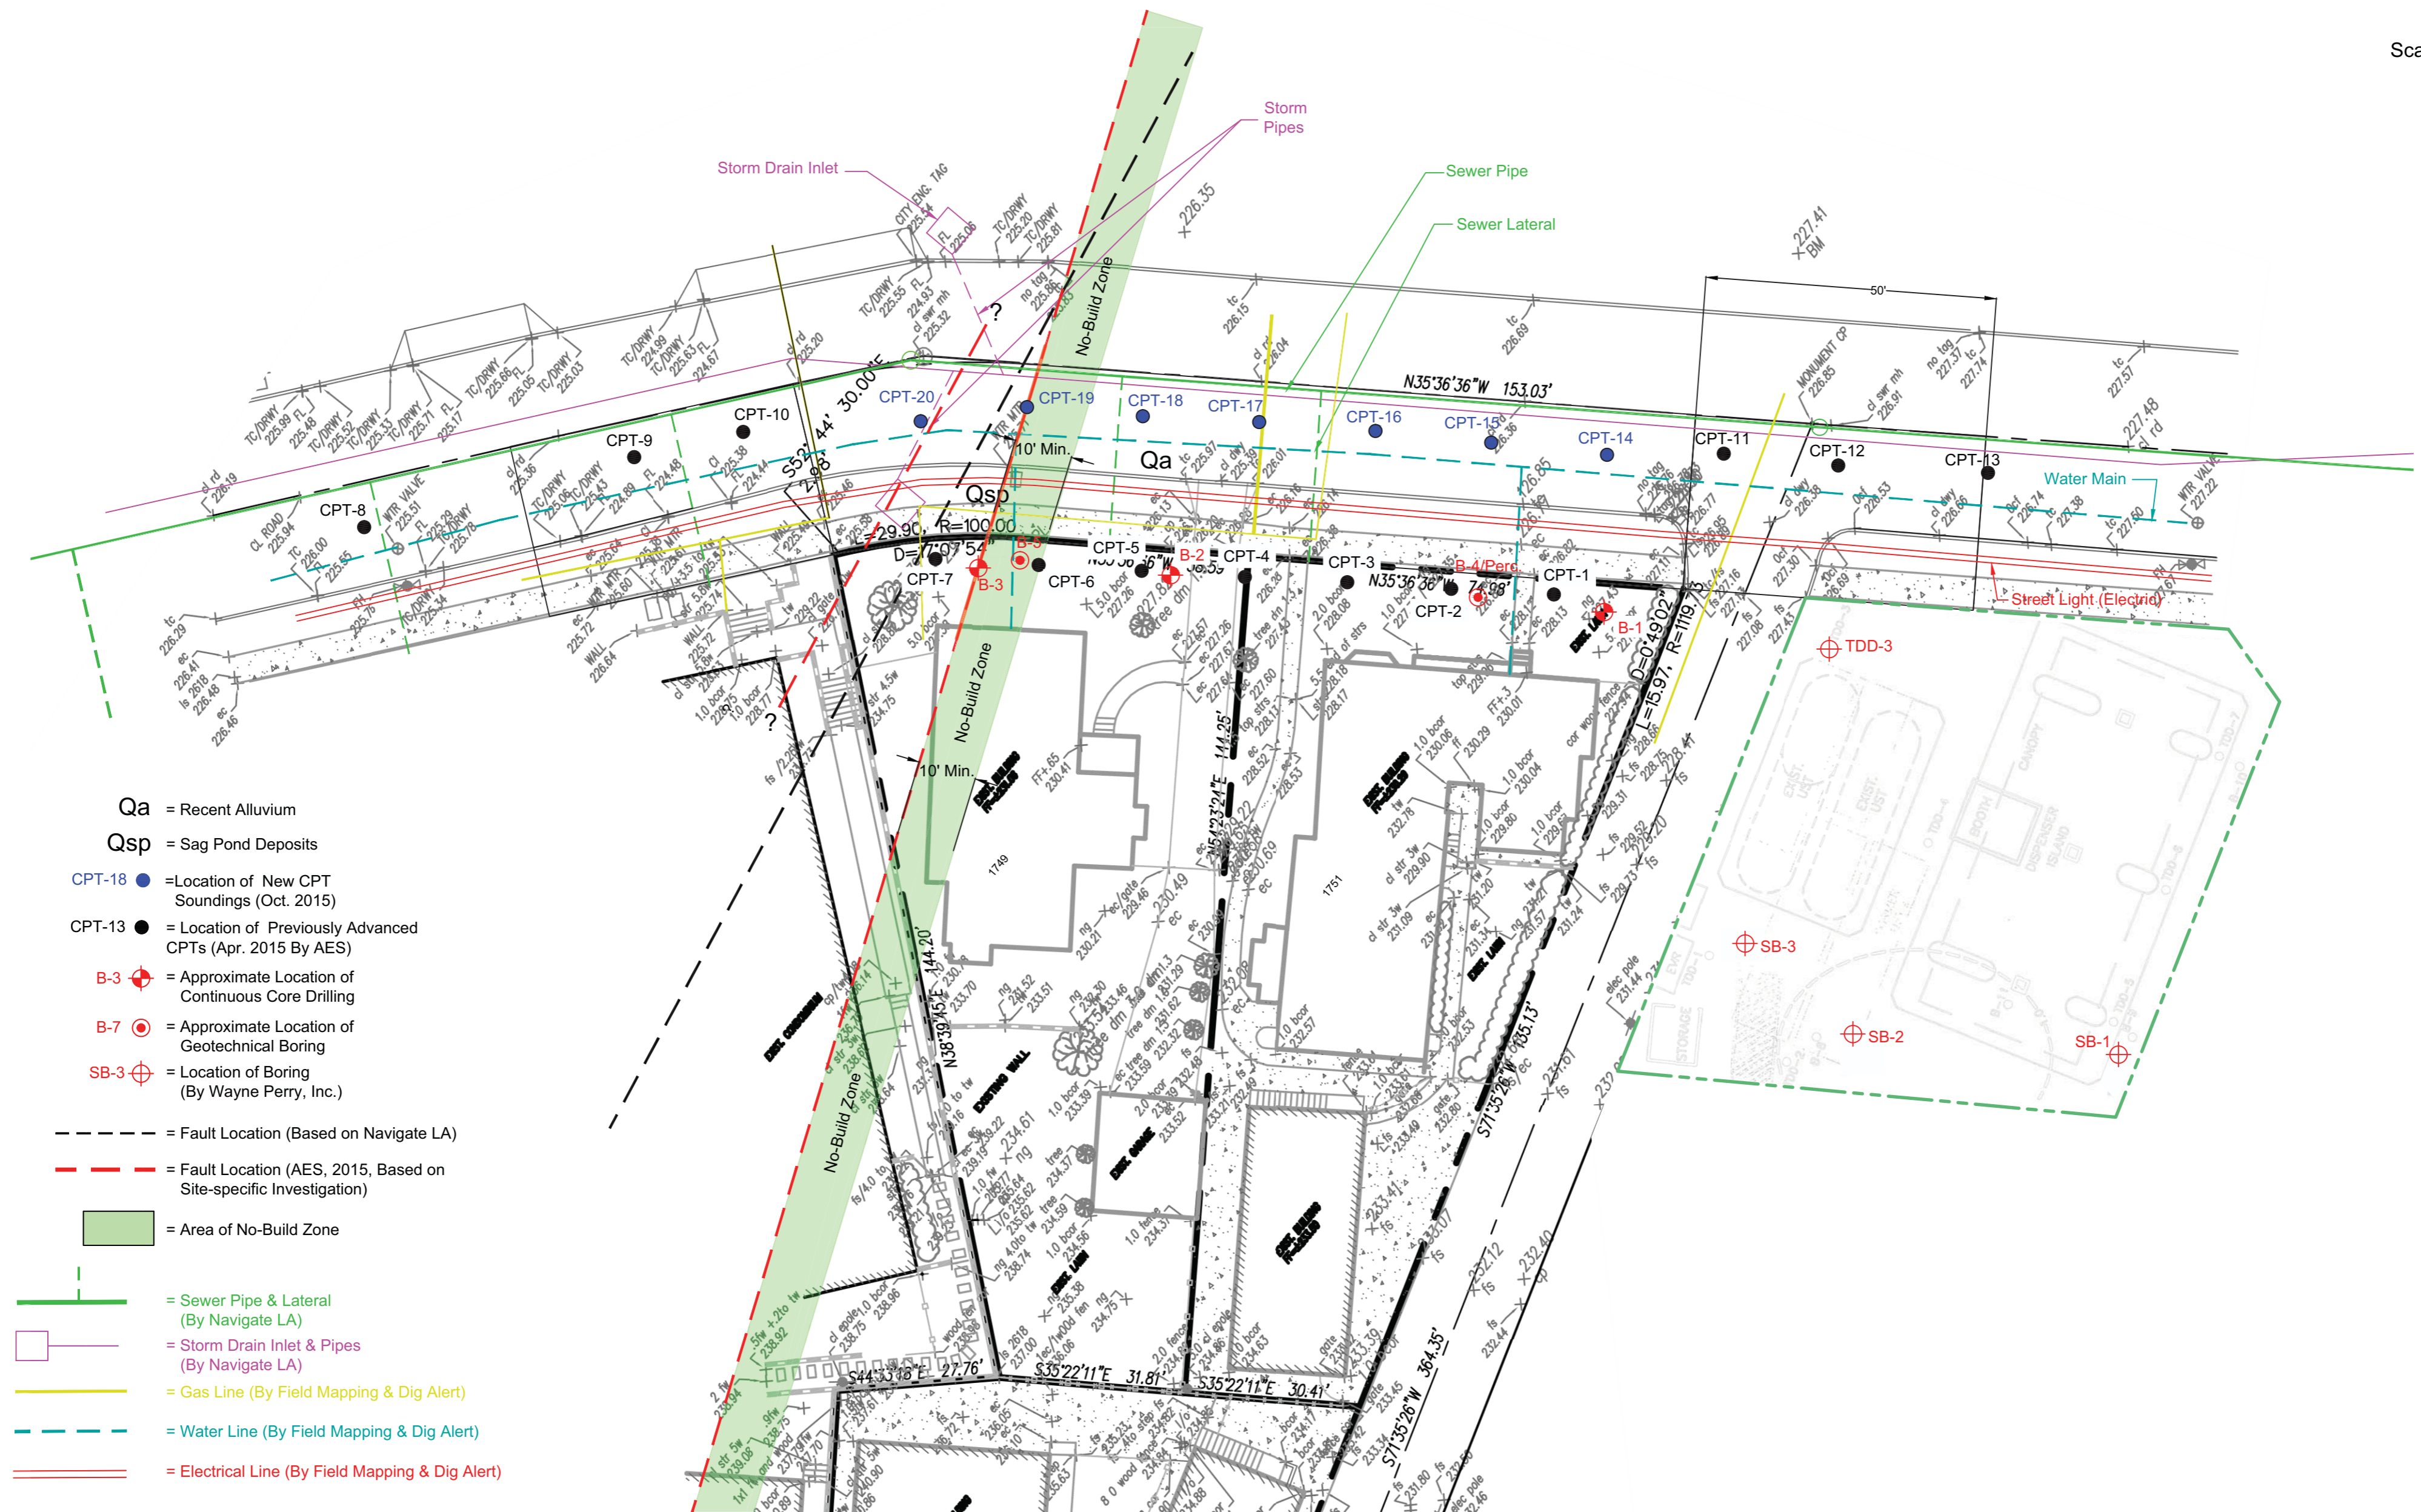
1. We have hereby revised the fault orientation to reflect the most conservative orientation, based on that fact that direct evidence or observation of the actual orientation of the fault with the exploration methods used is not possible. The revised fault orientation passes through B-3 and CPT-19.

2. Based on the presence of abundant fine-grained sag pond deposits north of the two faults encountered during our exploration, it is our opinion that the main trace of the Santa Monica fault lies north of the study area. This corresponds to the geomorphic and topographic evidence of the main trace being along the south-facing escarpment that forms the front lawn of the LDS temple, the northwestward projection of which extends north of the study area. The project area is likely located on the south part of a localized zone of transtension along the generally left-lateral strike-slip fault zone, related to the northwestward bend in the main fault trace one block east of the study area (Miles Kenney, 2014; Scott Lindvall, personal communication, Richard Crook, Jr., personal communication). It is therefore the opinion of the undersigned that the possibility of flower structures or non-linear variability west of the encountered fault is minute, since we consider this fault to be a splay of the main fault north of the project area. Furthermore, it is our opinion that any non-variability west of the study area (B-3) to the north property limit (a span of 50 feet) will be within the established ten-foot setback zone.

However, now that the most conservative possible fault orientation is being used as a basis for engineering design of the buildings, we have reduced the no-build setback from twenty to ten feet, as was originally recommended in our 7/21/15 original report. This reduction in setback back to ten feet, based on the most conservative possible fault orientation, was discussed and verbally agreed upon with Mr. Schneidereit of LADBS in our meeting on 1/13/16.

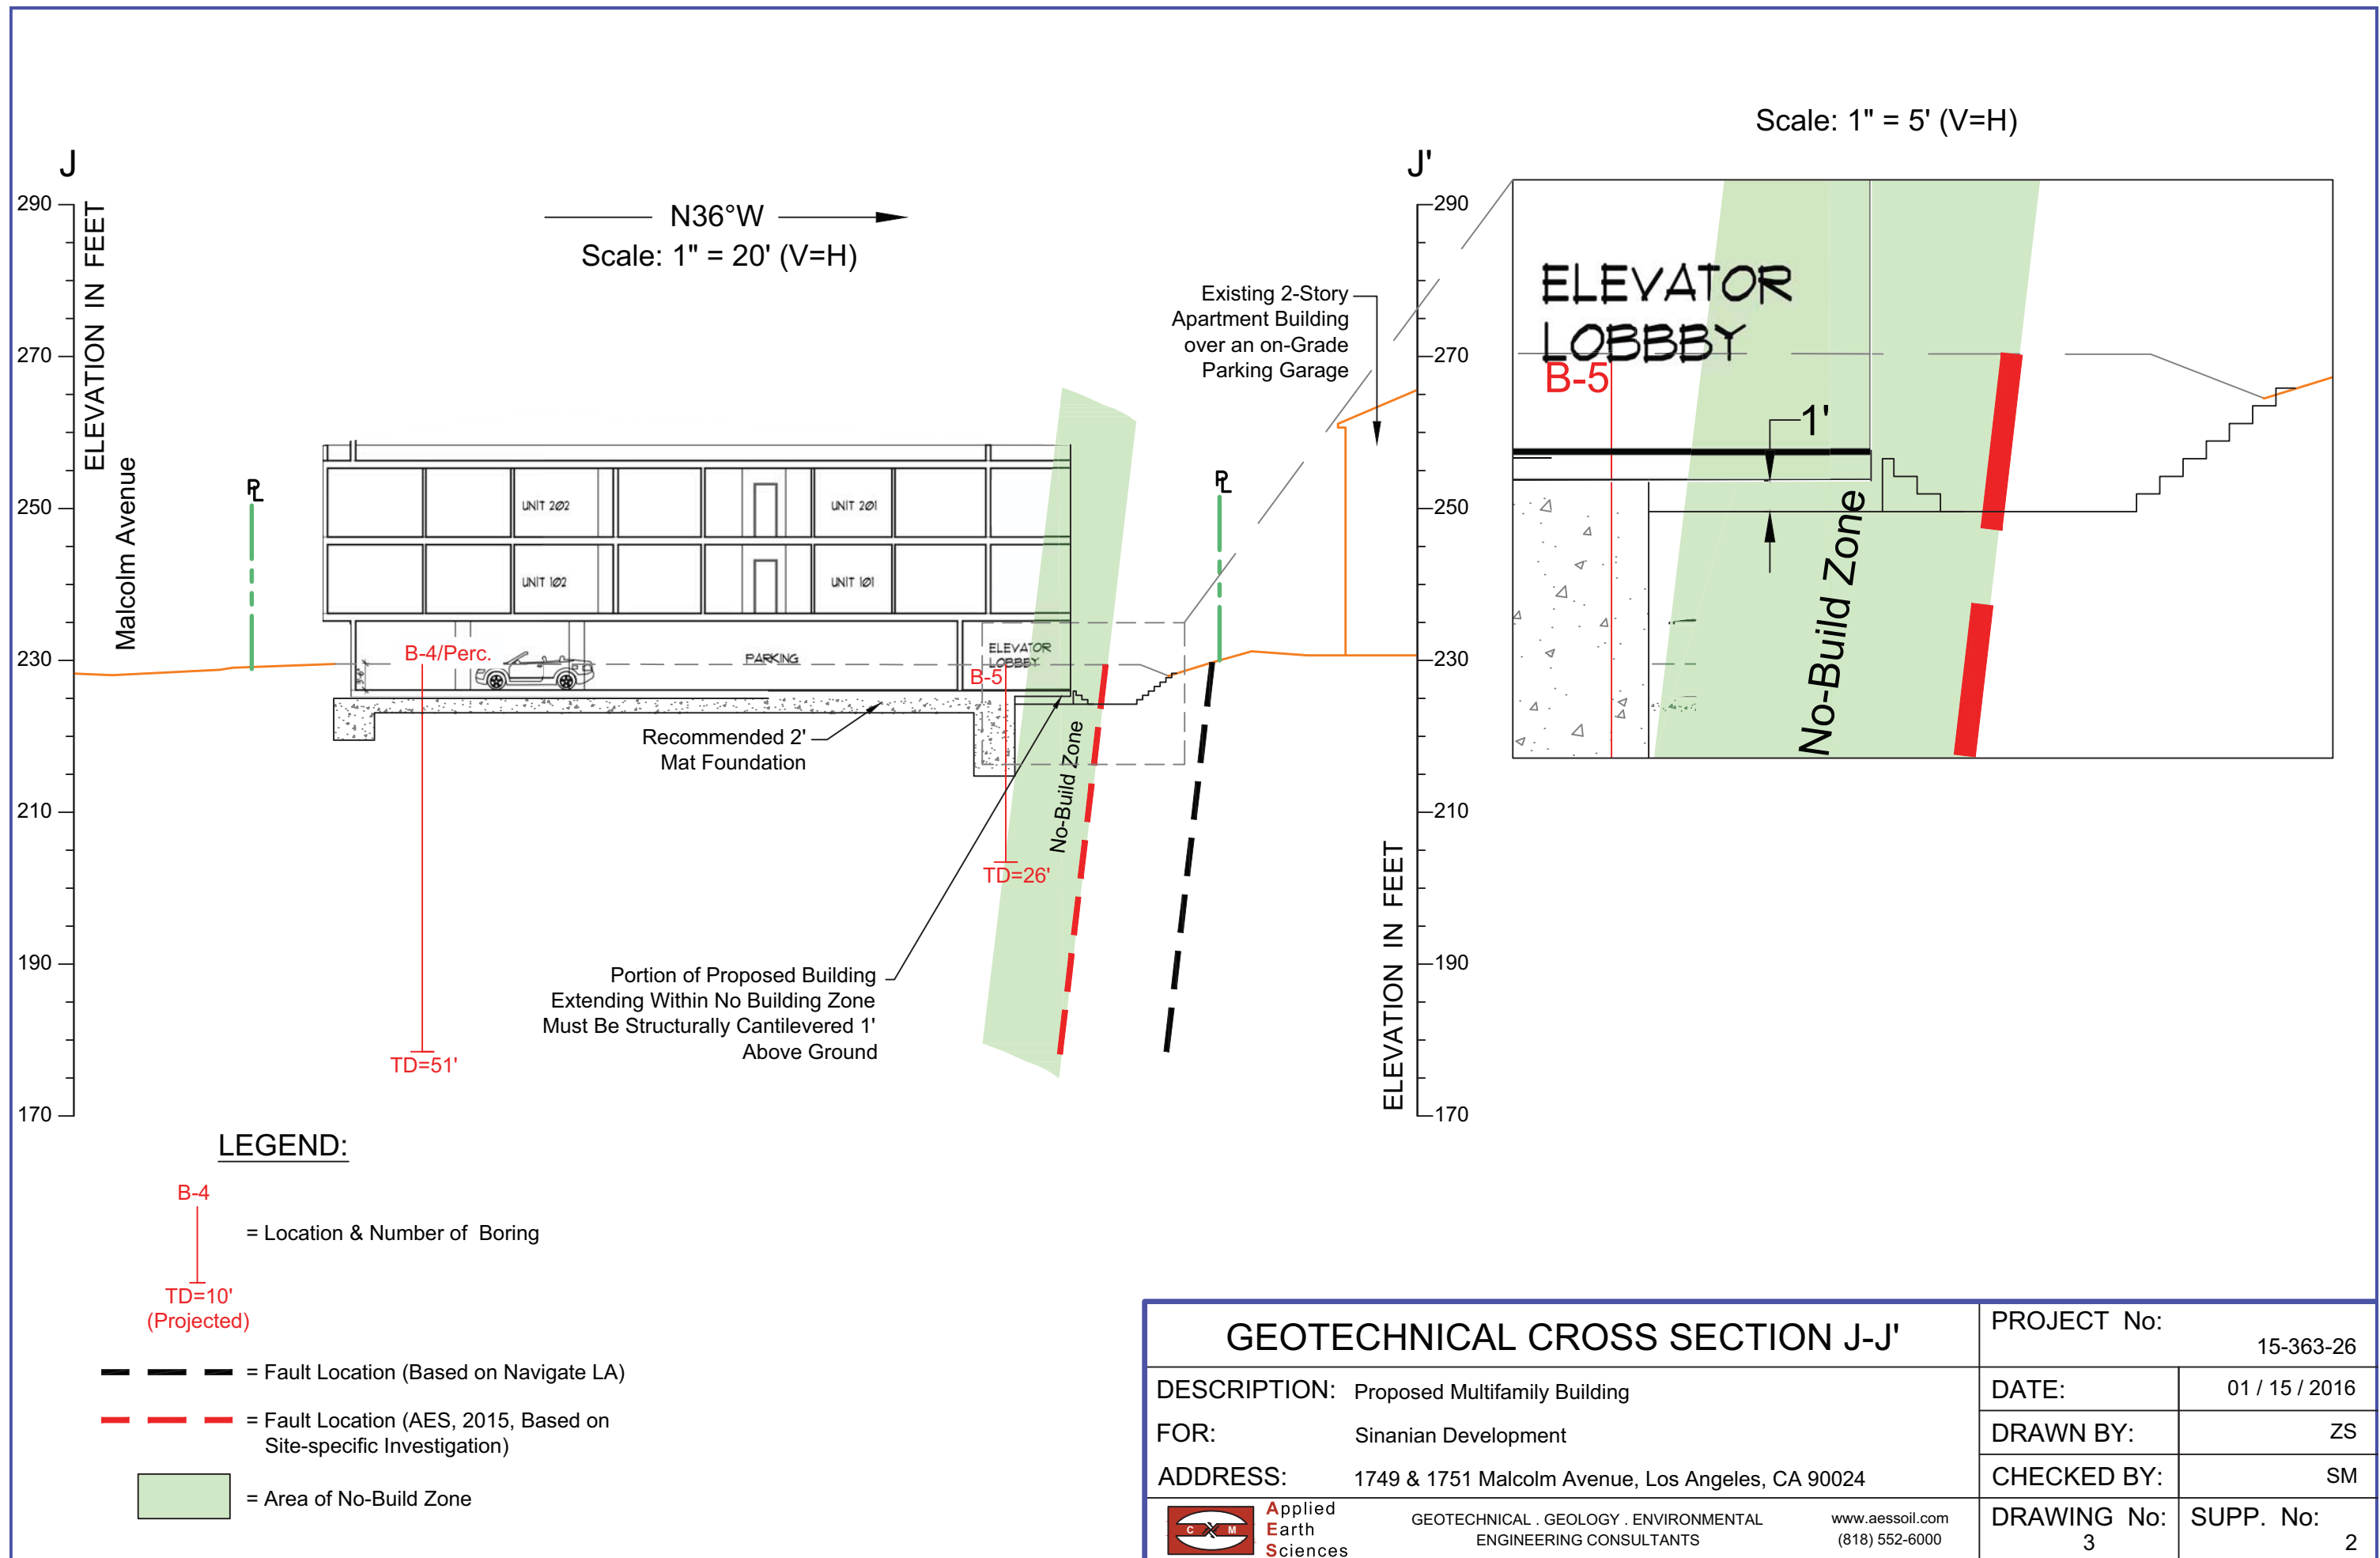
undersigned that the maximum vertical offset along this fault for a single earthquake event is 12 inches. We have depicted the cantilevered portion of the building as such: the area around the proposed new building which will be cantilevered within the setback zone shall be subject to minor grading/shaving of the ground surface, confined to the subject property, such that the cantilevered part of the proposed building will have a minimum of 12 inches clearance above the finished ground surface. Any appurtenant stair or bridge structures that provide access to the lower lobby level of the main building shall be structurally separate from the main building. We have revised our drawings to reflect this requirement; see revised Geotechnical Site Plan and new Geotechnical Cross Sections J and K attached.

In addition, to address off-fault deformation we have recommended a 2-foot thick mat slab foundation for both proposed new buildings, as previously discussed in prior Supplemental Report No. 1. Structural engineering plans for the proposed buildings shall be subject to our review and official stamp and signature approval to ensure that the requirements as set forth in our reports are adhered. Lastly, continuous deputy inspection by a geologist representative of this office during the grading phase of the course of construction shall be required.
