Malcolm/Glendon

Staff Report Reply

Reply to Staff Report, Conclusion

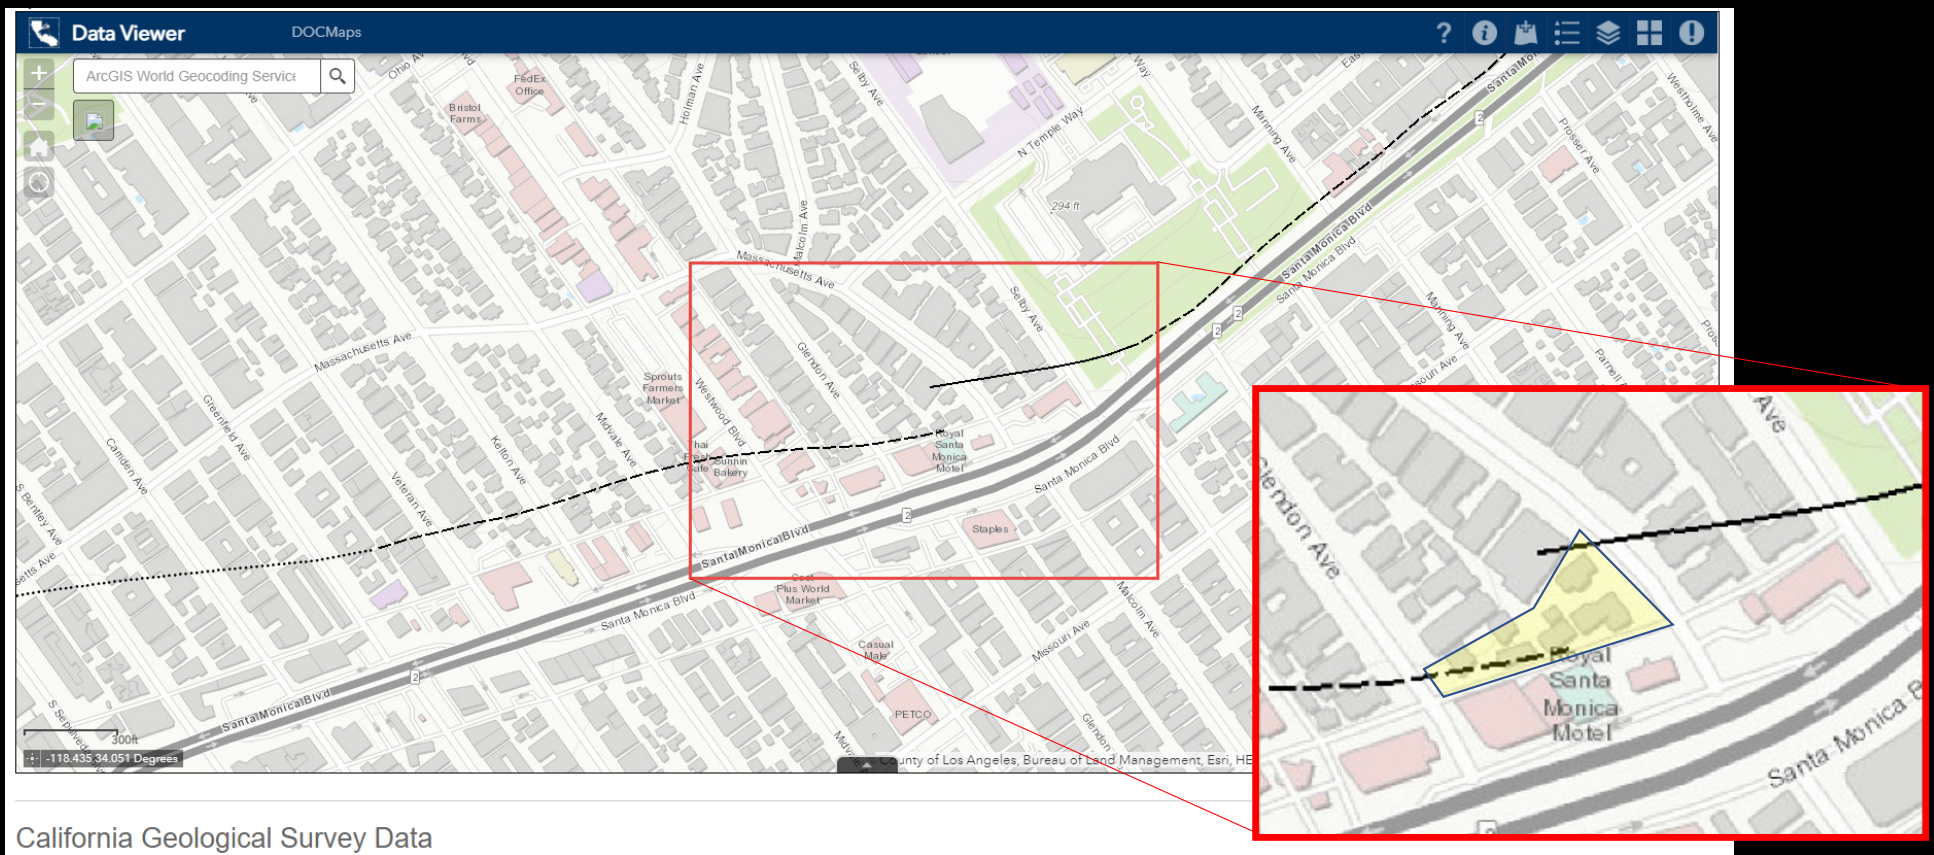
The Authoritative CGS Database Shows At Least Two Traces Under The Project

Both Structures are in an Earthquake Zone

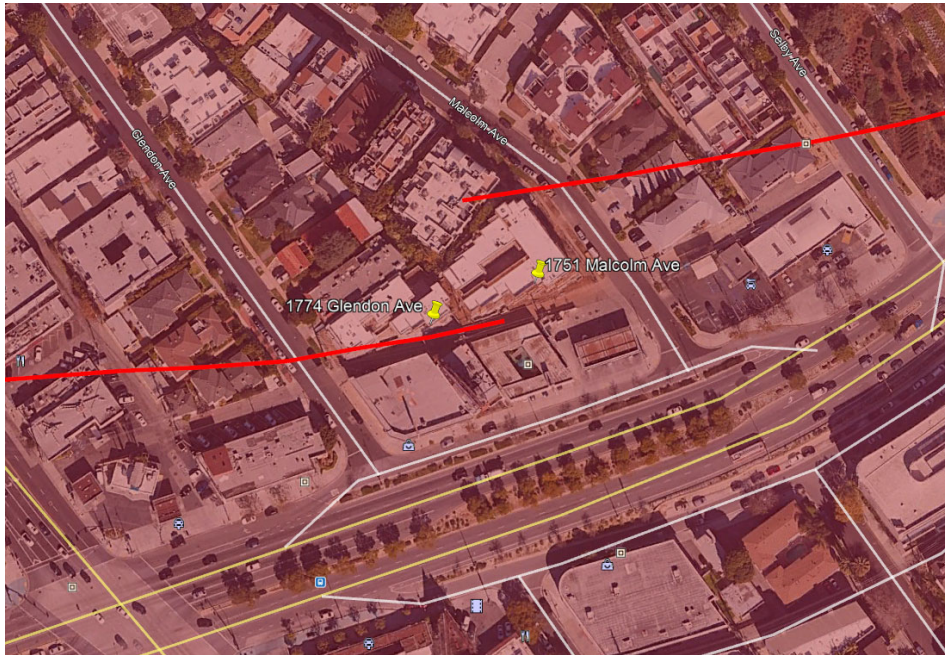
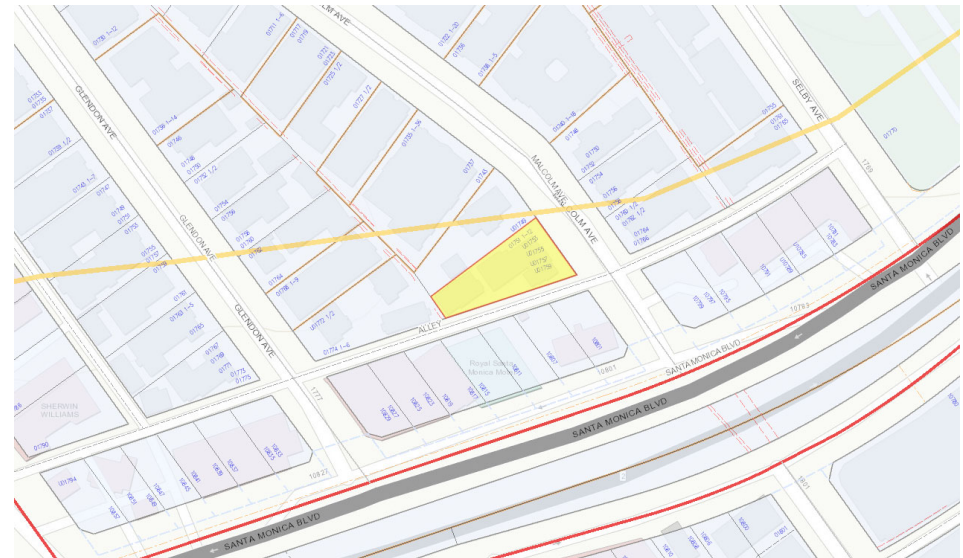
Difference Between Correct and Incorrect

More Error: Zimas/NavigateLA Contain Incorrect Distance to Fault Values

The distance is
ZERO, not .1657
km.

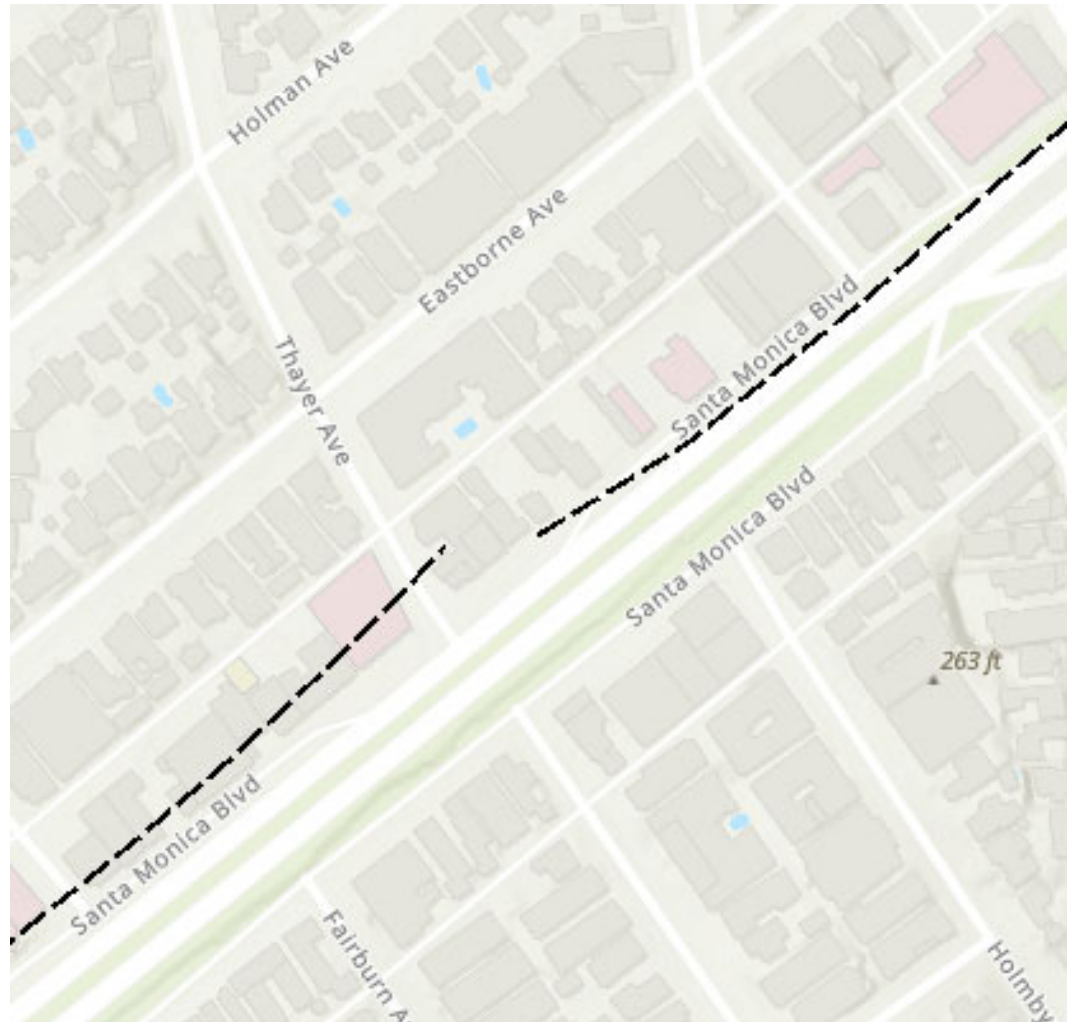
Developer's Report (Malcolm)

Fault traces can start within a property or enter within a boundary.

Exploration on one side does not disprove the presence of fault traces.

No study was done west of “CPT-7” just inside the eastern property line to determine “location, trend, nature” of the fault trace as required.

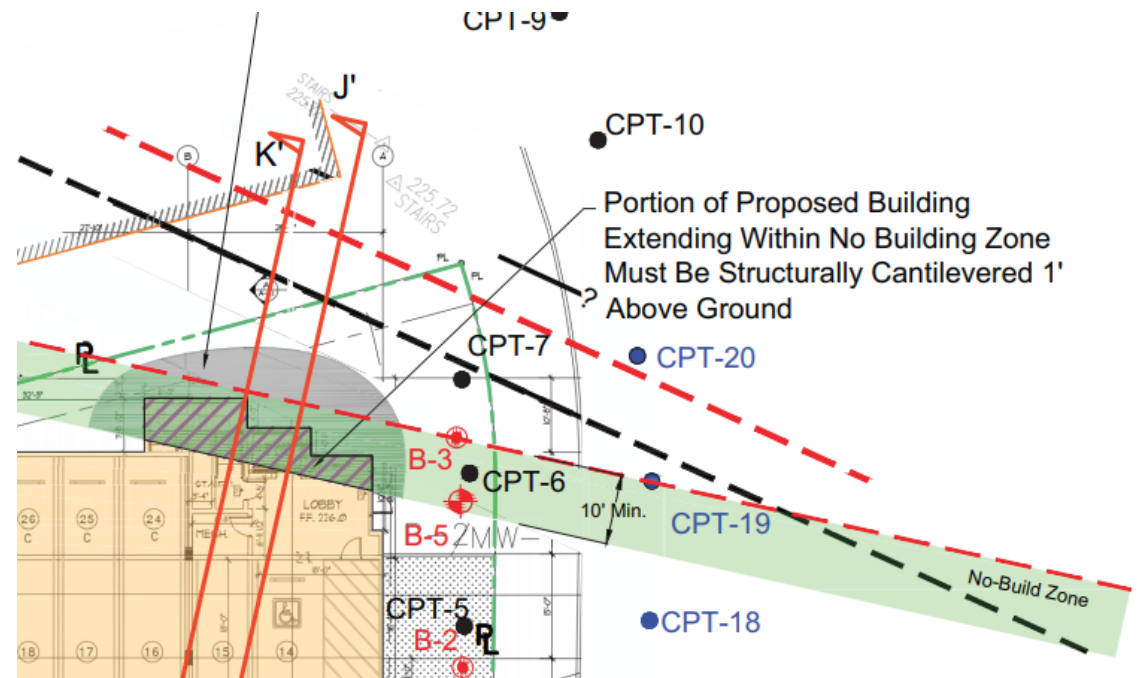
The Project is
built in a no-
build zone at
the fault
trace
resulting in
zero setback

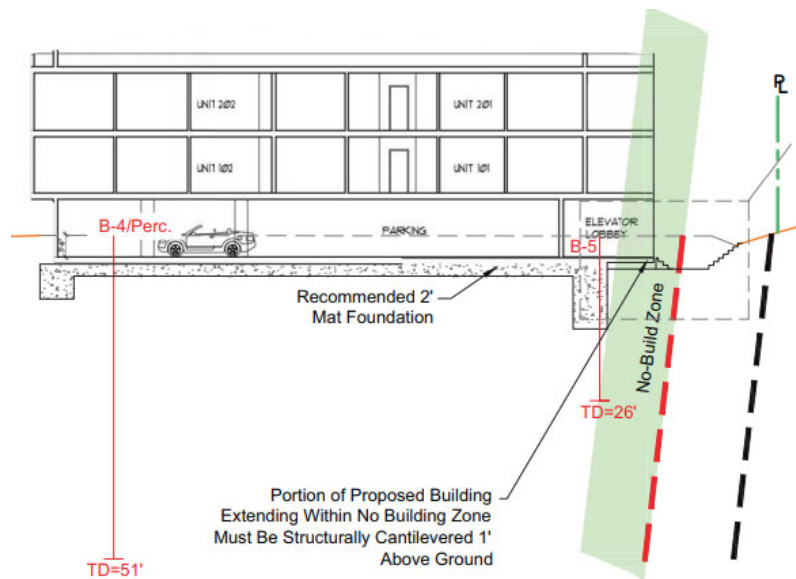
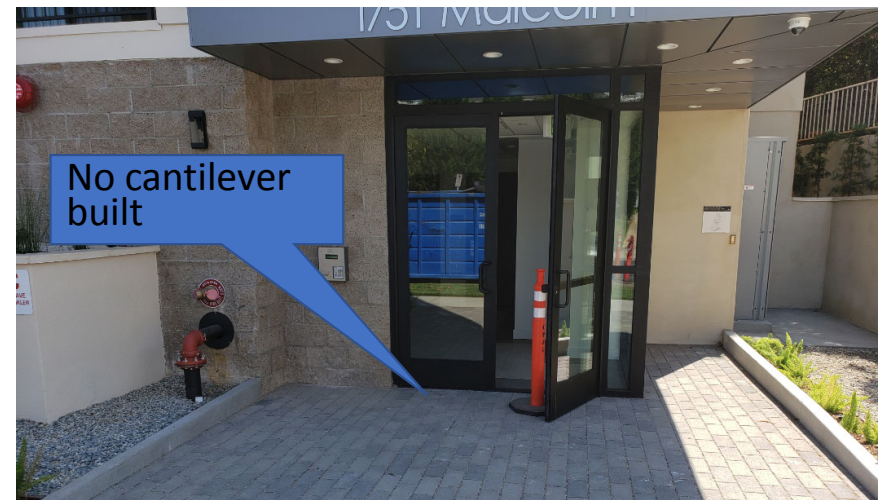
Required Cantilever* Is Not Visible

Note: Building over a fault trace is never allowed – even with a cantilever.

The at grade structure IS connected to the cantilevered section.

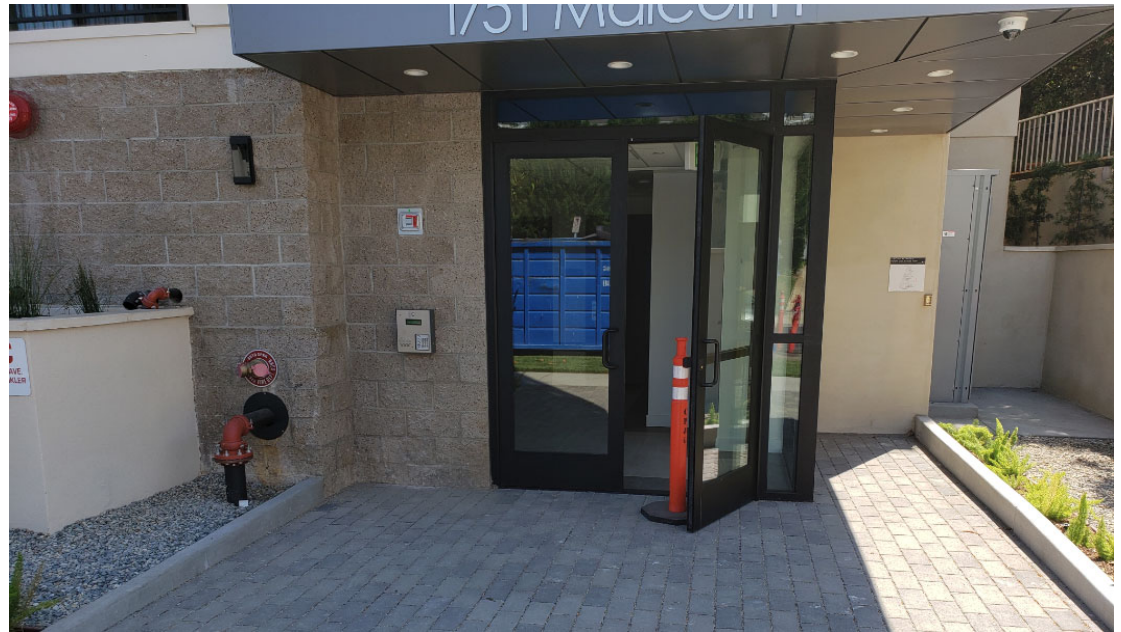
As the consultants recommend building a cantilevered structure within the “No-Build Zone”, the consultants shall provide recommendations as to the maximum vertical and horizontal offset of the fault; and, a recommendation for vertical and horizontal space to be maintained below the cantilevered structure. Provide a plan that depicts the required space maintained below the cantilevered structure. Note: The current plan appears to show a lobby with doorways in the cantilevered area. No at grade structures can be connected to the cantilevered section of the proposed building.
