**CALIFORNIA GEOLOGICAL SURVEY
FAULT EVALUATION REPORT FER 259**

**THE HOLLYWOOD, SANTA MONICA and NEWPORT-INGLEWOOD FAULTS
in the Beverly Hills and Topanga 7.5' Quadrangles
Los Angeles County, California**

by
Brian P.E. Olson
Engineering Geologist
January 5, 2018 (revised)

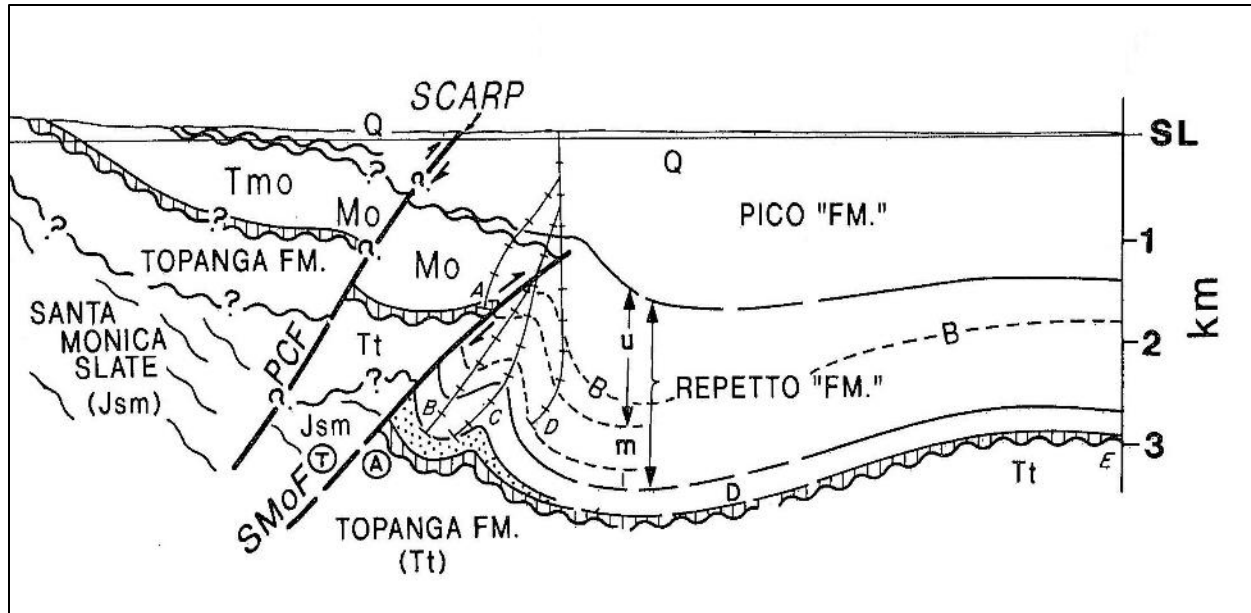
Figure 2 – Geologic cross section showing geometry and nomenclature of the Santa Monica Fault Zone. The basal low-angle blind thrust fault is referred to as the "Santa Monica Fault" (SmoF) and the high-angle hanging wall fault is named the "Potrero Canyon Fault" (PCF). Tmo/Mo = Modelo Formation; Tt = Topanga Formation (modified from cross section I-I' in Wright, 1991)

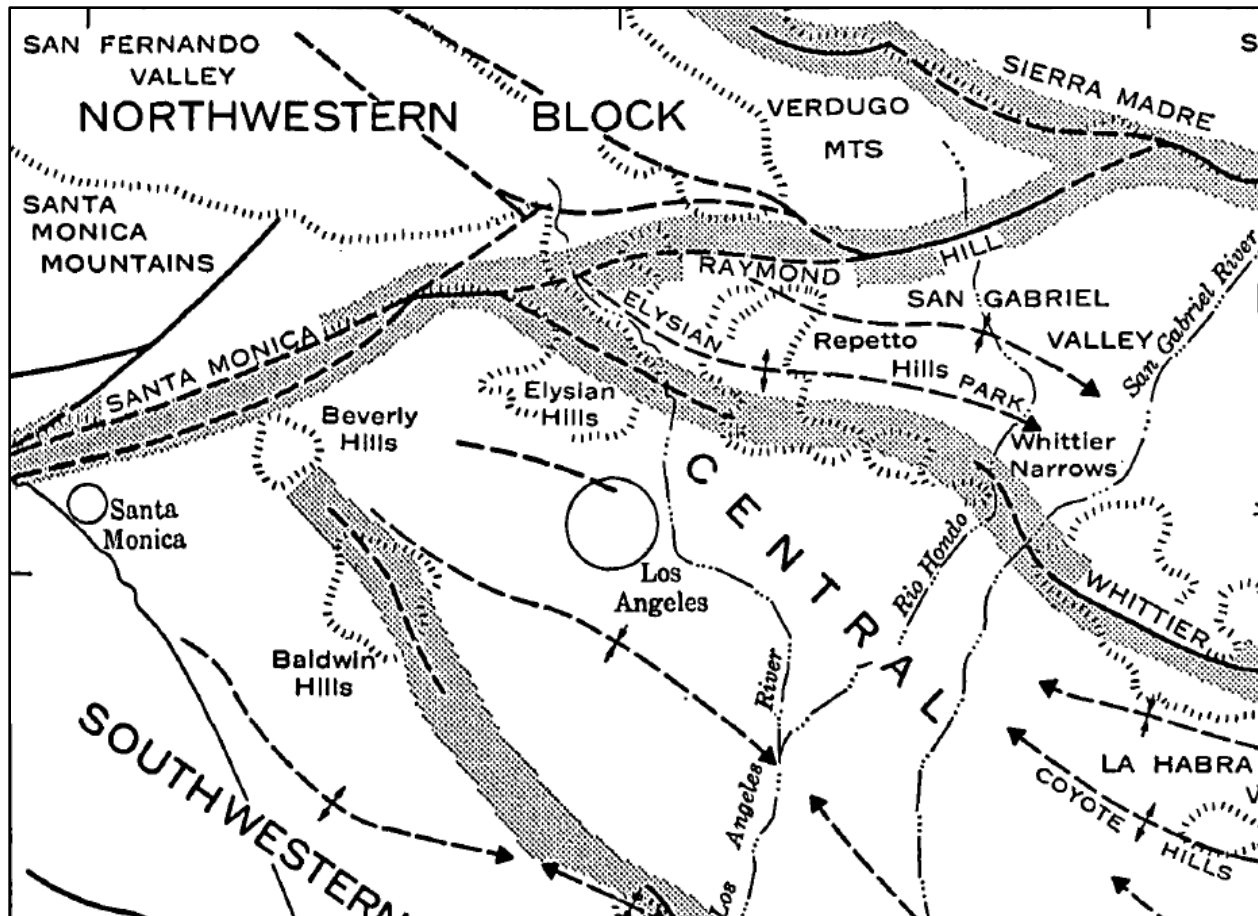
Figure 3 - Fault map from Yerkes *et al.* (1965) showing the "Santa Monica Fault Zone" consisting of two subparallel faults along the base of the Santa Monica Mountains.

The Hollywood and Santa Monica Faults as defined in this report were previously evaluated under the guidelines of the Alquist-Priolo Earthquake Fault Zoning Act (Bryant and Hart, 2007) in 1978. For the initial evaluation, Smith (1978) reviewed the two subparallel faults along the Santa Monica Mountains range front relying chiefly on mapping and observations by Hill *et al.* (1978), without reviewing any aerial photographs or performing any field observations (Figure 3). Zoning was not recommended by Smith for any portion of the "Santa Monica Fault",

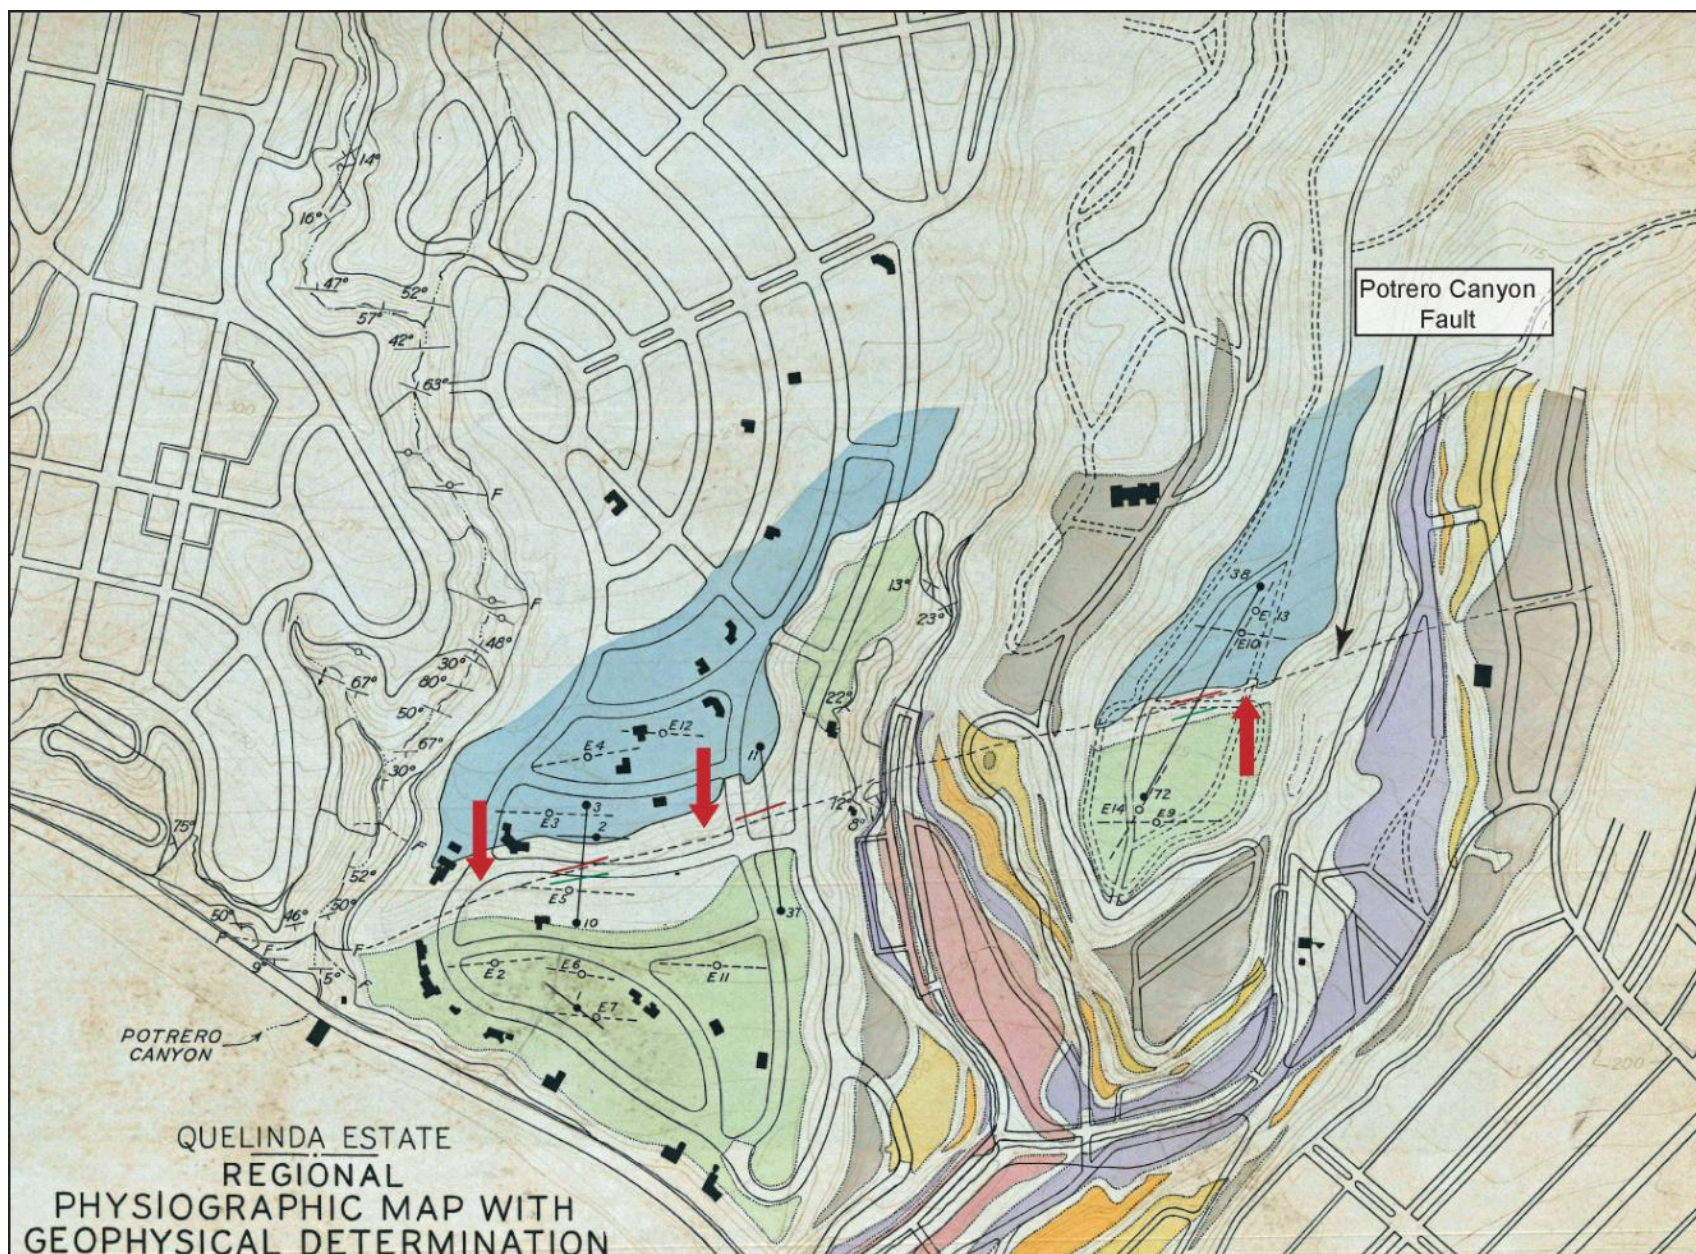
Figure 4 – Map showing various terrace surfaces (colored) and approximate surface trace of the "Potrero Fault". Numbered solid and dashed lines are geophysical transects, red and green line segments are probable fault crossing locations based on geophysical data. Red arrows point to breaks in slope between terrace surfaces interpreted as fault scarps. (modified from Johnson, 1932)

An important early study of the Santa Monica Fault was performed by Johnson (1932) as part of his geologic investigation of the Quelinda Estate in Pacific Palisades (Figure 4). The estate property, now subdivided into residential lots, is located at the top of the cliffs, east of the mouth of Potrero Canyon. Johnson (1932) performed detailed geologic mapping of the cliff faces around Potrero Canyon and along the coast to assess potential hazards related to landsliding and faulting. The fault exposed in the canyon cliff face was referred to as the "Potrero Fault" in this study.

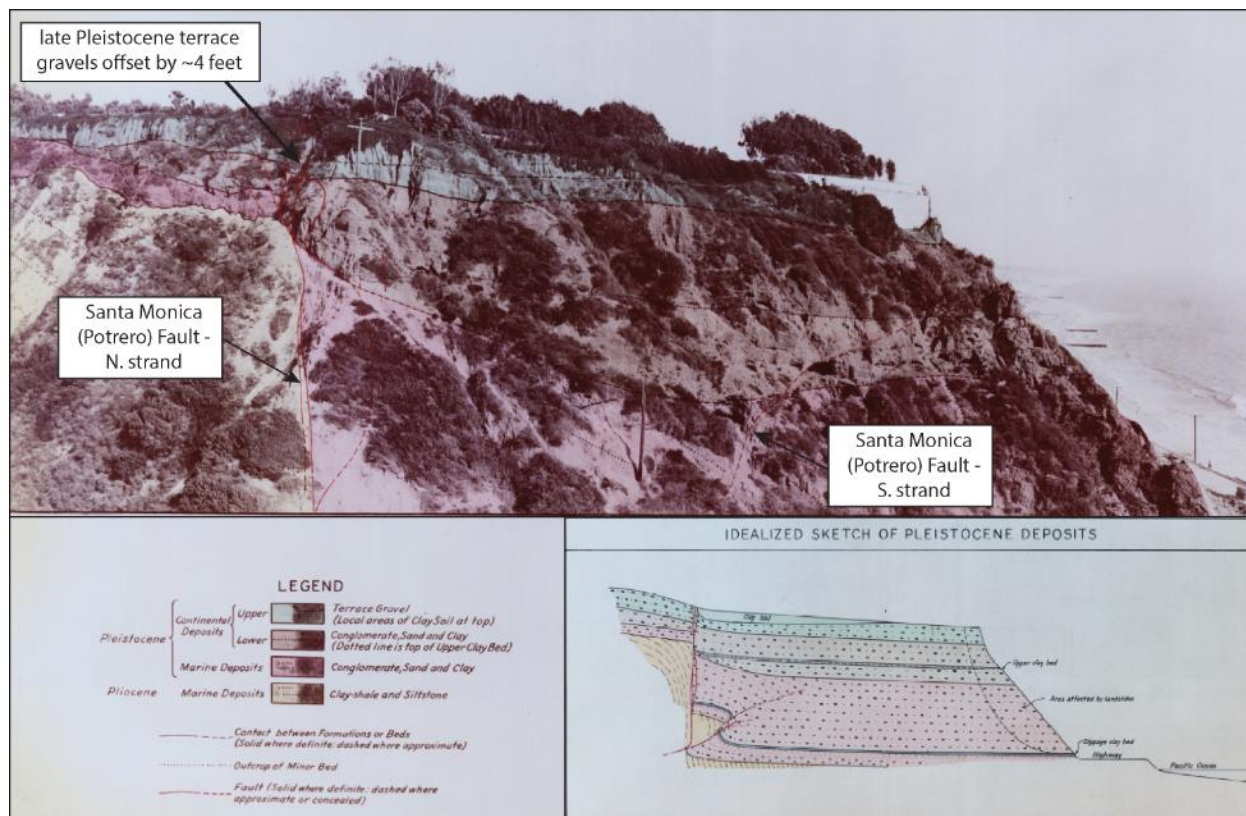
Figure 5 – Annotated photograph of the east wall of Potrero Canyon (c. 1932) showing steeply dipping northern strand and low-angle southern strand of the Santa Monica ("Potrero Fault"). Lower right is a simplified illustration of the stratigraphy and structure exposed in the canyon wall. (modified from Johnson, 1932)

Detailed study of this exposure indicated the Potrero Fault consists of a lower north-dipping fault strand and a near-vertical upper strand extending up to the surface from this lower fault. Up to 100 feet of offset within the Pleistocene sediments was measured, with the uppermost Pleistocene terrace gravels, which are the youngest sediments at the site, offset "at least four feet" (Figure 5). Johnson and his associates studied the uplifted terrace surfaces east of Potrero Canyon for geomorphic indicators of fault movement, studied stream gradient changes in the adjacent canyons, and performed two different types of geophysical surveys in an effort to map out the near-surface trend of the fault. They conclude the data collected "are almost sufficient to classify this fault as geologically active."

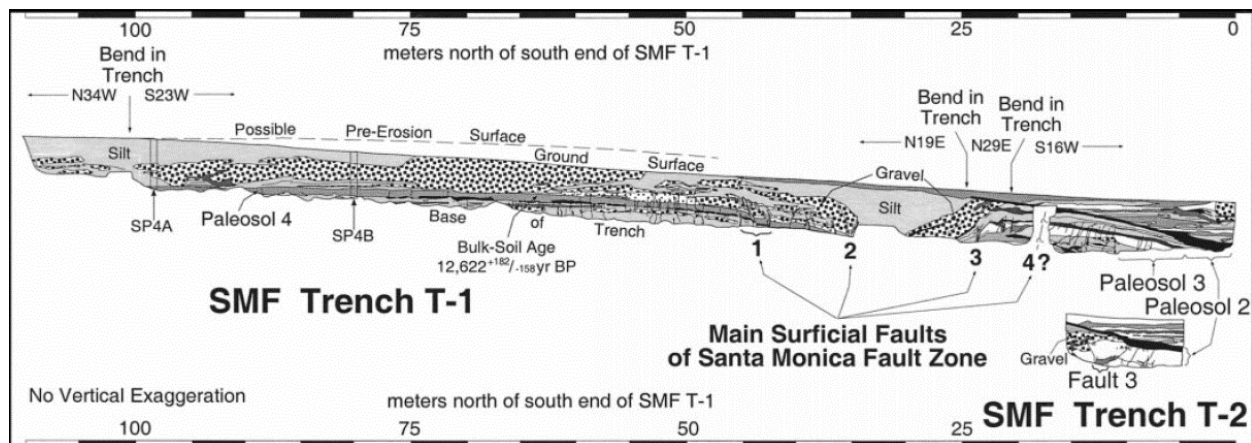
Figure 6 - Log of east wall of the Dolan *et al.* (2000b) trench T-1 at the Veteran's Administration Hospital property. Major paleosol markers and four principal fault strands indicated. Horizontal scale is distance, in meters, measured from the south end of the trench (modified from Dolan, 2000b).

Based on their observations, the authors conclude T-1 contains evidence of at least six surface rupturing earthquake events in about the last 50 k.y. The two most recent are of most concern for the present fault evaluation. Although not directly observed because of the buried electrical conduit, the most recent event recorded in the trench sediments (Event F) is believed

by the authors to have occurred between 1 and 3 k.y. ago on Fault 4. The penultimate event, which is evidenced by offset layers and the presence of a colluvial wedge within Package II, likely occurred about 10-16 ka. Using the approximate dates for the earthquake events on Faults 3 and 4, the authors calculate an average recurrence interval for surface-rupturing earthquakes in the Holocene-latest Pleistocene of about 7-8 k.y.

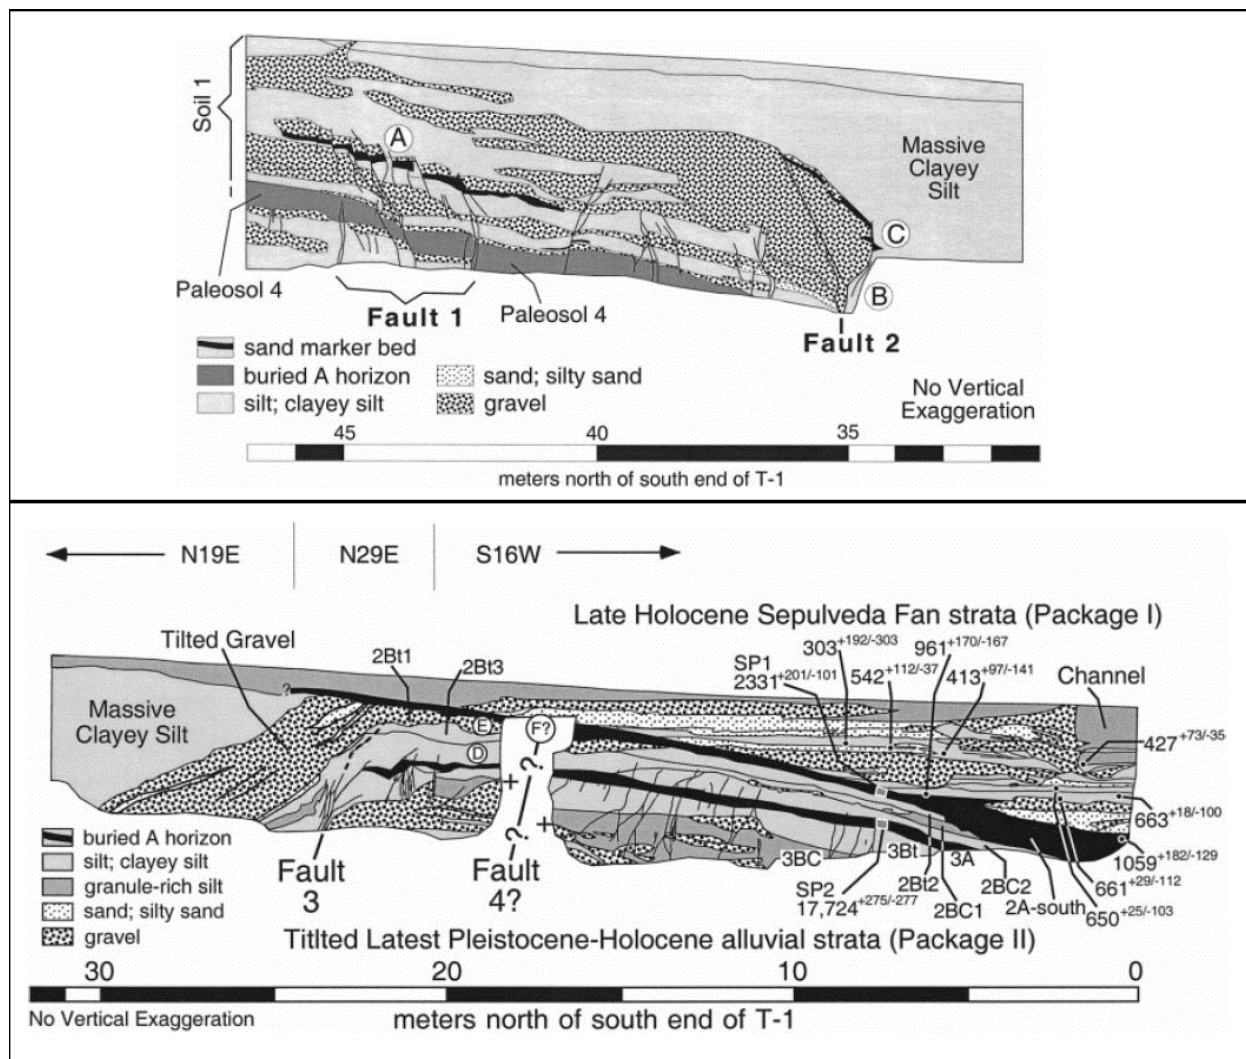
Figure 7 - Detail of central (top) and southern (bottom) walls of the Dolan *et al.* (2000b) trench T-1 at the Veteran's Administration Hospital. Circled letters represent structural or stratigraphic features used to interpret paleo-surface ruptures. **Top:** Deformed sediments associated with faults 1 and 2. **Bottom:** Disrupted south-dipping strata progressively overlain by flat-lying sediments of the Sepulveda fan. Solid black layers are buried A horizons. Small black dots show locations of detrital charcoal samples. Plus symbols mark the top of a displaced pebbly layer used to postulate the existence of fault 4. (modified from Dolan *et al.*, 2000b)

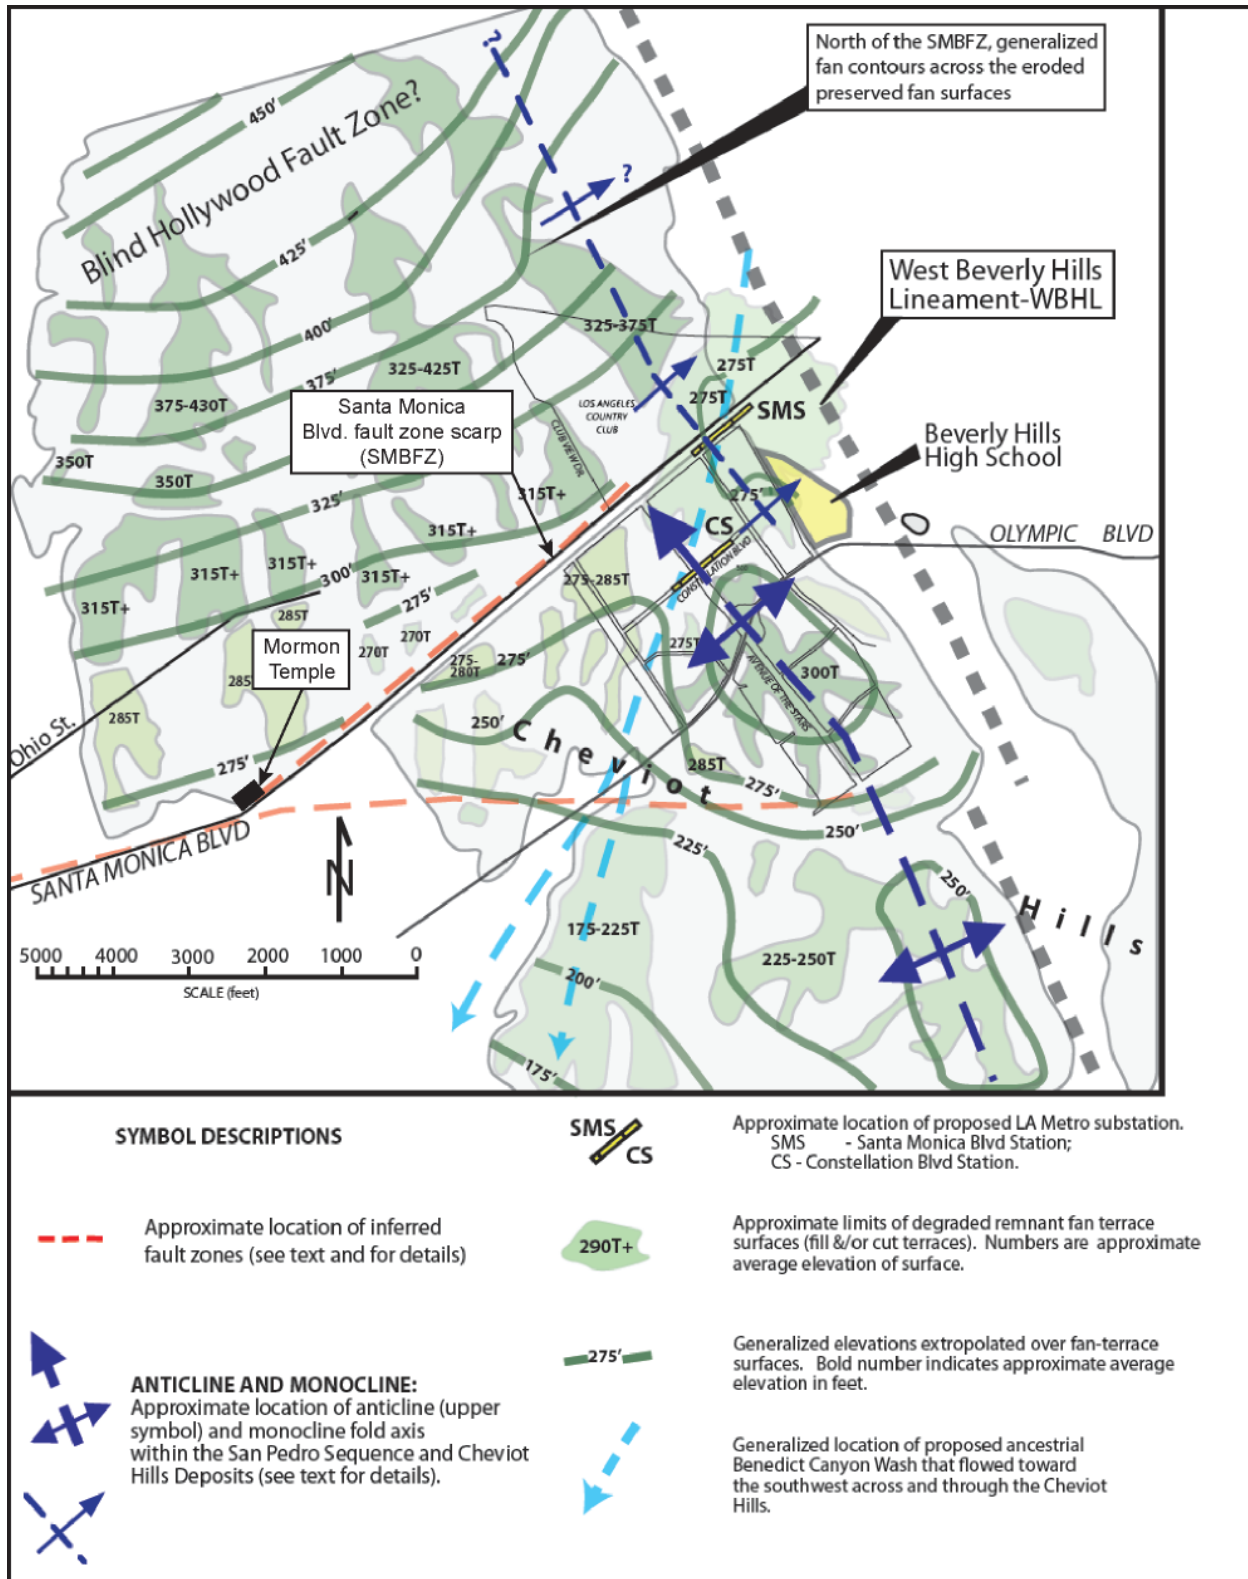
Figure 8 – Simplified contour map of terrace surfaces in the Cheviot Hills from KGS (2012, Plate ES-13)

Based on their detailed review the data, KGS (2011) stated the conclusions of the Parsons Brinckerhoff (2011) study were not supported by the geologic data. They indicated the faults mapped by Parsons Brinckerhoff along the WBHL do not exist and those paralleling Santa Monica Boulevard do exist, but are not active. KGS named this latter fault zone, which extends from the Mormon Temple to the Los Angeles Country Club and into western Beverly Hills, the Santa Monica Boulevard Fault Zone (SMBFZ) (Figure 8).

KGS (2011) refers to this fault zone, which extends from the Mormon Temple to the Los Angeles Country Club and into western Beverly Hills, as the "Santa Monica Boulevard Fault Zone" (SMBFZ) (Plate 1 and Figure 8). Similar to the fault strands mapped at Potrero Canyon and observed by Dolan *et al.* (2000a), KGS postulates the SMBFZ consists of various sub-vertical secondary upper plate faults rooting into a blind low-angle basal oblique reverse fault at depth. Based on the subsurface data reviewed, they identified two major sets of faults. The first set parallels Santa Monica Boulevard and is sub-divided into three zones: Fault Zone A, Fault Zone F, and Fault Zone G (Figure 10). Zone A is interpreted as a series of primarily strike-slip faults that trend northeast and parallel to the strong geomorphic scarp identified by Dolan and Sieh (1992) along Santa Monica Boulevard and turning northeasterly through the country club. KGS (2014) proposes this fault zone may continue on trend across the WBHL and the northern Beverly Hills alluvial plain to connect with the western Hollywood Fault (Plate 1). Zones F and G are subparallel and south of Zone A, and some splays of Fault Zone F may continue across the WBHL and extend across the Beverly Hills alluvial plain where they may connect with the blind North Salt Lake Fault and the Hollywood Fault (Plate 1). The Fault Zone G strands are interpreted from relatively sparser data set than other areas, and therefore, the general strike, number of faults, and sense of offset are not well constrained. East of BHHS and roughly orthogonal to Fault Zones F and G, KGS identified a set of northwest-trending faults, which do not parallel the regional trend of the WBHL. They indicate displacements across the Zone H faults appear to be down to the east, but the activity of these faults is not well known. Based on the postulated strike of Fault Zone H, it is possible it could connect with strands of the Newport-Inglewood Fault identified by Erickson and Spaulding (1975) east of the WBHL.

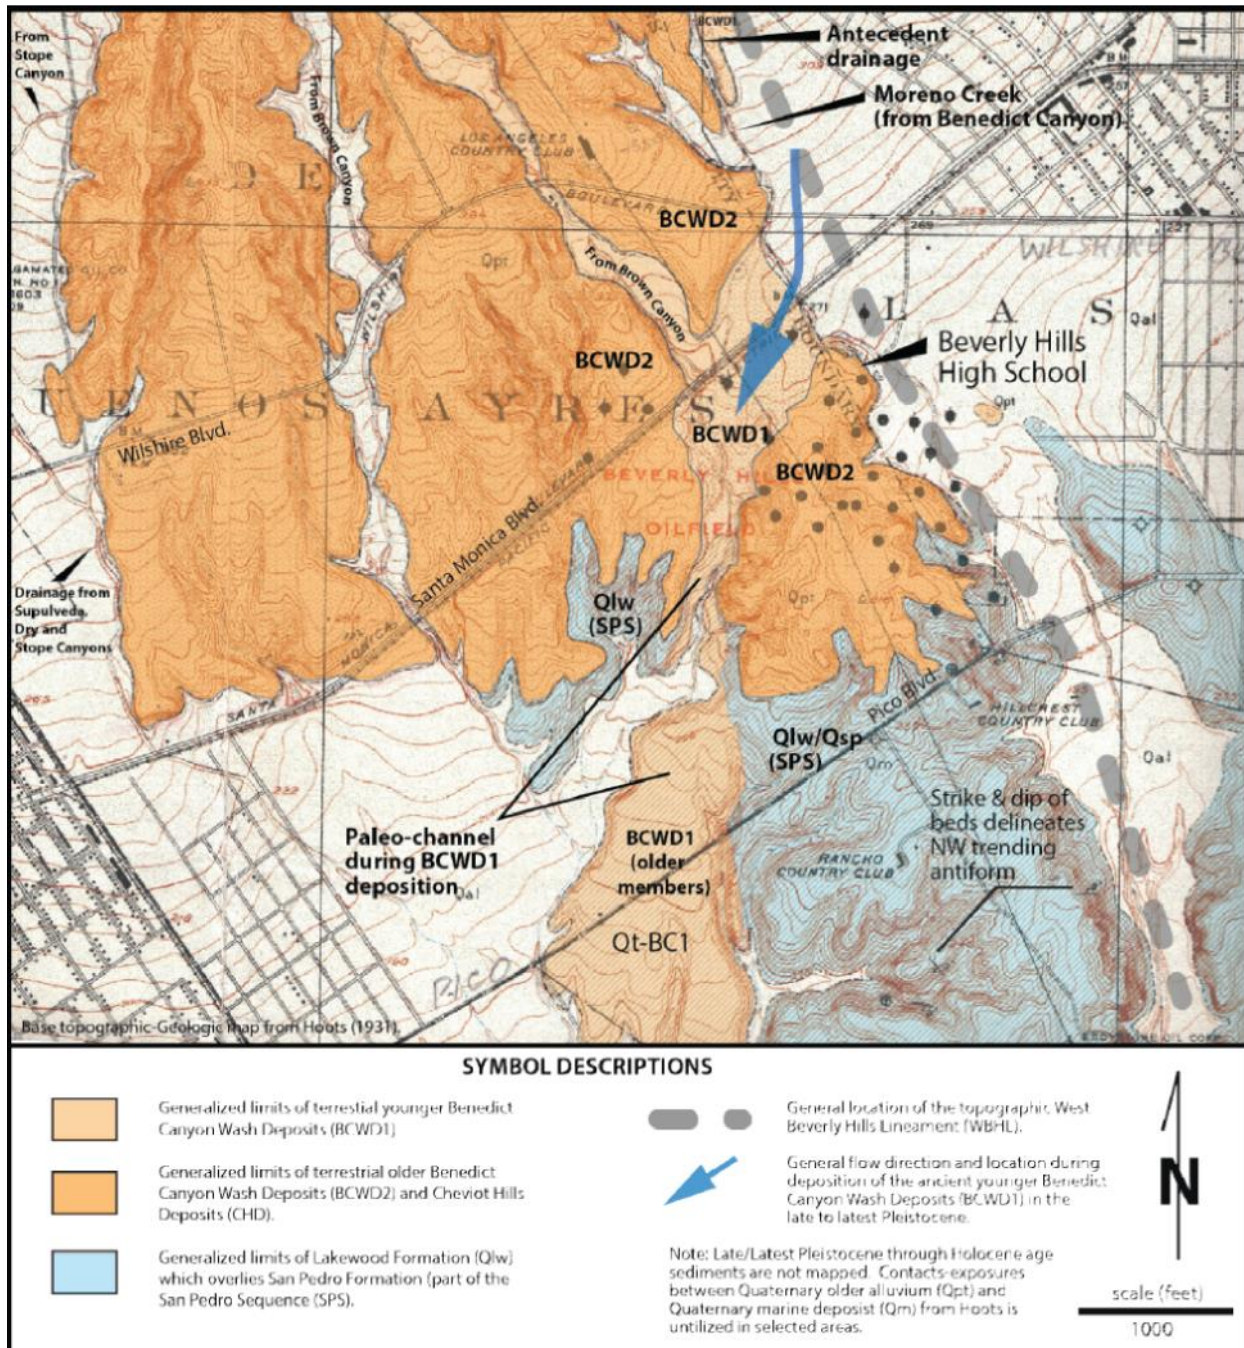
Figure 9 - Generalized geologic map of the Cheviot Hills from KGS (2014, Figure 15).

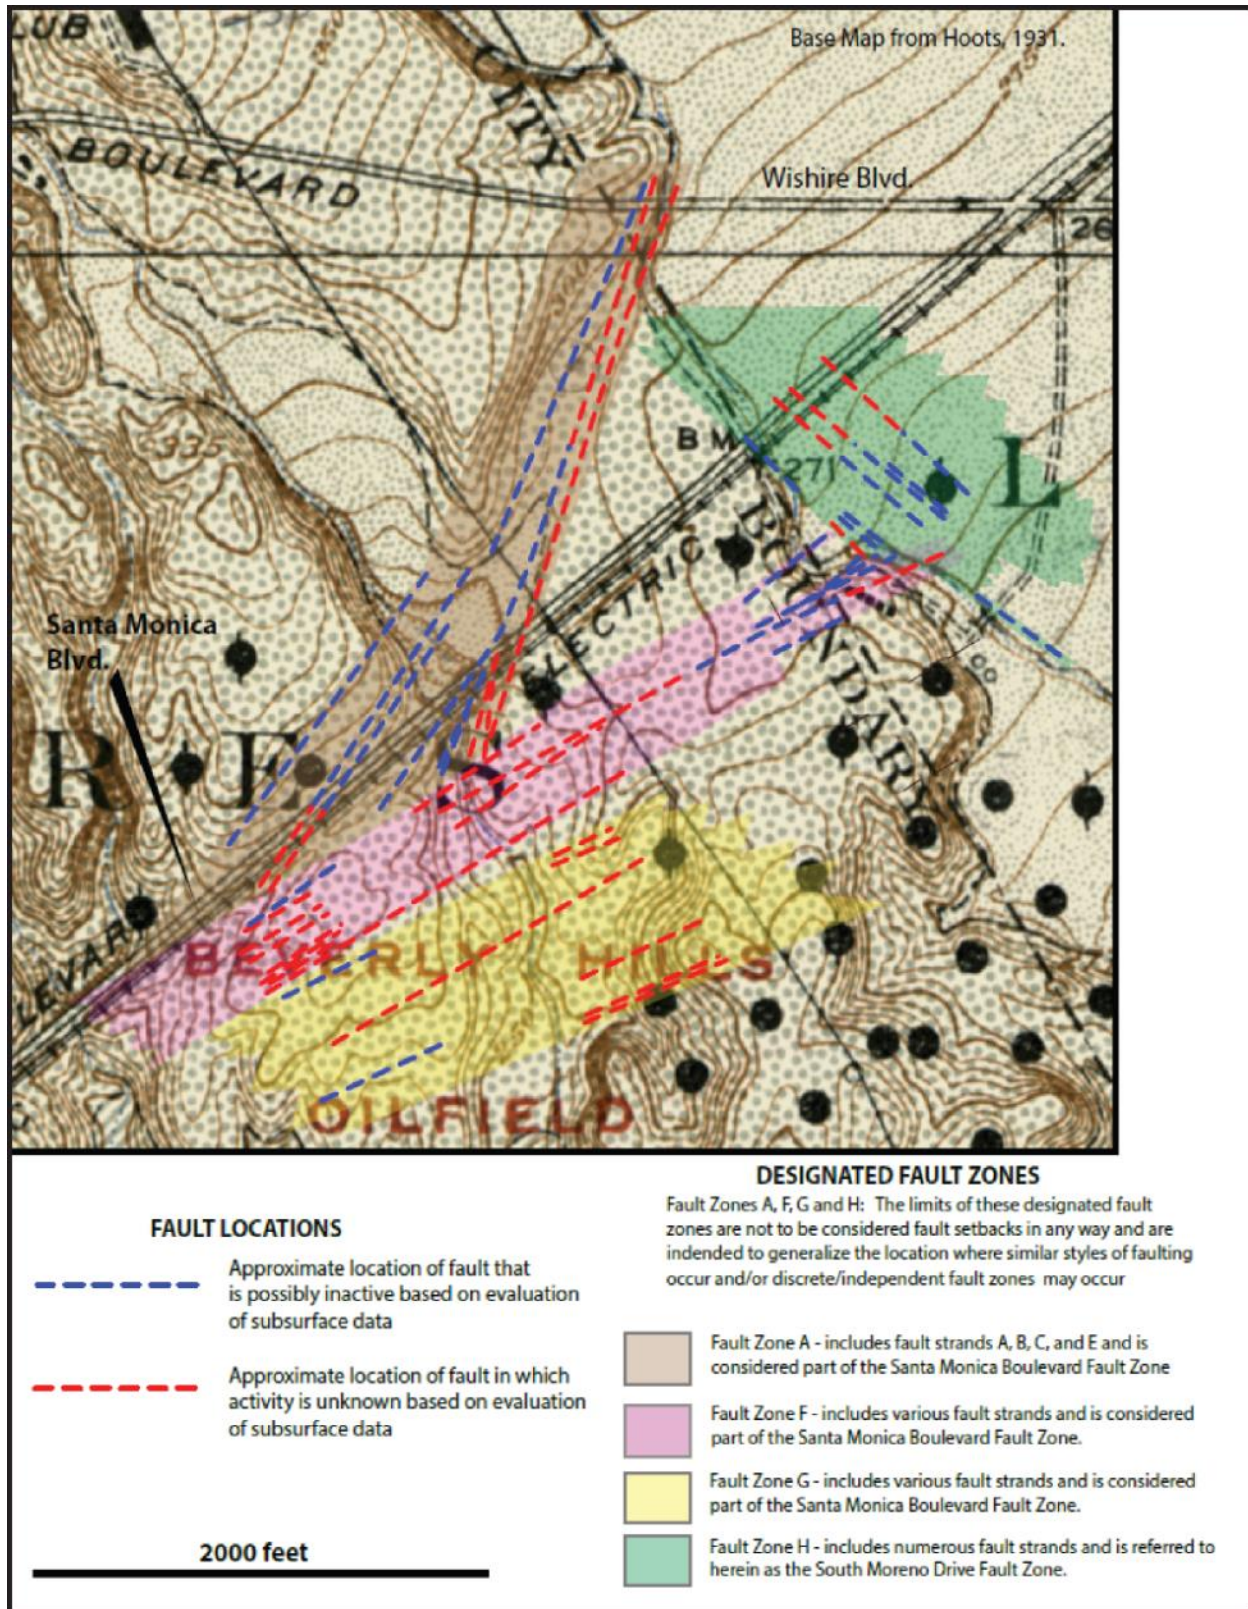
Figure 10 - Major fault zones identified by KGS and discussed in text. (base image, symbology, and descriptions from KGS, 2013, Figure 1)

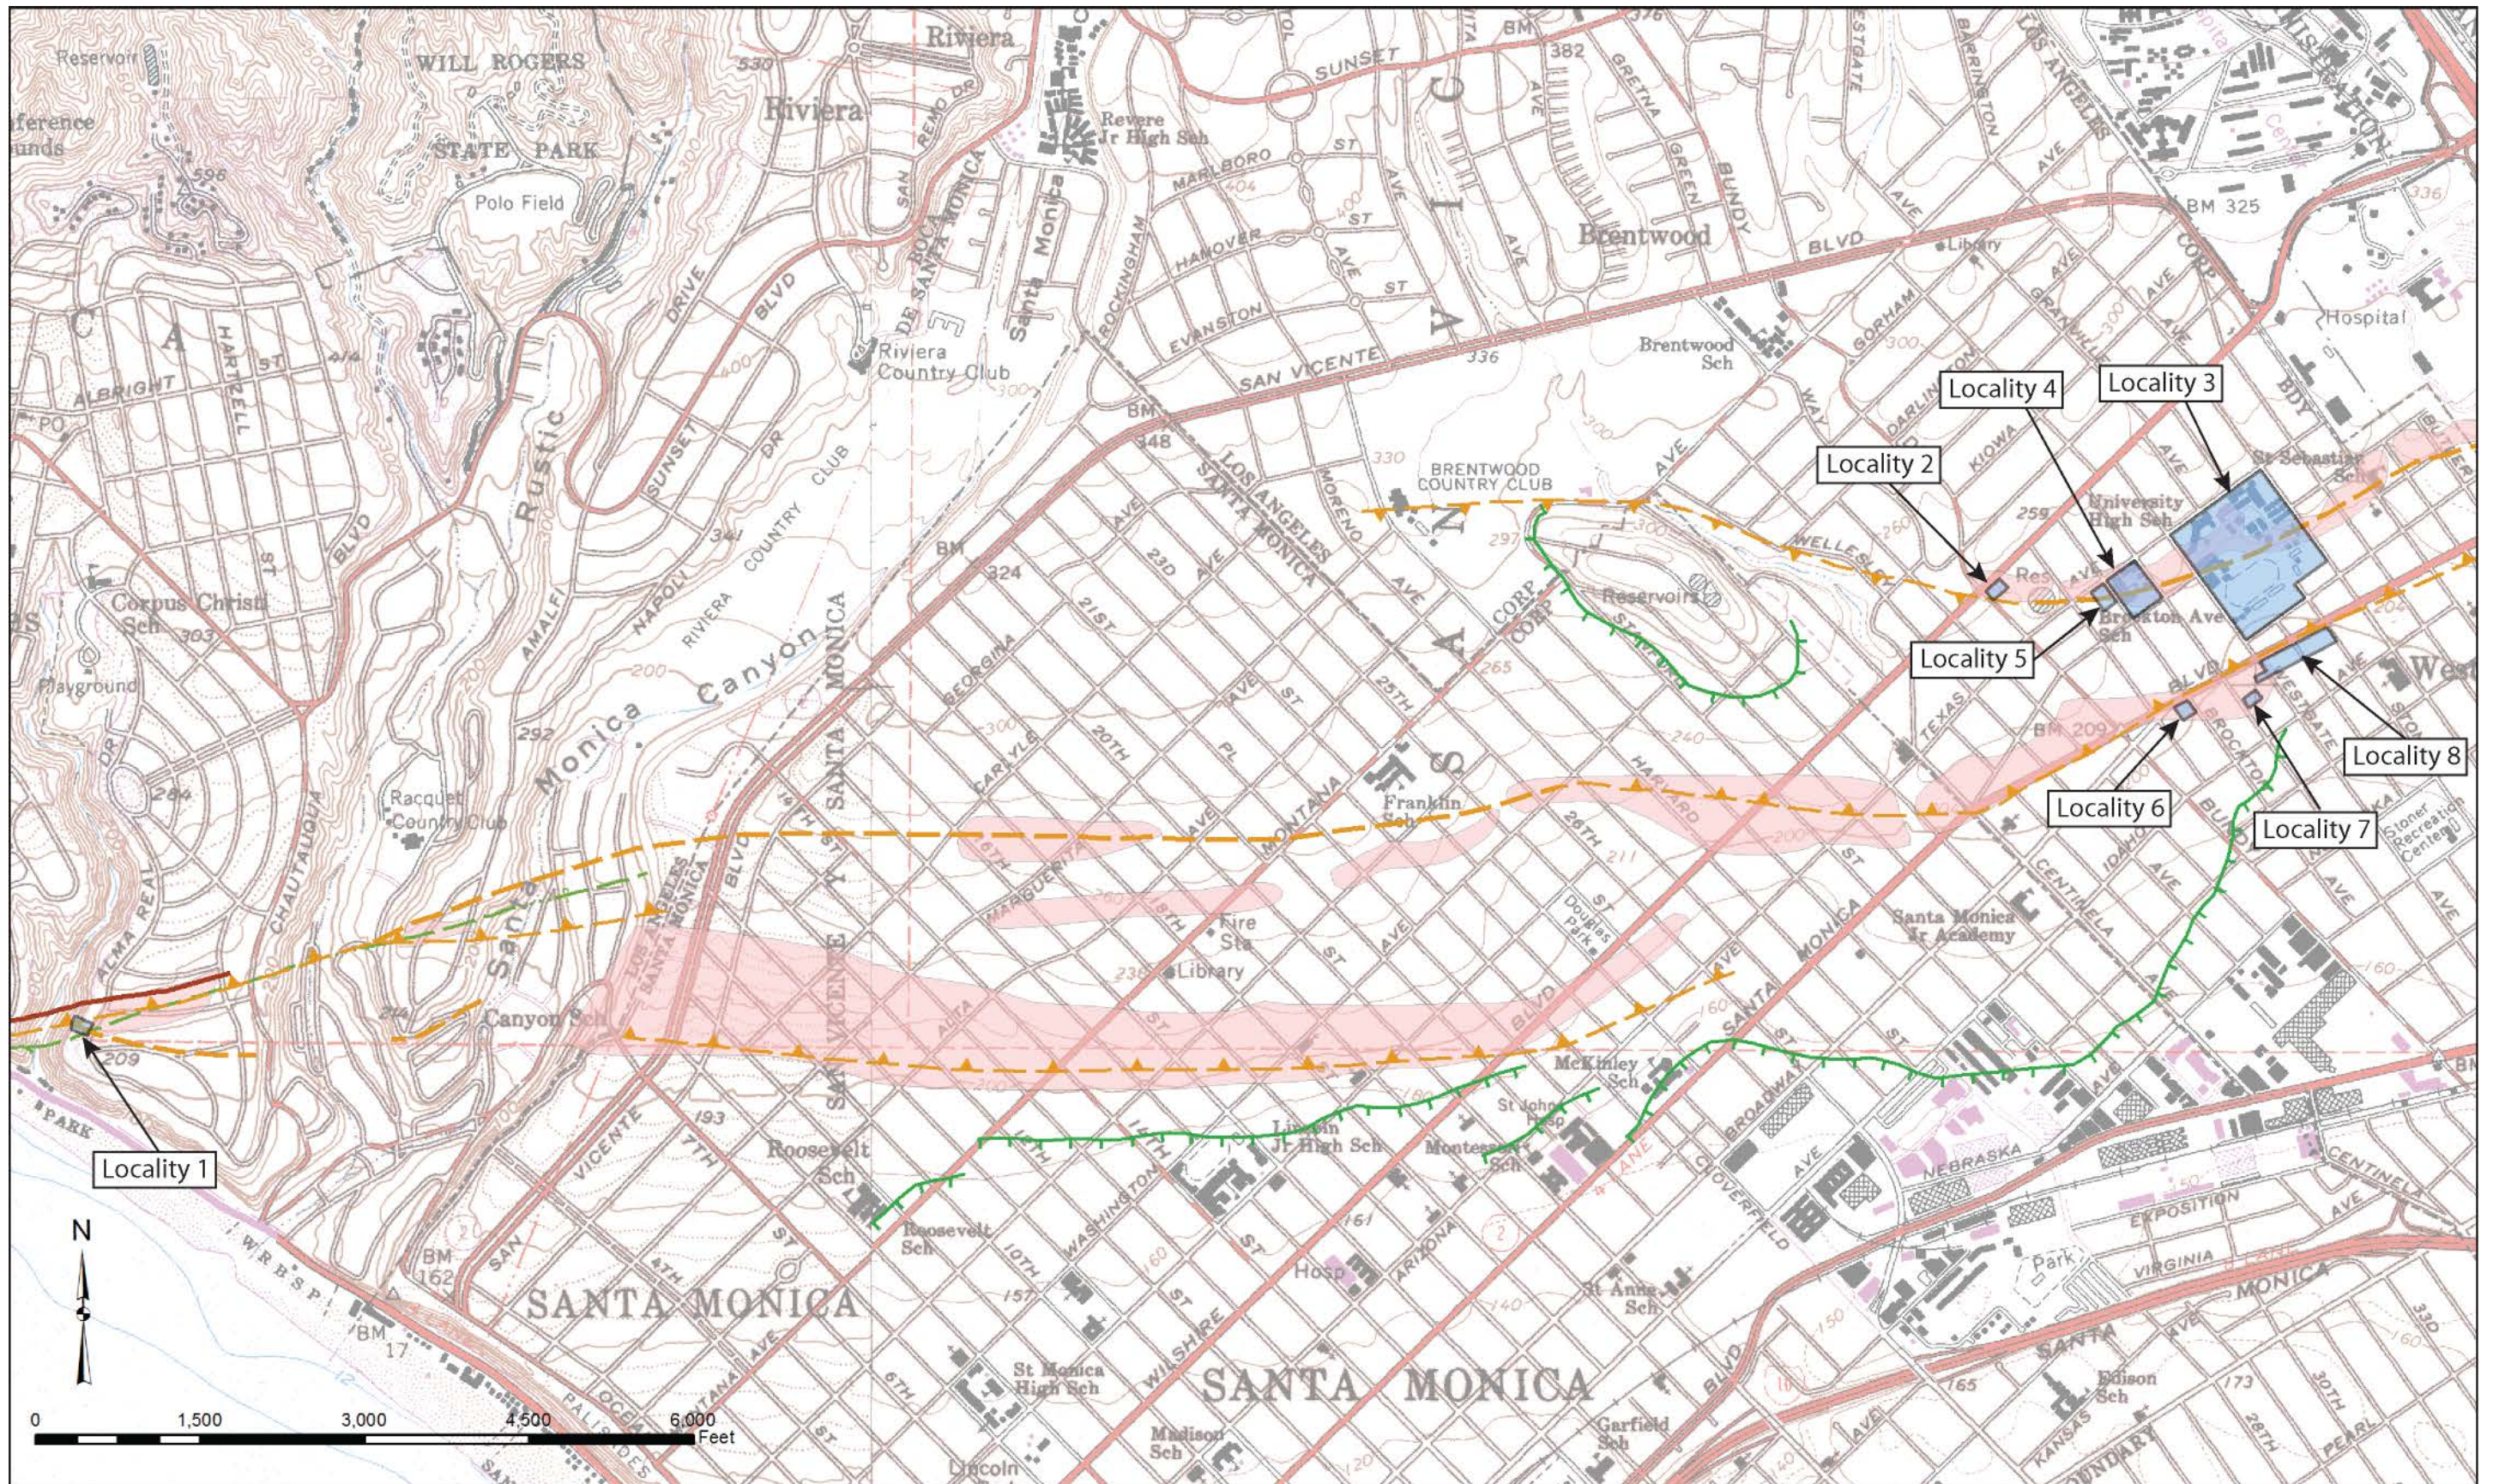
Figure 11 - Study site boundaries (light blue boxes) where investigations provide data relevant to evaluation of the Santa Monica Fault Zone west of Interstate 405 (localities 1 through 8, discussed in text). See legend on Plate 1 for fault types and mapping sources. Shaded area is the approximate limit of "fold scarps" identified by Dolan *et al.* (2000a).

(for referenced localities, see Figures 11 and 14)

Subsurface geologic and fault investigation studies related to various proposed developments and environmental monitoring have been completed throughout the study area. Pertinent studies were reviewed for data relating to the evaluation of the Santa Monica Fault Zone and are summarized below with locations depicted on Figures 11 and 14.

In 1997, a groundwater monitoring program was initiated at a gas station located at 12054 Wilshire Boulevard (Figure 11 – locality 2). Approximately 45 groundwater monitoring wells were installed at the site and to the south (down-gradient) to determine the hydrogeology of the site and monitor the groundwater remediation program. Based on the subsurface data collected from these wells, the consultants identified two faults, which act as groundwater barriers. The groundwater elevation data shows an approximately 60-foot drop in groundwater level across the northern strand and about a 15-foot change in the groundwater surface across the southern strand. (Worley Parsons Komex, 2009). A similar sharp drop in depth to groundwater was reported in Dolan *et al.* (2000a) on a site at the northwest corner of Wilshire Boulevard and Bundy Drive, immediately adjacent to this site. Additionally, a strand of the SMFZ was observed in an excavation for a building at the same intersection (G.A. Brown, 1993, pers. comm., reported in Dolan *et al.*, 2000a).

Two blocks west of University High School (Figure 11 – locality 3), MACTEC (2006) performed another fault investigation of the Santa Monica Fault Zone at Brockton Avenue Elementary School. The well-defined scarp noted at the Veteran's Hospital and University High School extends farther west and crosses the southern edge of the campus where it was clearly defined and up to 9 meters high before being modified and partly obscured by grading for the southern parking lot. The study consisted of drilling four continuous core borings and 20 CPTs along two different transects perpendicularly across the scarp. Sediments similar in age and lithology to those encountered at University High School were observed in the core samples collected by the consultants.

Geotechnologies, Inc. (2005) conducted a geotechnical investigation for a property south of the intersection of Brockton and Texas Avenues in Los Angeles (see Figure 11 – locality 5). There was no fault study *per se* conducted for this site, but a groundwater elevation anomaly was noted by the consultants in their borings drilled across the site from north to south. They indicate this elevation difference likely represents discontinuous perched groundwater bodies within the alluvium. However, groundwater anomalies are associated with the Santa Monica Fault at both University High School (Locality 3) and Brockton Avenue Elementary School (Locality 4) to the east, and therefore, may suggest the presence of faulting in the subsurface at this site also.

Beginning in 1988, a soil and groundwater remediation program was initiated at a gas station located at 11954 Santa Monica Boulevard (Figure 11 – locality 6). As part of this mitigation effort, several groundwater monitoring wells were installed at the site to document groundwater elevation and gradient, and to allow for water sample collection and testing. The consultants note a distinct stratigraphic discontinuity between the monitoring well installed in the northwestern corner of the property and the wells across the rest of the site (Delta Consultants, 2010). Additionally, groundwater elevation data collected from the seven wells installed throughout the

Applied Earth Sciences (2014a) (Figure 11 – locality 7) performed a fault investigation by constructing a linear profile consisting of two continuous core borings drilled to approximately 90 feet deep and nine CPTs advanced to a maximum depth of 91 feet. The borings and CPTs were drilled along Armacost Avenue within one of the "fold scarps" identified by Dolan *et al.* (2000a). Both Holocene and Pleistocene alluvium was encountered and the consultants identified four distinct depositional units within these sediments, which dipped to the south roughly parallel to the existing ground surface. These layers were continuous and unbroken along the entire length of the transect. Additionally, they observed there were no notable breaks in slope or scarps near the site that might suggest the presence of faulting. Consequently, they conclude there are no strands of the Santa Monica Fault Zone at this location.

Geocon West, Inc. (2014a, 2015, Figure 11, locality 8) conducted a fault investigation along Westgate Avenue for a proposed mixed-use development. The site is located at the eastern end of a "fold scarp" identified by Dolan *et al.* (2000a) that the authors postulate is formed by near-surface faulting within the Santa Monica Fault Zone. The subsurface investigation consisted of a linear transect of 10 continuous core borings drilled to depths ranging from 65 to 75 feet along Westgate Avenue, which runs essentially perpendicular to the mapped trace of the SMFZ. Geocon West, Inc. reviewed the recovered core samples and identified two distinct alluvial units: Holocene young alluvial deposits and Late Pleistocene older fan/terrace deposits. Three buried argillic soils were identified within the Pleistocene deposits, and the overall sedimentary package dips shallowly to the south. The upper Pleistocene and Holocene sediments were continuous and unbroken across the length of the boring transect. The youngest of these (Marker Bed 1) was determined to range in age from 18,000 to 45,000 years old, and the oldest (Marker Bed 3) is approximately 52,000 to 108,000 years old. Below these soil marker horizons, the consultants interpreted at least three faults were present, which offset older stratigraphic horizons, but not the upper three Pleistocene marker beds. Therefore, they conclude these faults are not active based on the minimum estimated age of Marker Bed 3.

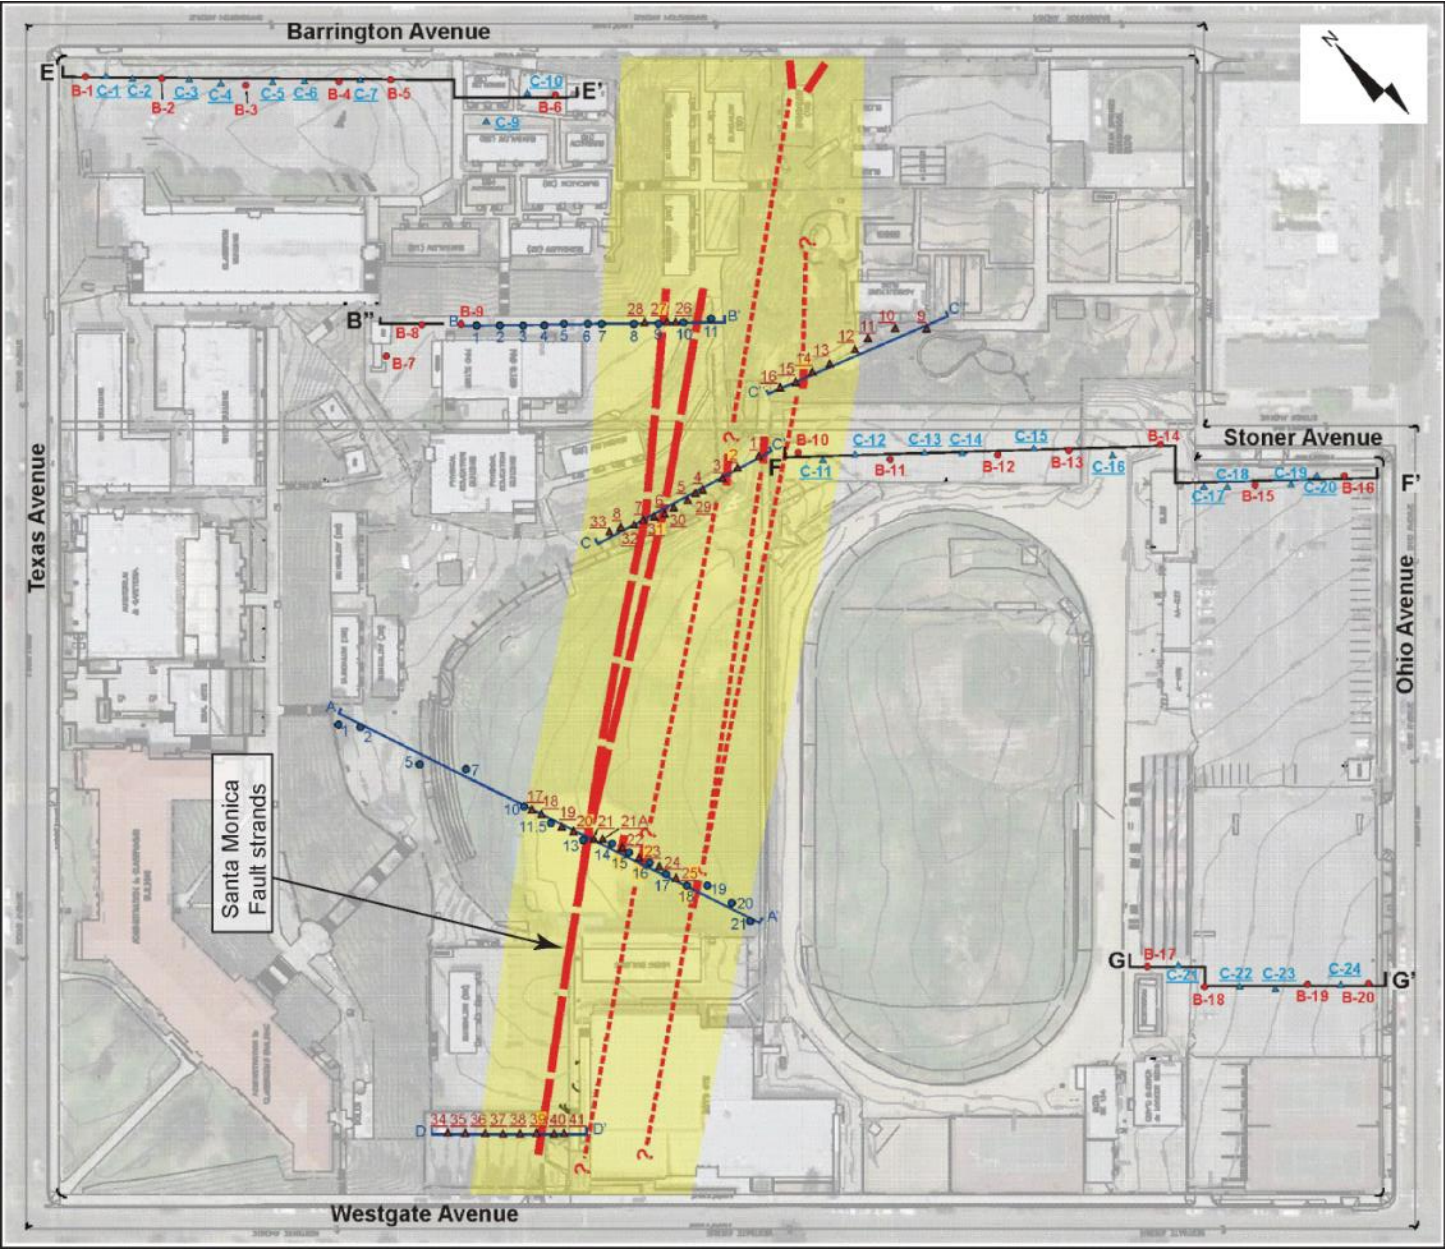
Figure 12 - Map showing interpreted Santa Monica Fault Zone strands crossing the University High School (MACTEC, 2004a & 2007). Red dashed lines are near-surface faults, red dotted lines represent deeper faults projected to the surface. Thin black and blue lines are geologic profiles. Circles are continuous core borings, triangles are CPT soundings. (modified from MACTEC, 2007, Figure 2)

Based on stratigraphic anomalies identified along the four transects, the consultants identified several active traces of the Santa Monica Fault in a zone trending N50°E to N55°E (Figure 12). In general, the faults identified dip steeply to the south with normal south-side down sense of slip (Figure 13). Additionally, significant lateral displacement is suggested by thickness changes or truncation of sedimentary units across the fault zone.
