**CALIFORNIA GEOLOGICAL SURVEY
FAULT EVALUATION REPORT FER 259**

**THE HOLLYWOOD, SANTA MONICA and NEWPORT-INGLEWOOD FAULTS
in the Beverly Hills and Topanga 7.5' Quadrangles
Los Angeles County, California**

by
Brian P.E. Olson
Engineering Geologist
January 5, 2018 (revised)

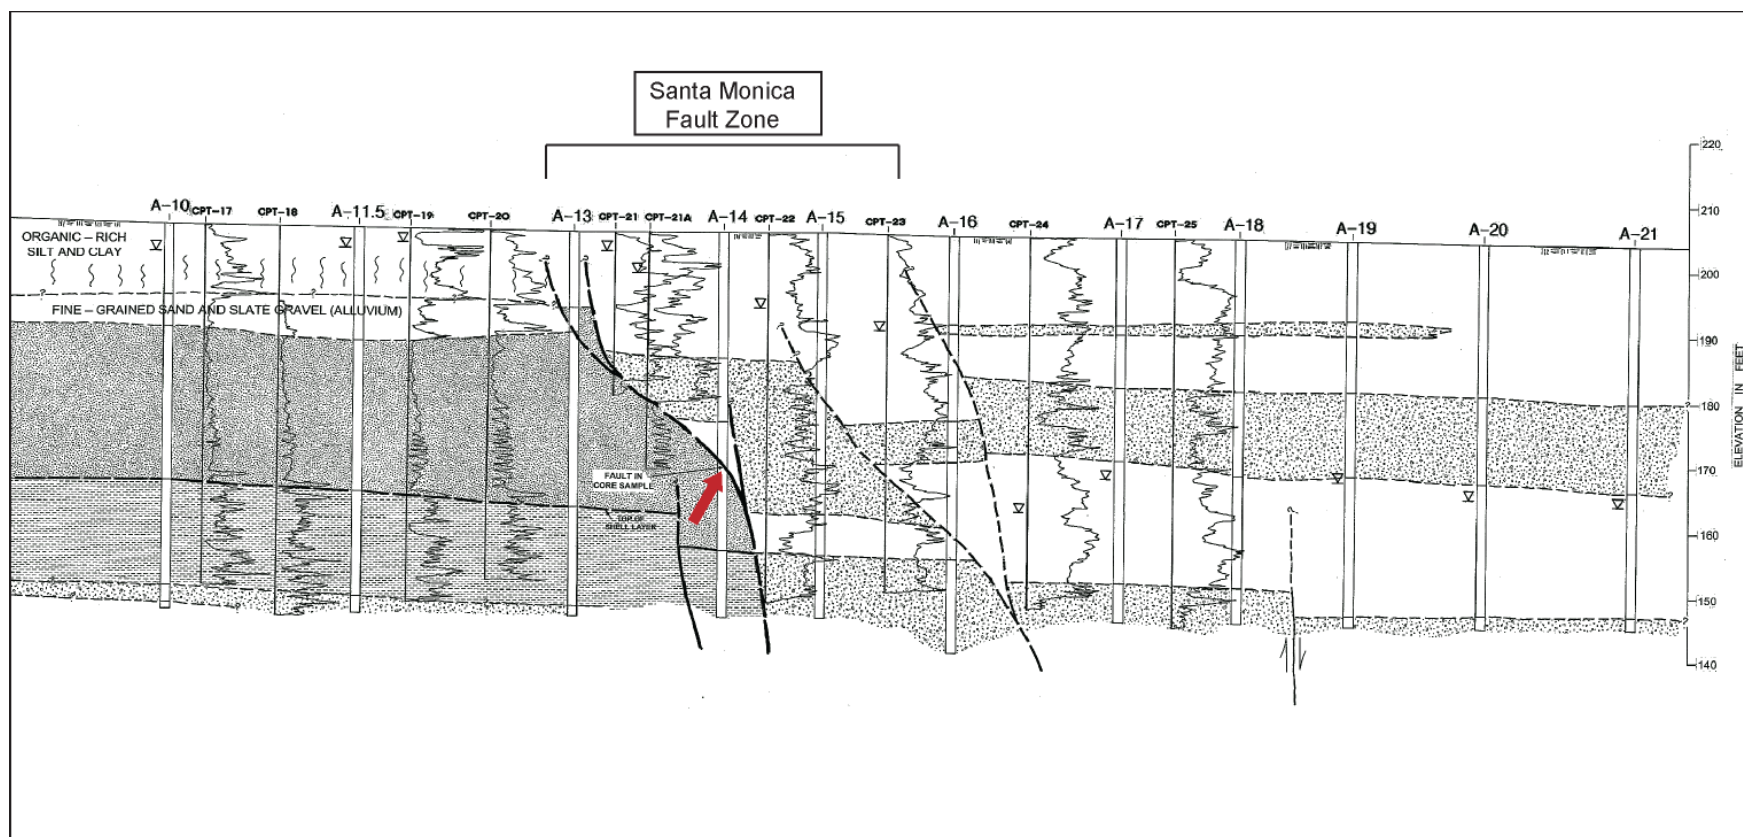
Figure 13 - Portion of geologic cross section A-A' from MACTEC (2004a) at University High School showing discontinuous and offset stratigraphic units and interpreted faults. Red arrow pointing to location where fault zone was observed in the recovered core sample. See Figure 12 for profile location. (modified from MACTEC, 2004a, Figure 5.1)

Based on stratigraphic anomalies identified along the four transects, the consultants identified several active traces of the Santa Monica Fault in a zone trending N50°E to N55°E (Figure 12). In general, the faults identified dip steeply to the south with normal south-side down sense of slip (Figure 13). Additionally, significant lateral displacement is suggested by thickness changes or truncation of sedimentary units across the fault zone.

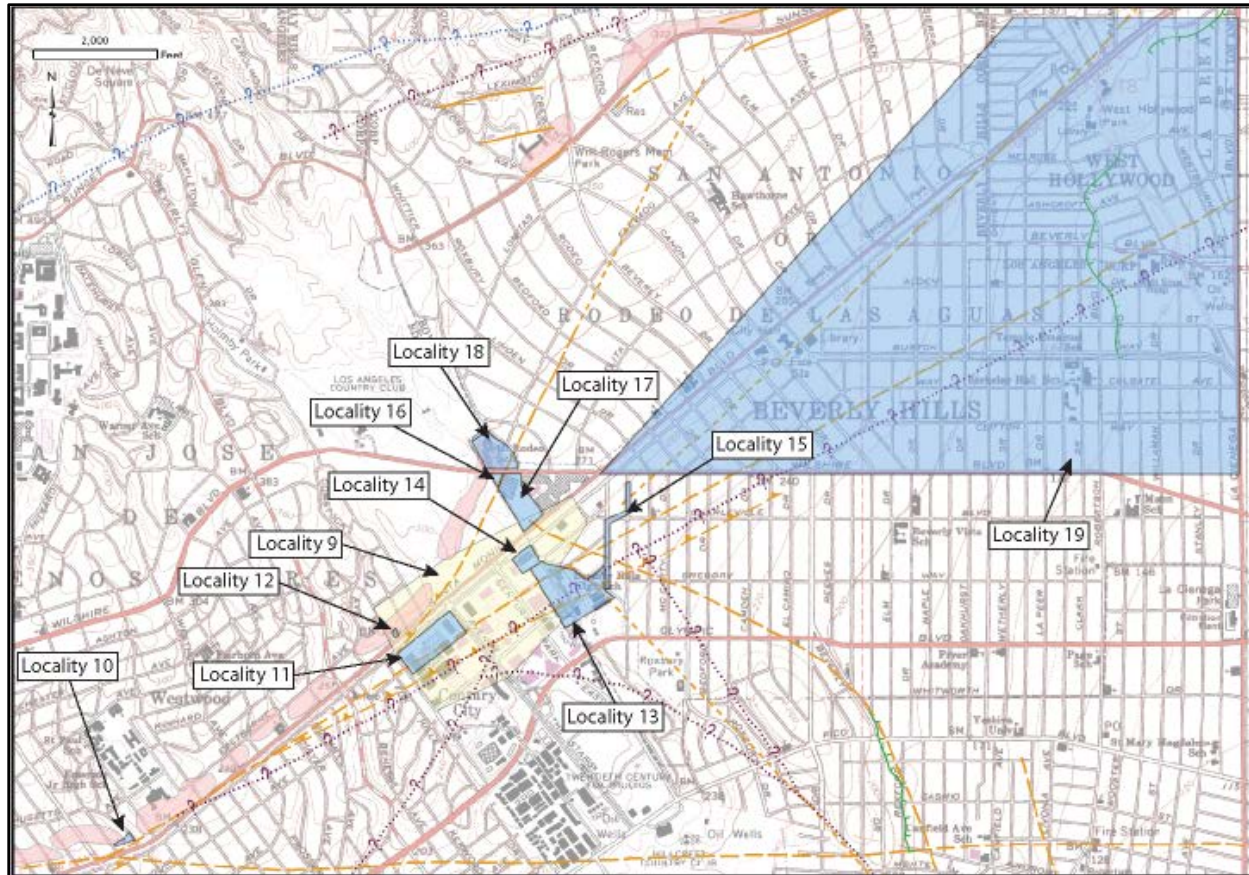
Figure 14 - Study site boundaries (blue shaded area) where investigations provide data relevant to evaluation of the Santa Monica Fault Zone east of Interstate 405 (localities 9 through 19, discussed in text). Light yellow box (Locality 9) is the approximate areal extent of the LA Metro fault investigation. See explanation on Plate 1 for faults types and mapping sources. Light red shaded area is the approximate limit of "fold scarps" identified by Dolan *et al.* (2000b).

(for referenced localities, see Figures 11 and 14)

Subsurface geologic and fault investigation studies related to various proposed developments and environmental monitoring have been completed throughout the study area. Pertinent studies were reviewed for data relating to the evaluation of the Santa Monica Fault Zone and are summarized below with locations depicted on Figures 11 and 14.

A large-scale preliminary investigation of the Santa Monica Fault zone was conducted in the Century City area of west Los Angeles (Figure 14 – locality 9) as part of the Westside Purple Line Extension Project (Parsons Brinckerhoff, 2011). Two potential tunnel alignments through this area were approved by the Metro Board in 2010, both of which cross the Santa Monica Fault zone and a postulated fault zone associated with the West Beverly Hills Lineament (WBHL). As a result, a fault investigation was conducted "to determine the location of active faults in the vicinity of the Century City station options and tunnel alignments." Supplemental fault investigations were later conducted east of Beverly Hills High School (Metro, 2017a) and west of the Los Angeles Country Club (Metro, 2017b).

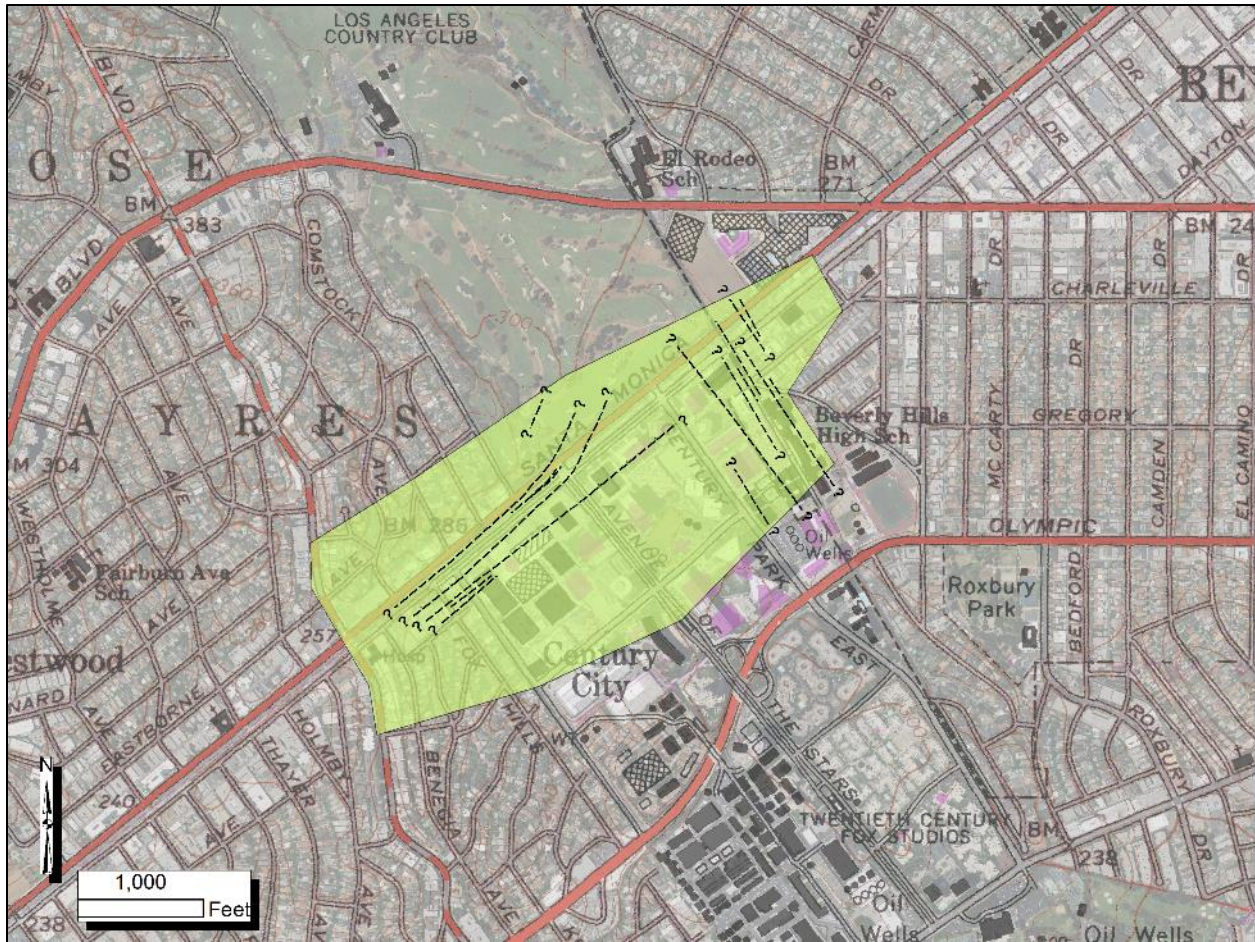
Figure 15 - - Map showing extent of fault investigation for the Century City segment of the Los Angeles Metro subway extension. Dashed black lines are faults interpreted by Parsons Brinckerhoff (2011).

A zone of generally northeast-trending faults associated with the Santa Monica Fault Zone were identified by the consultants paralleling Santa Monica Boulevard (Figure 15). These faults were inferred by noting the locations of "strong discontinuities" between adjacent CPTs, as well as lithologic changes and offset of marker beds observed between core borings along the transects. Additionally, they note these interpreted fault locations coincide with faults interpreted in the seismic reflection profiles and significant drops in groundwater level elevation observed in their borings. However, it could not be determined whether these faults were active because no Holocene units were encountered along these transects. Consequently, only those faults that coincided spatially with the geomorphic scarp were classified as "active".

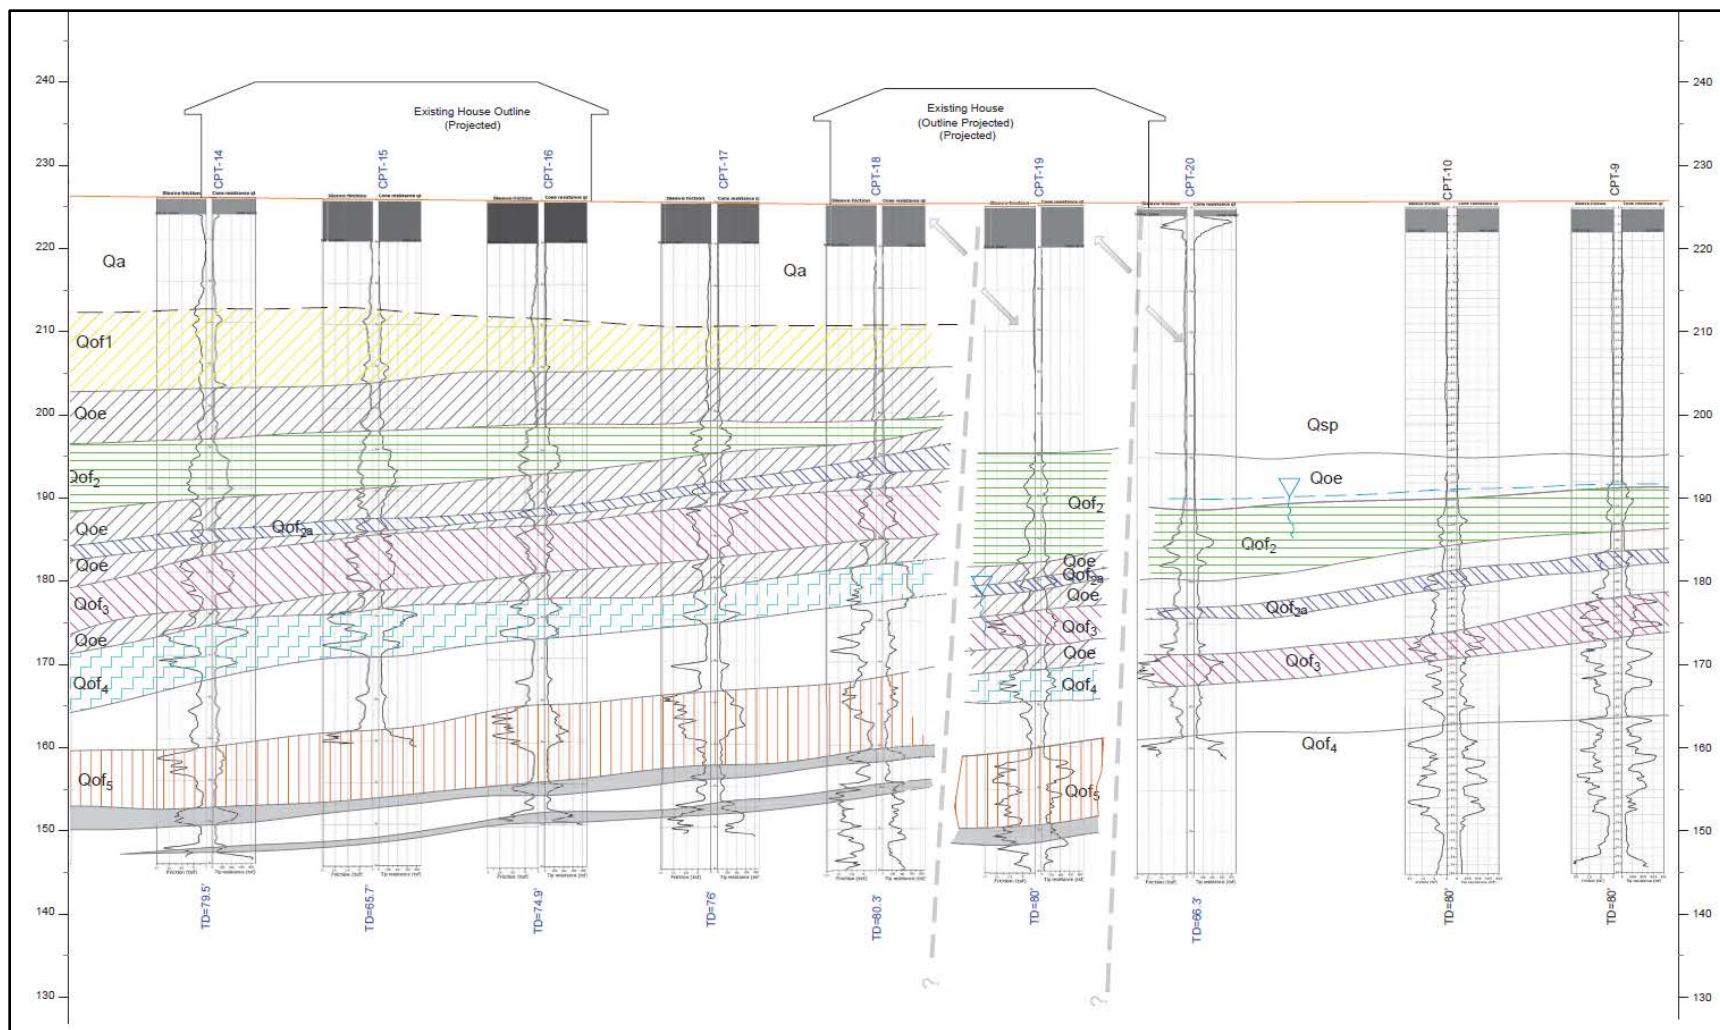
Figure 16 - Portion of geologic cross section A-A' constructed along Malcolm Avenue by AES (2015b, Drawing 2) looking west. Note the thick sequence of Holocene "sag pond" deposits (Qsp) faulted against broadly folded Pleistocene older fan (Qof) and older estuarine (Qoe) deposits in apparent north-side-down vertical separation.

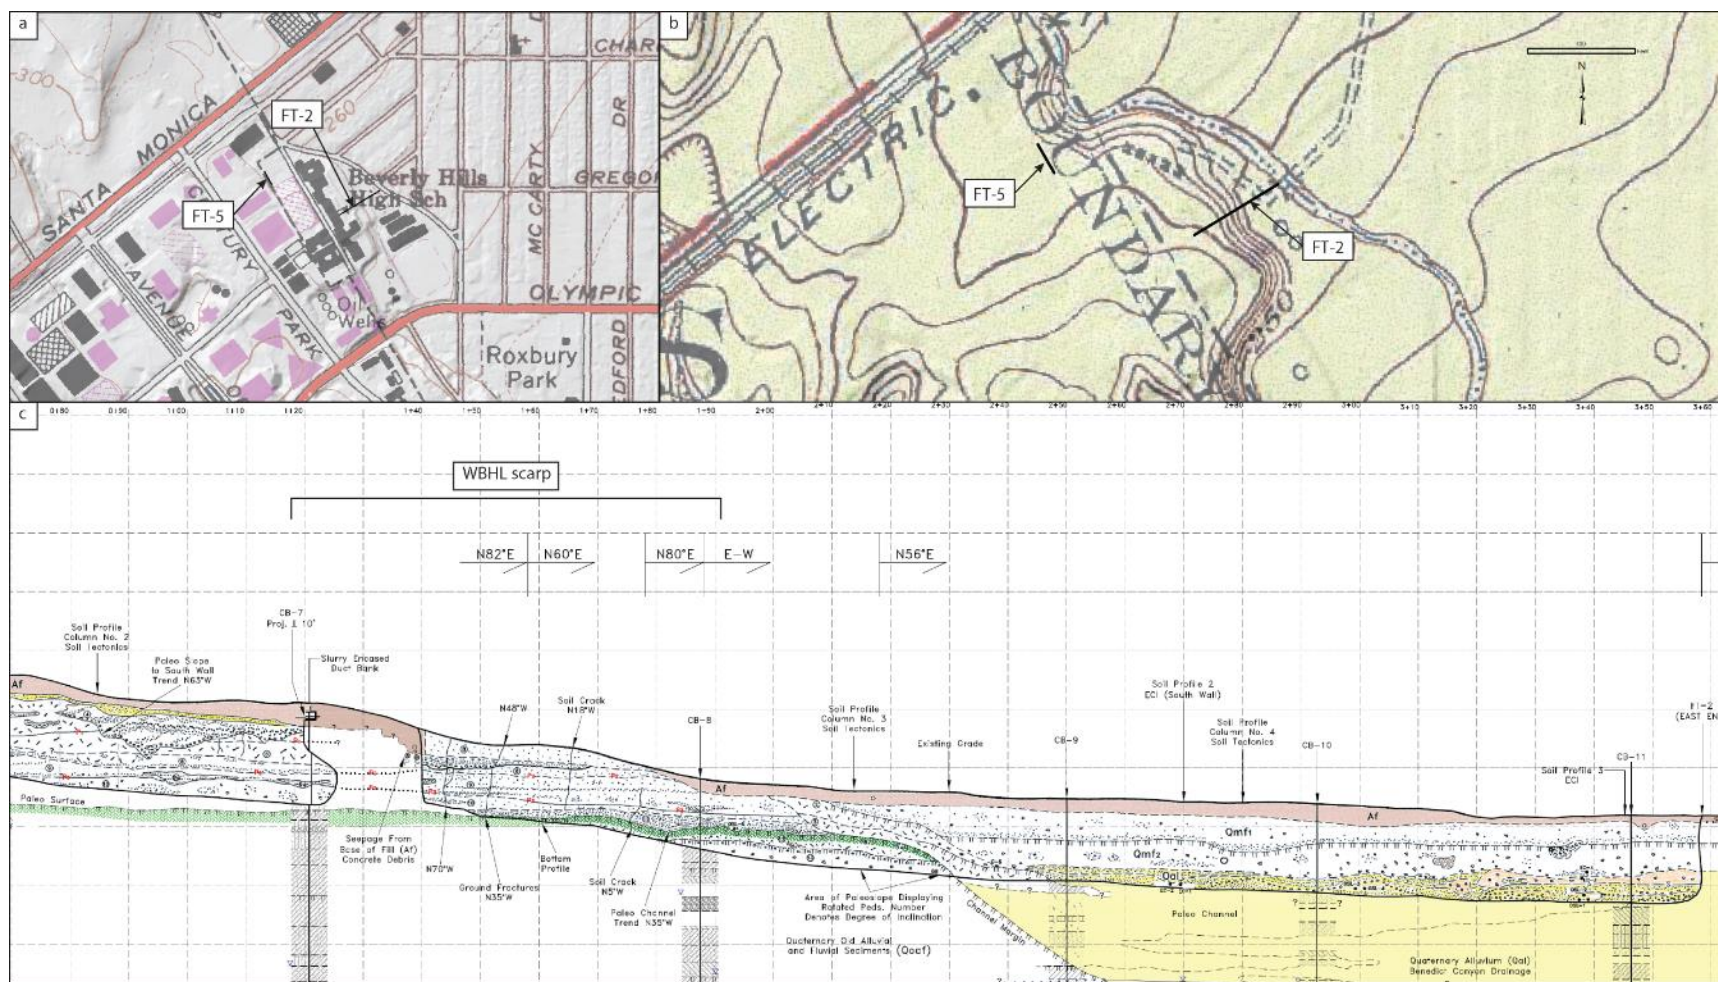
Figure 17 - a) Index map showing location of trenches FT-2 and FT-5 on modern topographic base map. b) Trench locations on 1925-era topographic map showing WBHL scarp prior to modification. c) Portion of geologic cross section and fault trench log for FT-2 at Beverly Hills High School (from Leighton Consulting, Inc., 2012a, Plate 3). Af = artificial fill; Qmf = mud flow deposits (Holocene); Qal = alluvium (Holocene); Qoaf = older alluvial fan deposits (late Pleistocene)

The consultants identified several paleosols, other marker beds, and the contact with the underlying San Pedro Formation in their core borings, which they trace along the entirety of each transect across the WBHL. Based on soil development in the older alluvium exposed in the trenches and observed in the core samples, the sediments underlying the elevated western surface were estimated to range from a minimum of 70,000 to 100,000 years old. Additionally, observations made in their Fault Trench 2 (FT-2) demonstrate the older alluvial deposits are

laterally truncated, which the consultants conclude indicates an erosional origin for this slope (Figure 17). The erosional contact between the older alluvium and the younger alluvium of Benedict Canyon forms a buttress unconformity, which the consultants state can be followed below the trench exposure and observed in their core borings along the transect (Figure 16c). Thus, they conclude there are no active faults along the WBHL as reported by Parsons Brinckerhoff (2011) and the scarp feature appears to be erosional, not tectonic, in nature.

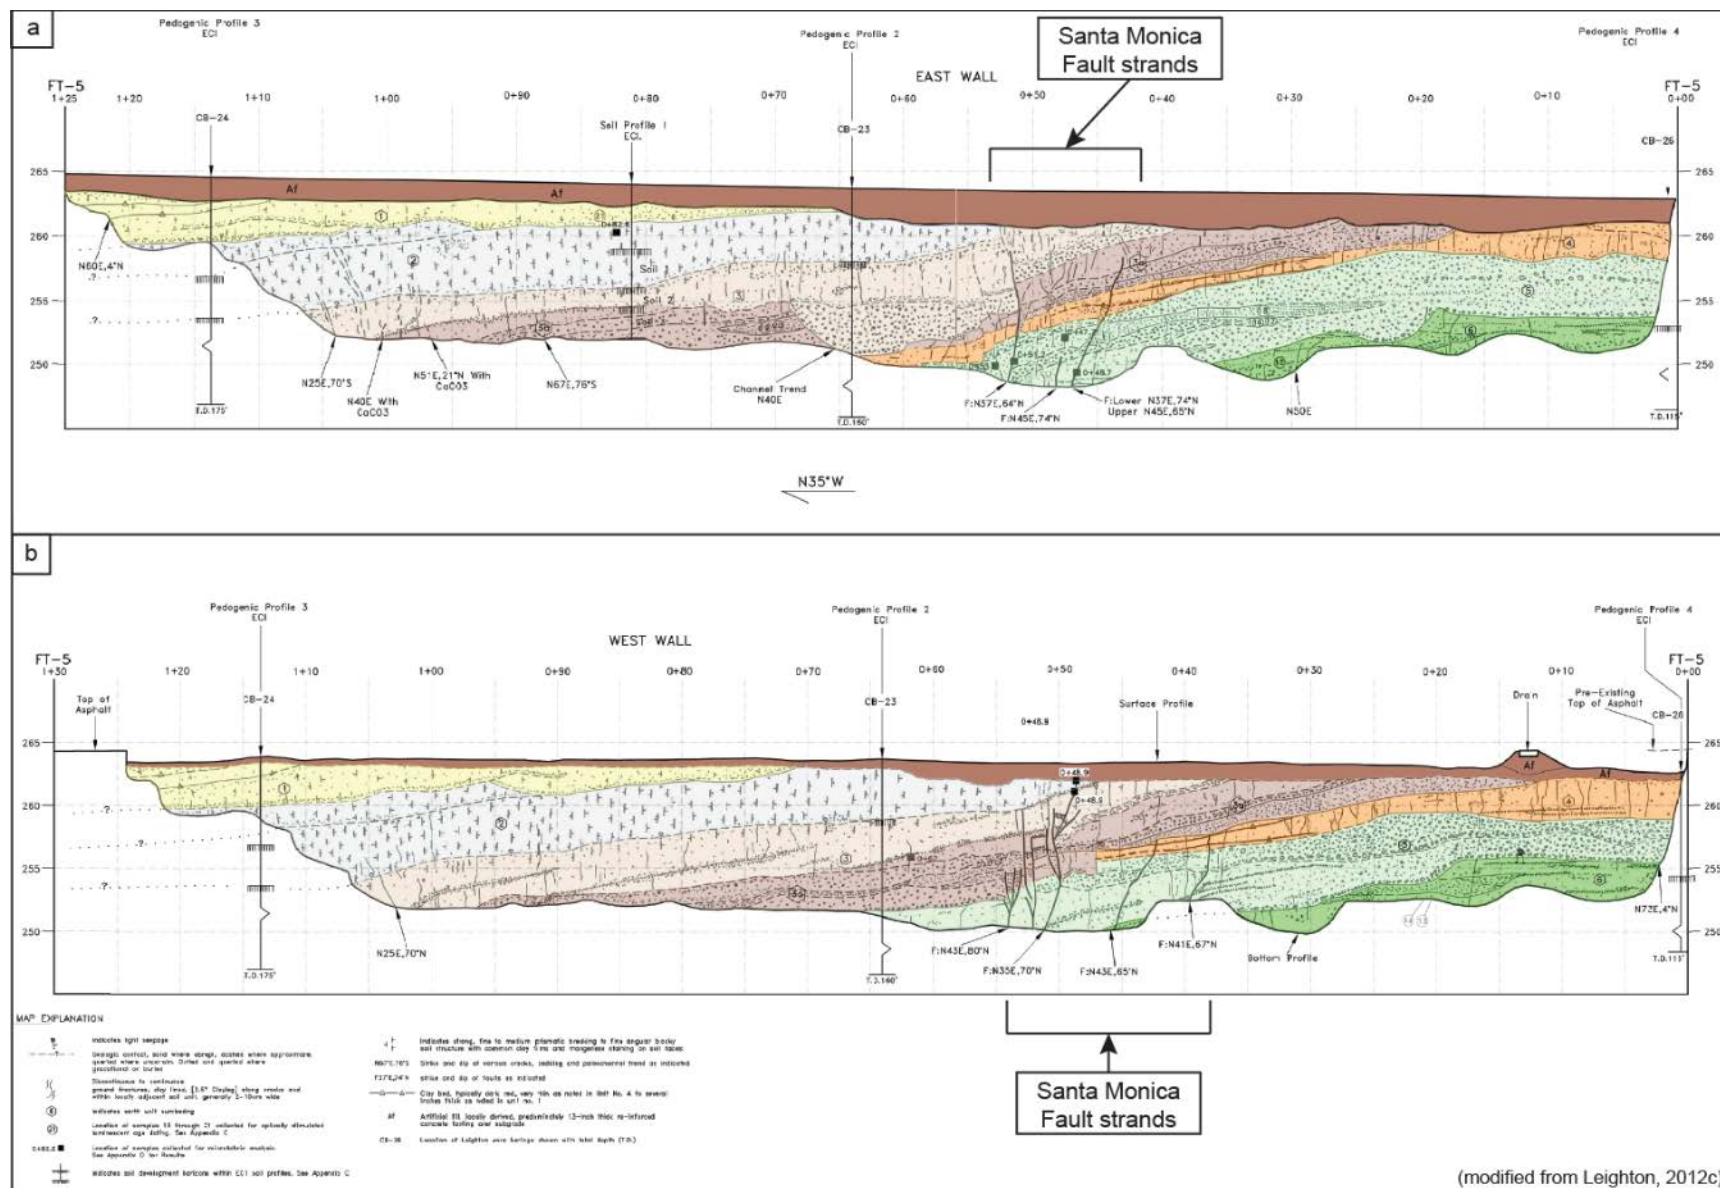
Figure 18 - Log of Fault Trench 5 (FT-5) at Beverly Hills High School depicting (a) east and (b) west walls. Log depicts folded and faulted late Pleistocene units. Leighton (2012c) concluded these fault strands were inactive. (modified from Leighton Consulting, Inc., 2012c, Plate 5)

In the northwestern corner of the campus, a northwest-trending boring transect identified an approximately 90-foot drop to the north in the San Pedro bedrock surface near where a trace of the Santa Monica Fault Zone mapped by Parsons Brinckerhoff (2011) would project onto the campus (Leighton Consulting, Inc., 2012c). Consequently, the consultants excavated a fault trench along a portion of the transect and observed faulting within the alluvial sediments near the surface (Figure 18). Based on soil-stratigraphic age estimates, the consultants concluded the youngest sediments exposed in this trench range from approximately 30,000 to 60,000 years old (Unit 1), and the oldest unit was estimated at 143,000 to 335,000 years old (Unit 6). Several faults were exposed in the trench and were described as an "upwardly flowering and stepping zone of faults and fractures about 20 feet wide and having a cumulative \pm 3 feet of north side down displacement, and some undetermined lateral offset". Attitudes on the faults ranged from N35°E to N43°E with dips between 65° to 75° north. Detailed logging by the consultants allowed for the interpretation of at least two, and possibly three, distinct rupture events recorded in the trench sediments. The most recently active strand of the fault zone extends up from the bottom of the trench and appears to offset the base of Unit 2. They note the fault is much less clearly defined within Unit 2, which they interpret as being due to a lack of recent movement and progressive destruction of the fault rupture surface by soil development. Consequently, they conclude the most recent event occurred "when Unit 2 was the ground surface but before the development of the strong B_t that caps it, because the fault traces are only readily visible within the C horizon [Unit 3] beneath the B_t." It appears the location of this fault zone is generally consistent with the fault projection mapped by Parsons Brinckerhoff (2011). Because Unit 2 is Pleistocene in age, and the faulting at the base appears to pre-date the argillic B_t horizon, Leighton Consulting, Inc. concluded these faults are not active. However, unlike the alluvial deposits along the WBHL, it does appear the Pleistocene sedimentary sequence north of this fault is notably folded with all units dipping on the order of 10° to the north (Figure 18).

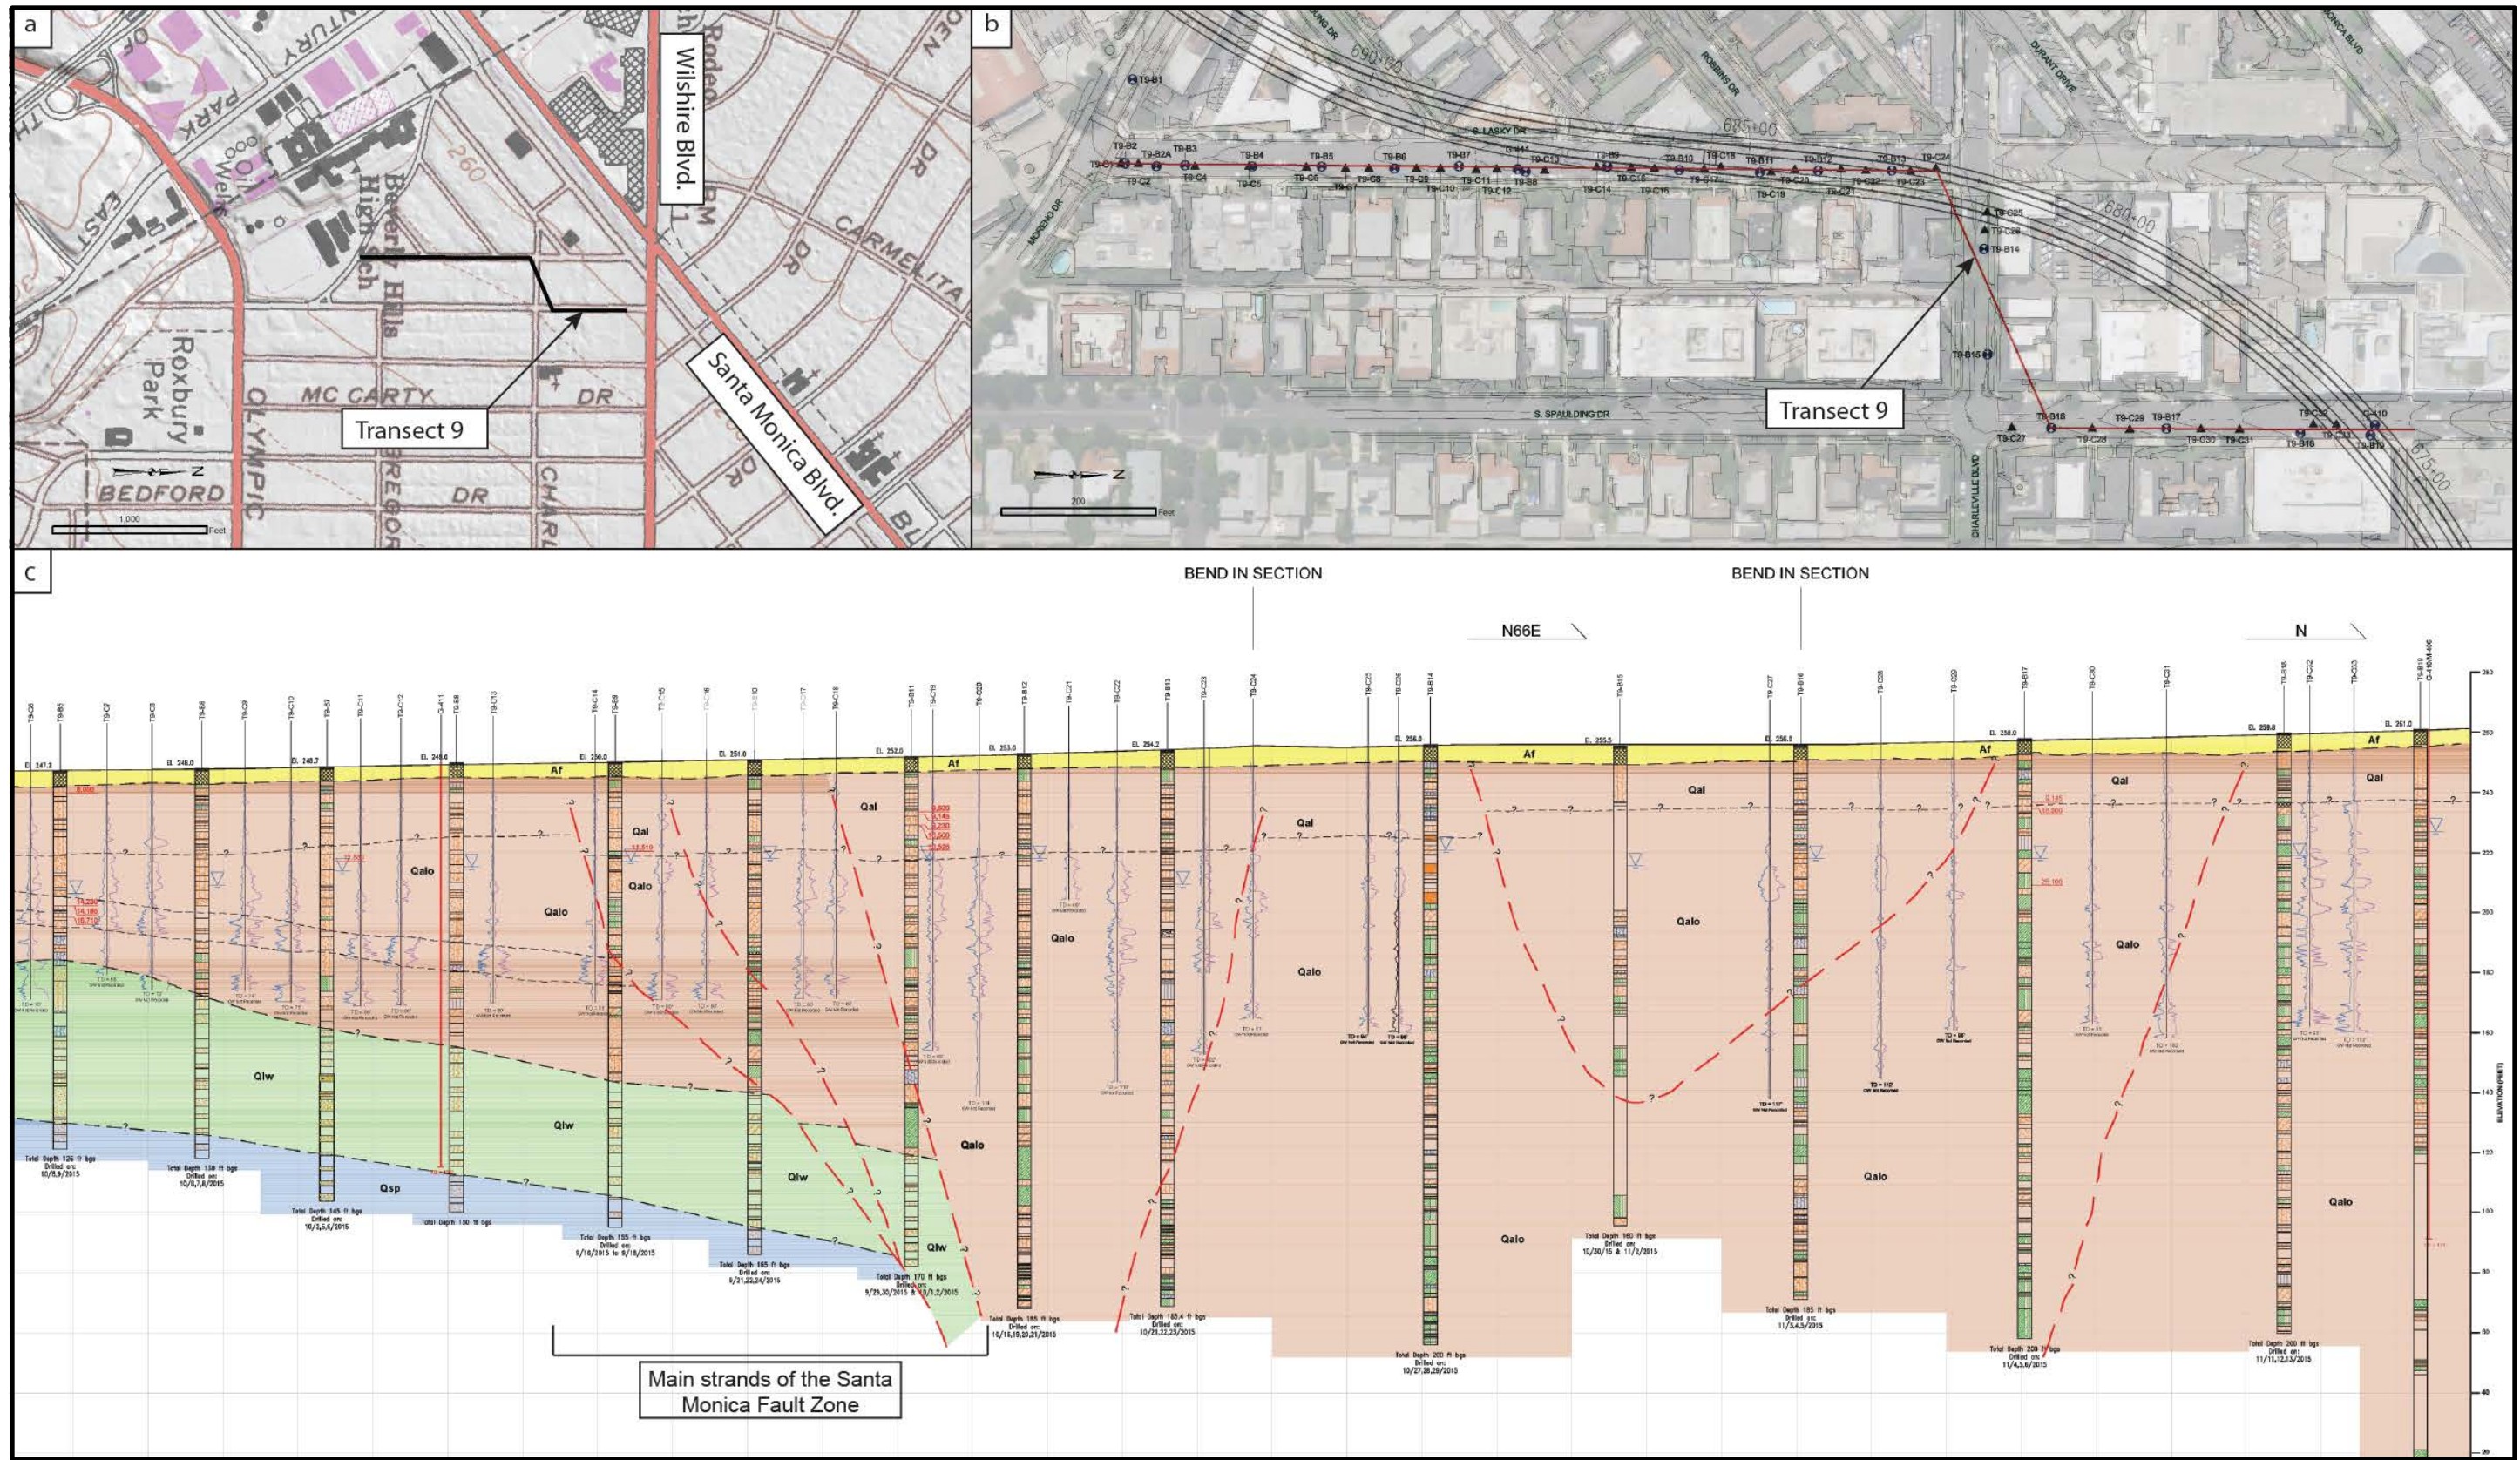
Figure 19 – Location and geologic profile at Locality 15. a) Index map showing location of Transect 9 from Metro (2017a) report. b) aerial photo map depicting locations of borings and CPTs drilled along the transect. c) portion of geologic cross section constructed along Transect 9 by Metro (2017). Af = artificial fill; Qal = alluvium (Holocene); Qalo = older alluvium (late Pleistocene); Qlw = Lakewood Formation (late Pleistocene; non-marine); Qsp = San Pedro Formation [modified from Metro (2017a, Plate 2)]

From their observations and interpretations of the subsurface data, AMEC Foster Wheeler identified a **significant fault zone** at depth between their stations 6+50 and 9+00 (Figure 19) consisting of up to three strands, which dip steeply to the north. The faults exhibited greater than 90 feet of apparent down-to-the-north vertical displacement of the contact between the older alluvium and the Lakewood Formation. From the southern end of the cross section, the depth to the Pleistocene bedrock units consistently increases to the north until they are abruptly truncated and no longer encountered north of the inferred fault zone. AMEC states these faults appear to extend up near the present-day ground surface and offset Holocene sediments dated between approximately 9,100 and 16,500 years old based on radiometric dating of charcoal samples. The locations of the fault traces in the near surface sediments is based on identifying the location where laterally persistent laminated fine-grained "sag deposits" to the north are abruptly missing in adjacent down-gradient borings. It is postulated these fine-grained silts and clays were deposited in depressions or impounded drainages formed by topographic scarps created by surface-rupturing events along faults in this zone. Additional faults were also interpreted between borings north and south of this main zone.

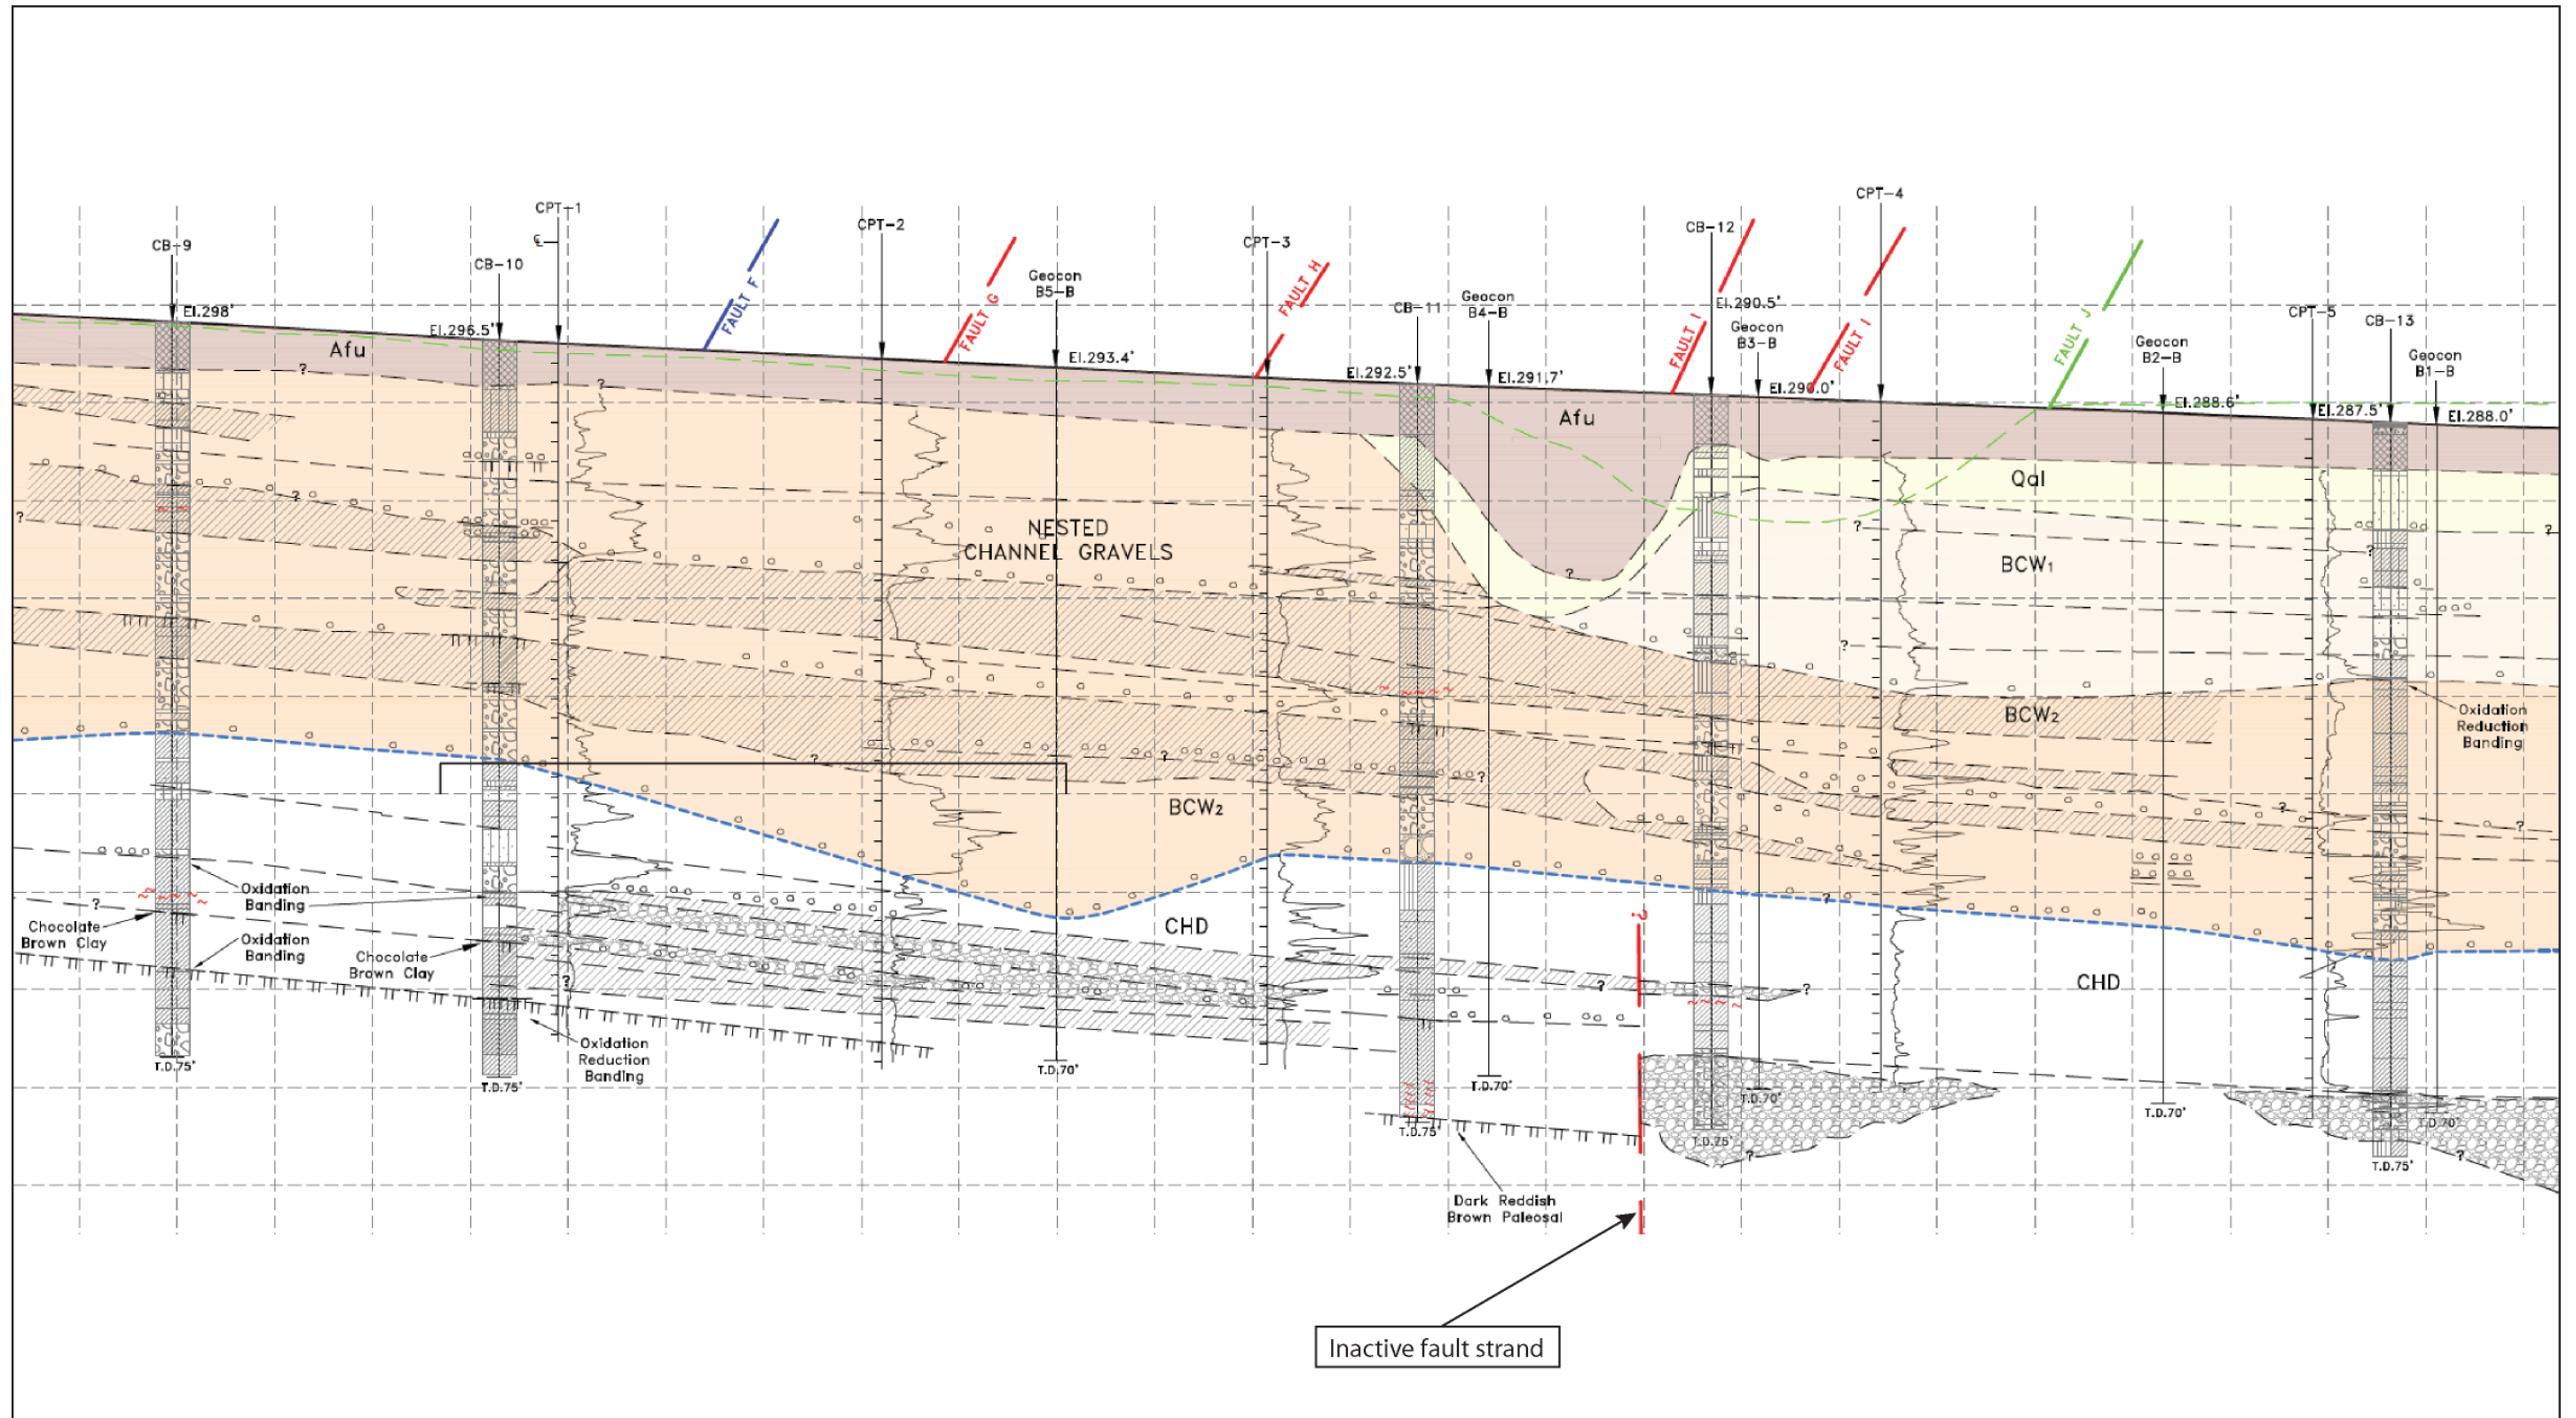
Figure 20 - Portion of geologic cross section along Wilshire Blvd., south of El Rodeo Elementary School. Colored fault labels along top of profile note inferred locations of faults by Geocon West (2014b). Afu = undocumented artificial fill; Qal = Quaternary alluvium (Holocene); BCW = Benedict Canyon Wash Deposits (late Pleistocene); CHD = Cheviot Hills Deposits (late Pleistocene) [from Leighton Consulting, Inc., 2016, Plate 3]

Leighton Consulting, Inc. identified several paleosols, other marker beds, and major erosional surfaces, which they trace along the entirety of the transect across the trace of the projected faults (Figure 20). Based on logging of the soil cores and sediments, as well as the various degrees of soil development exposed in the trenches and observed in the core samples, the consultants determined that the elevated western portion of the campus is underlain by Older Benedict Canyon Wash Deposits (BCWD₂), which are folded into an east-dipping monocline. The lower, eastern portion of the school site is underlain by the younger BCWD₁ deposits that onlap the BCWD₂ from the east creating a buttress unconformity. This depositional model explained several apparent stratigraphic discontinuities that were initially thought to be fault related by Geocon West, Inc. (2014b) who assumed all strata in this area to be horizontal. Some faults were inferred at depth in the transect, but they were overlain by apparently continuous and unbroken Pleistocene sediments and paleosols (Figure 20). No evidence of faulting was observed within the Pleistocene alluvial soils exposed in any of the trenches excavated across the projected Geocon or Leighton Consultants fault traces. Thus, they concluded there are no active faults at the site.

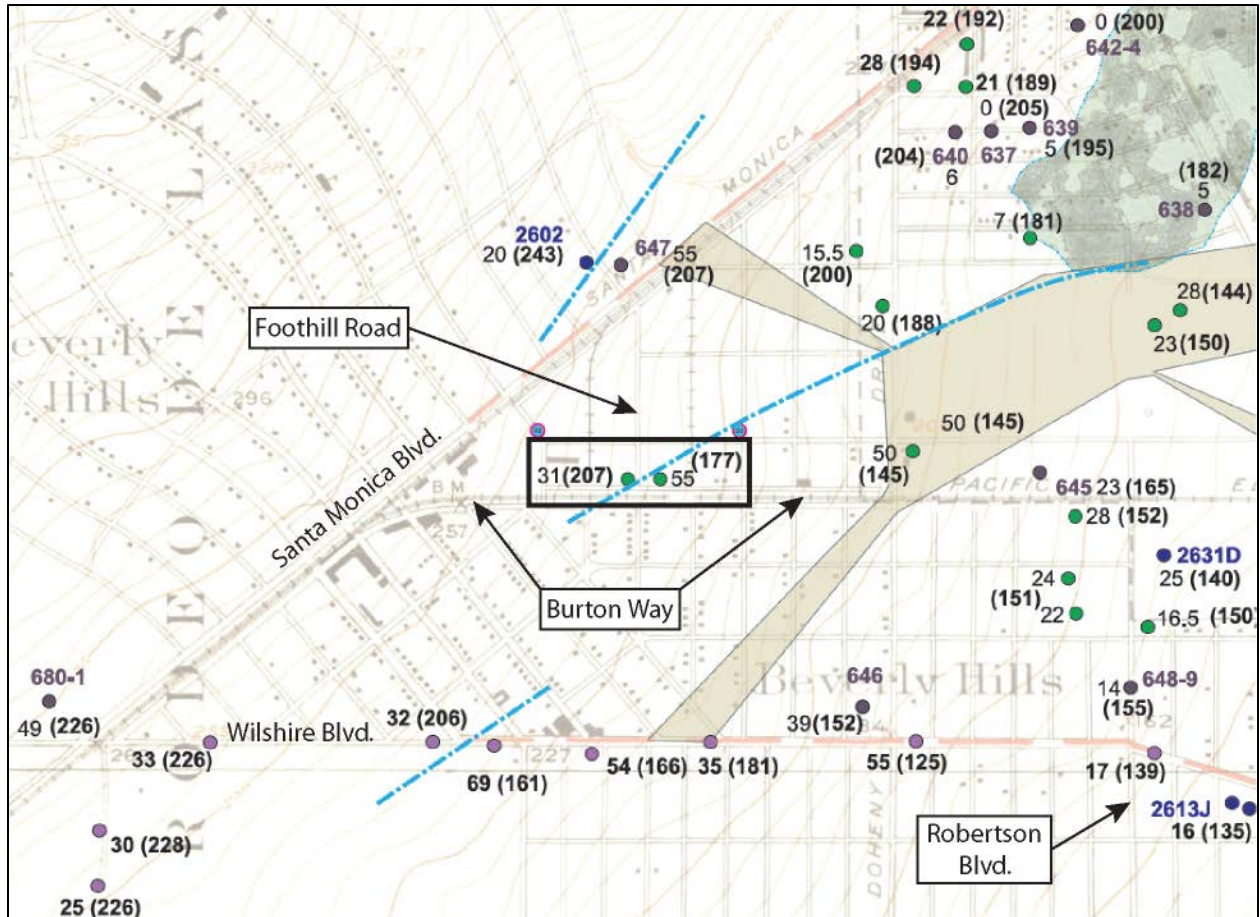
Figure 21 – Map depicting groundwater well data and differential subsidence zones in the western Beverly Hills alluvial plain. Colored dots represent locations of borings/wells with groundwater elevation in parentheses. Dashed blue lines are interpreted groundwater barriers by M. Schultz. Tan shaded area is the zone of differential subsidence based on City of Los Angeles benchmark elevation surveys conducted between 1985 and 2000. Variegated shaded area is the limits of a historical marsh reported by Mendenhall (1905). (modified from map provided by M. Schultz, pers. comm., 2014)
