**CALIFORNIA GEOLOGICAL SURVEY
FAULT EVALUATION REPORT FER 259**

**THE HOLLYWOOD, SANTA MONICA and NEWPORT-INGLEWOOD FAULTS
in the Beverly Hills and Topanga 7.5' Quadrangles
Los Angeles County, California**

by
Brian P.E. Olson
Engineering Geologist
January 5, 2018 (revised)

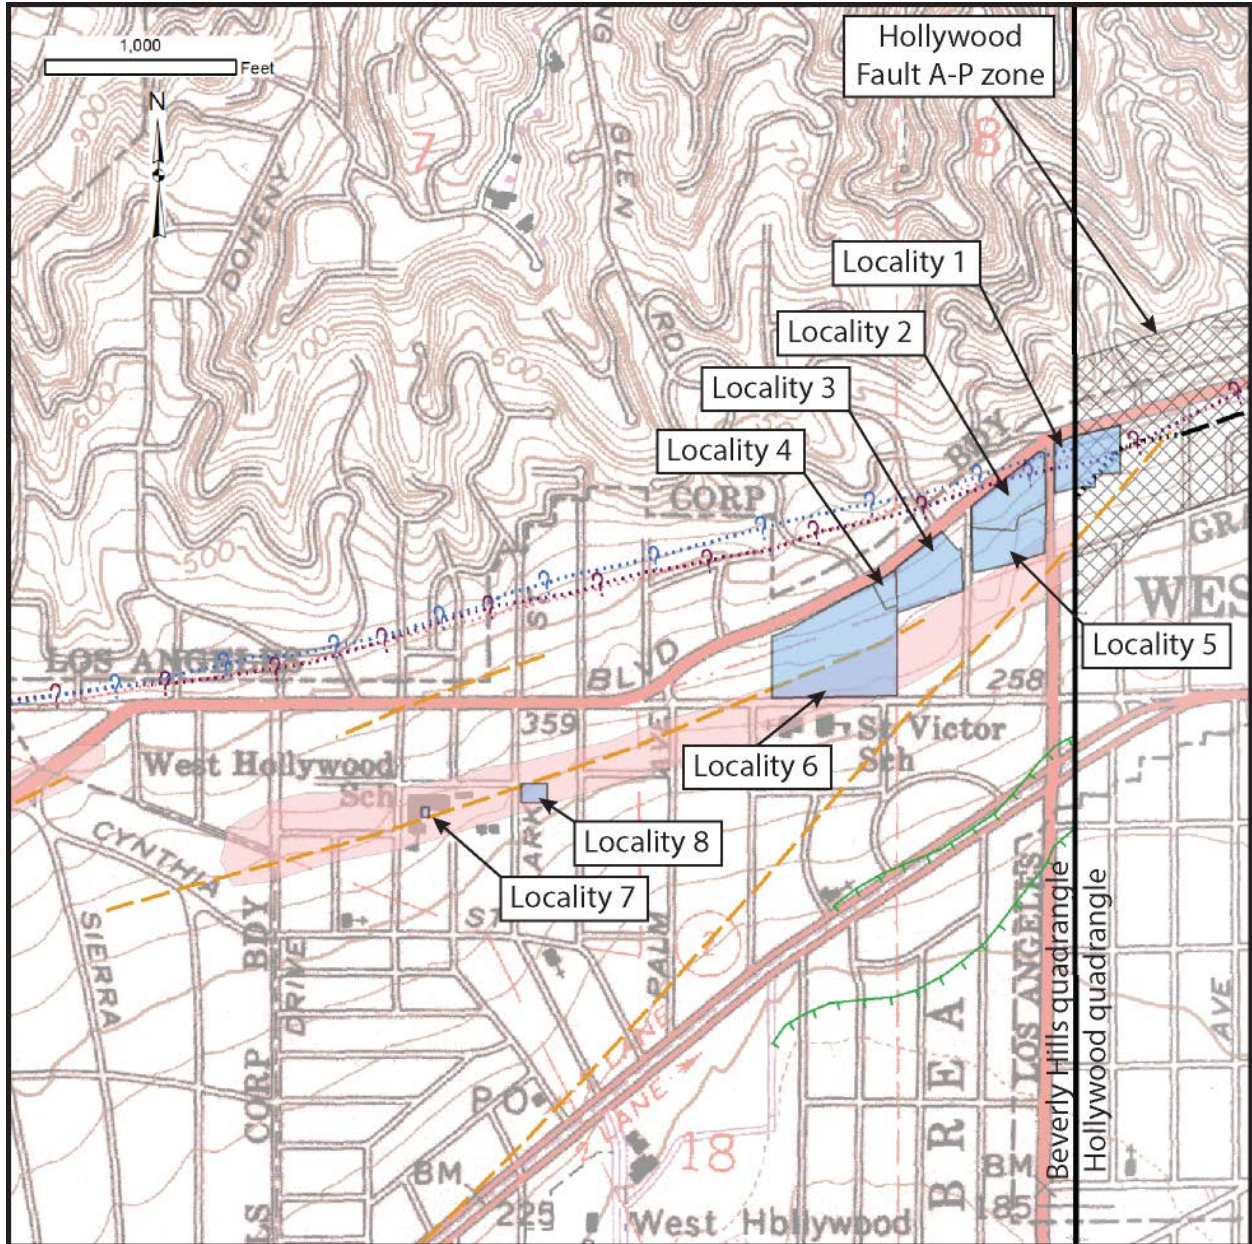
Figure 22- Study site boundaries (light blue boxes) where investigations provide data relevant to evaluation of the Hollywood Fault Zone in the study area (localities 1 through 8, discussed in text). See legend on Plate 1 for fault types and mapping sources. Shaded area is the approximate limit of the "fold scarp" identified by Dolan *et al.* (1997).

The City of West Hollywood's Fault Precaution Zone Map, and Geologic and Seismic Hazard Technical Background Report (KFM Geoscience, 2010) is a crucial component of the City of West Hollywood General Plan. Included in the KFM report is a summary of Fault Rupture Hazard Studies from 29 sites that are on file with the City, collected from 1997 to 2013. Of these reports, eight sites yielded data that active faulting exists within those sites or otherwise helped constrain the fault location near the eastern boundary of the Beverly Hills Quadrangle. Of these eight sites, several studies were performed adjacent or in close proximity to one another; these are shown on Figure 22.

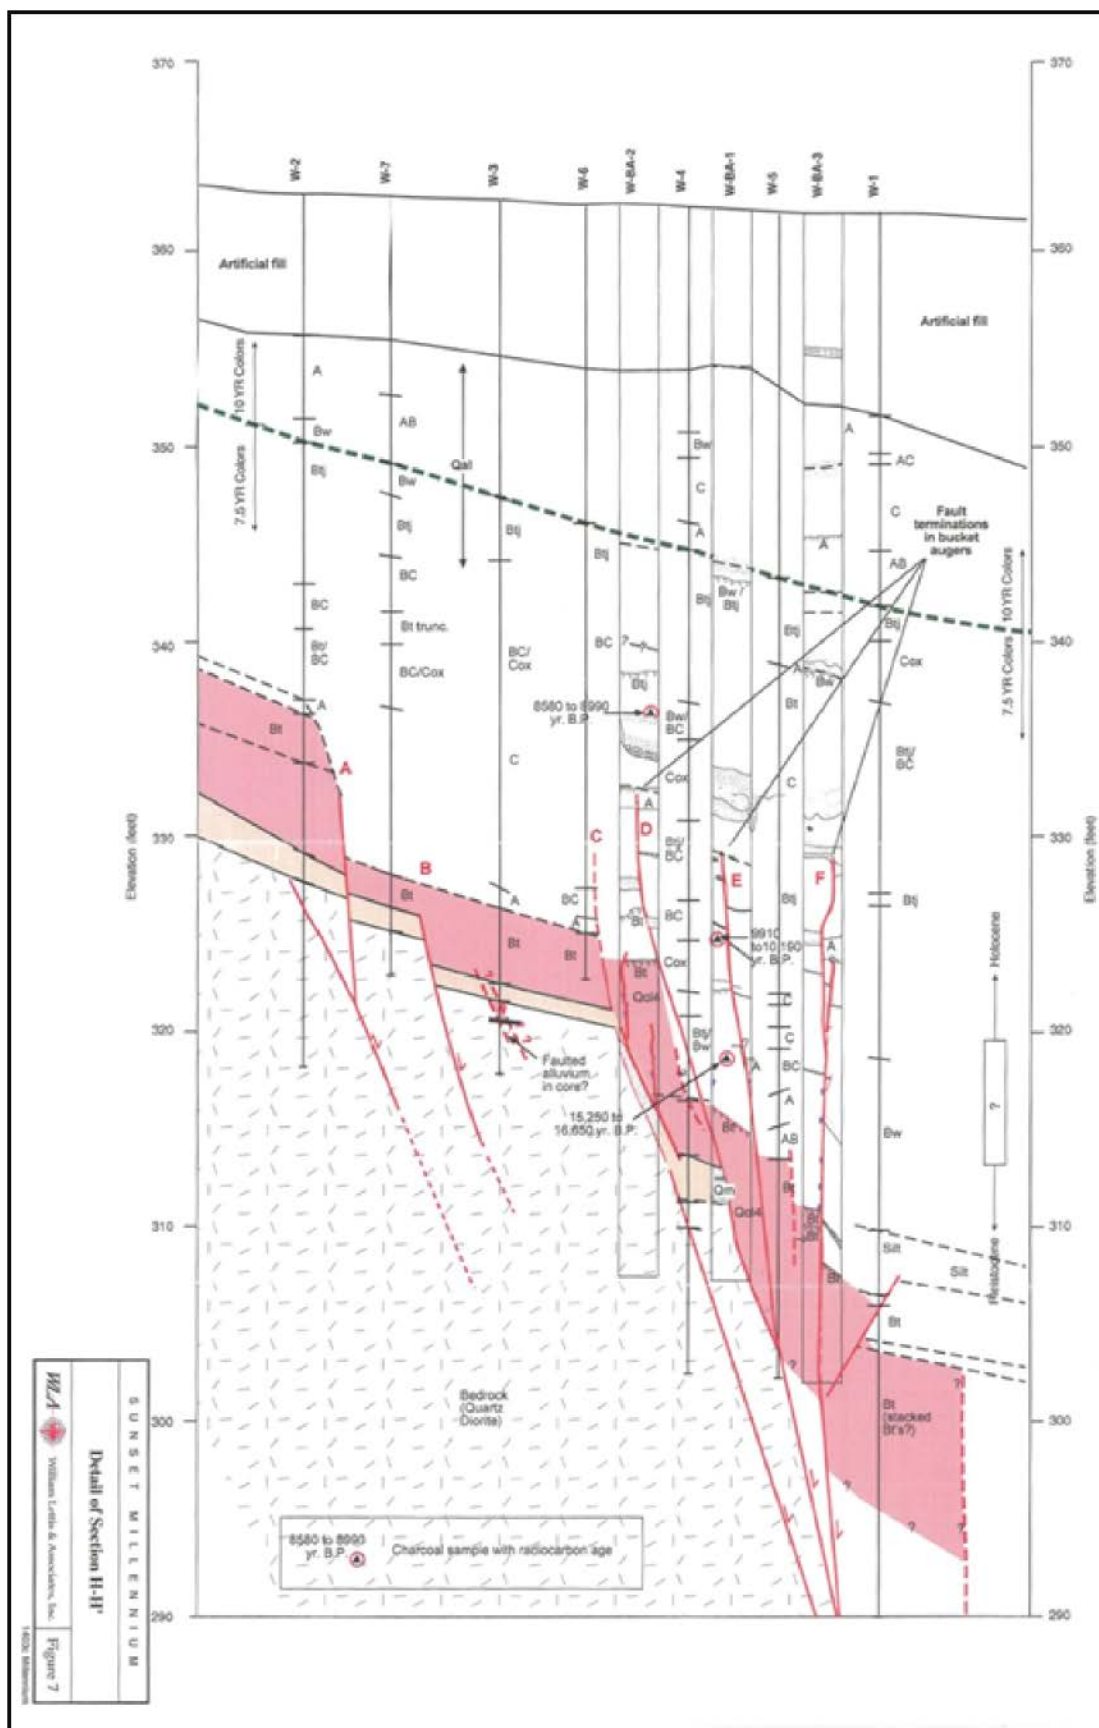
Figure 23 – Geologic cross section showing upward terminations of fault strands D, E, and F within Fault 1 at Locality 1; modified from William Lettis & Associates, Inc. (2004).

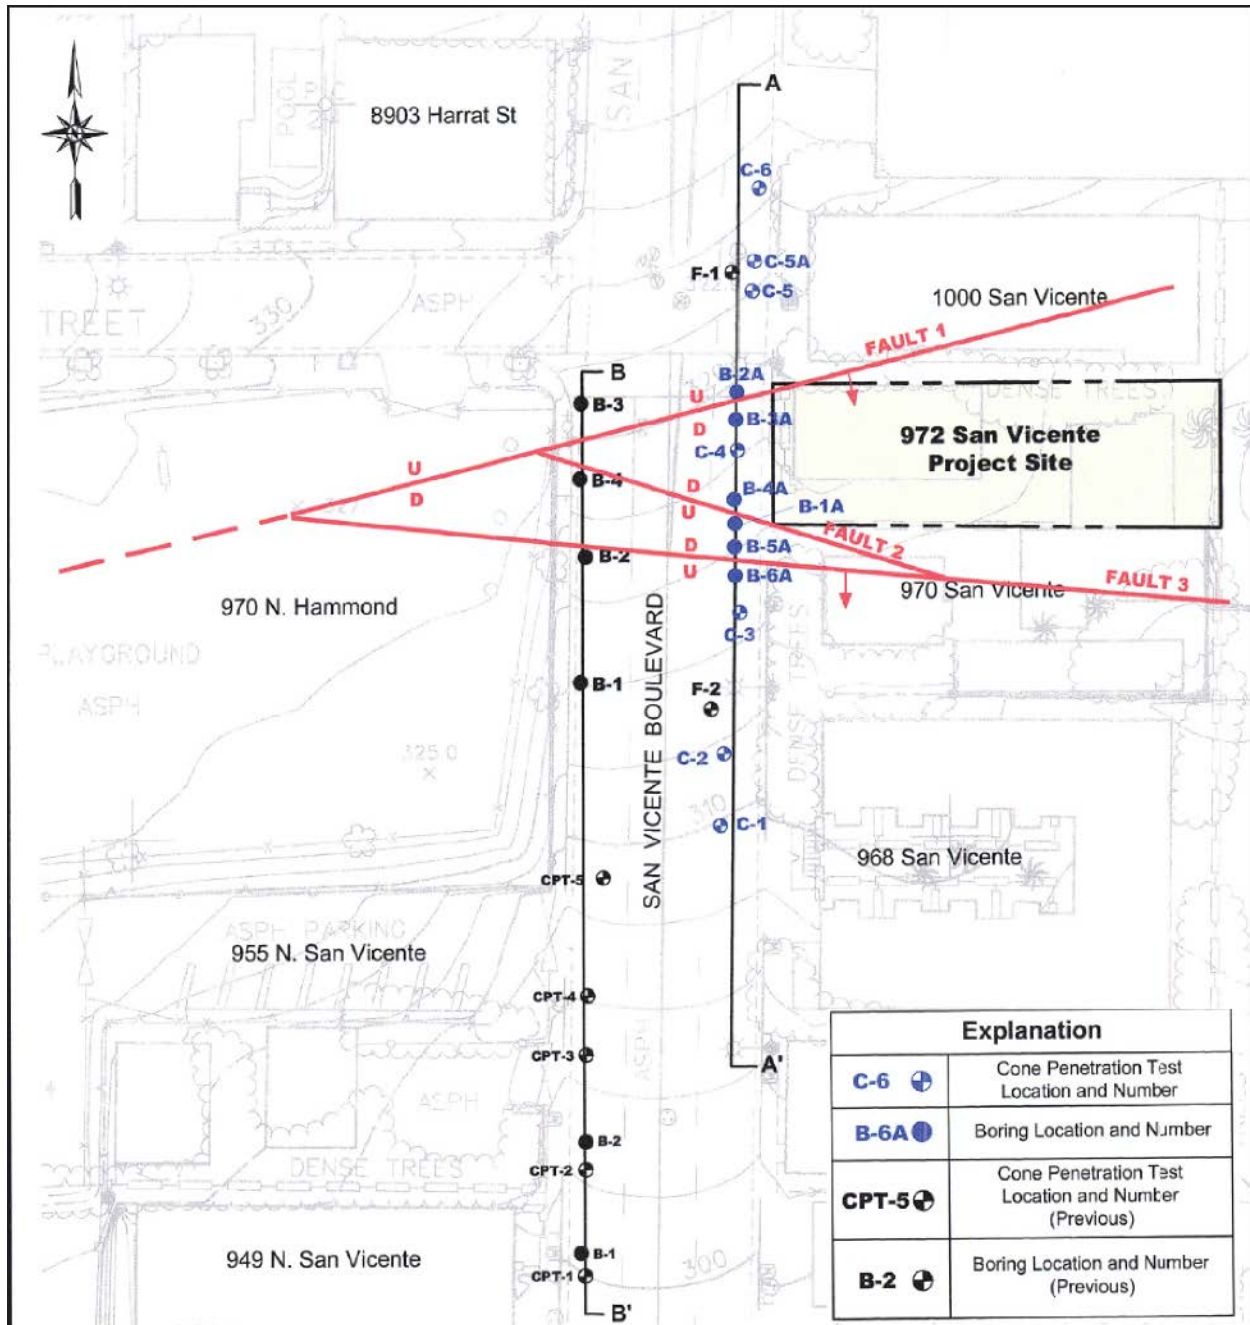
Figure 24 - Fault and boring/CPT location map from Helms (2017) along N. San Vicente Boulevard in the City of West Hollywood. Note difference in fault trend between Fault 1 and Faults 2 and 3, which are truncated, suggesting Fault 1 is the controlling and more recently active fault.

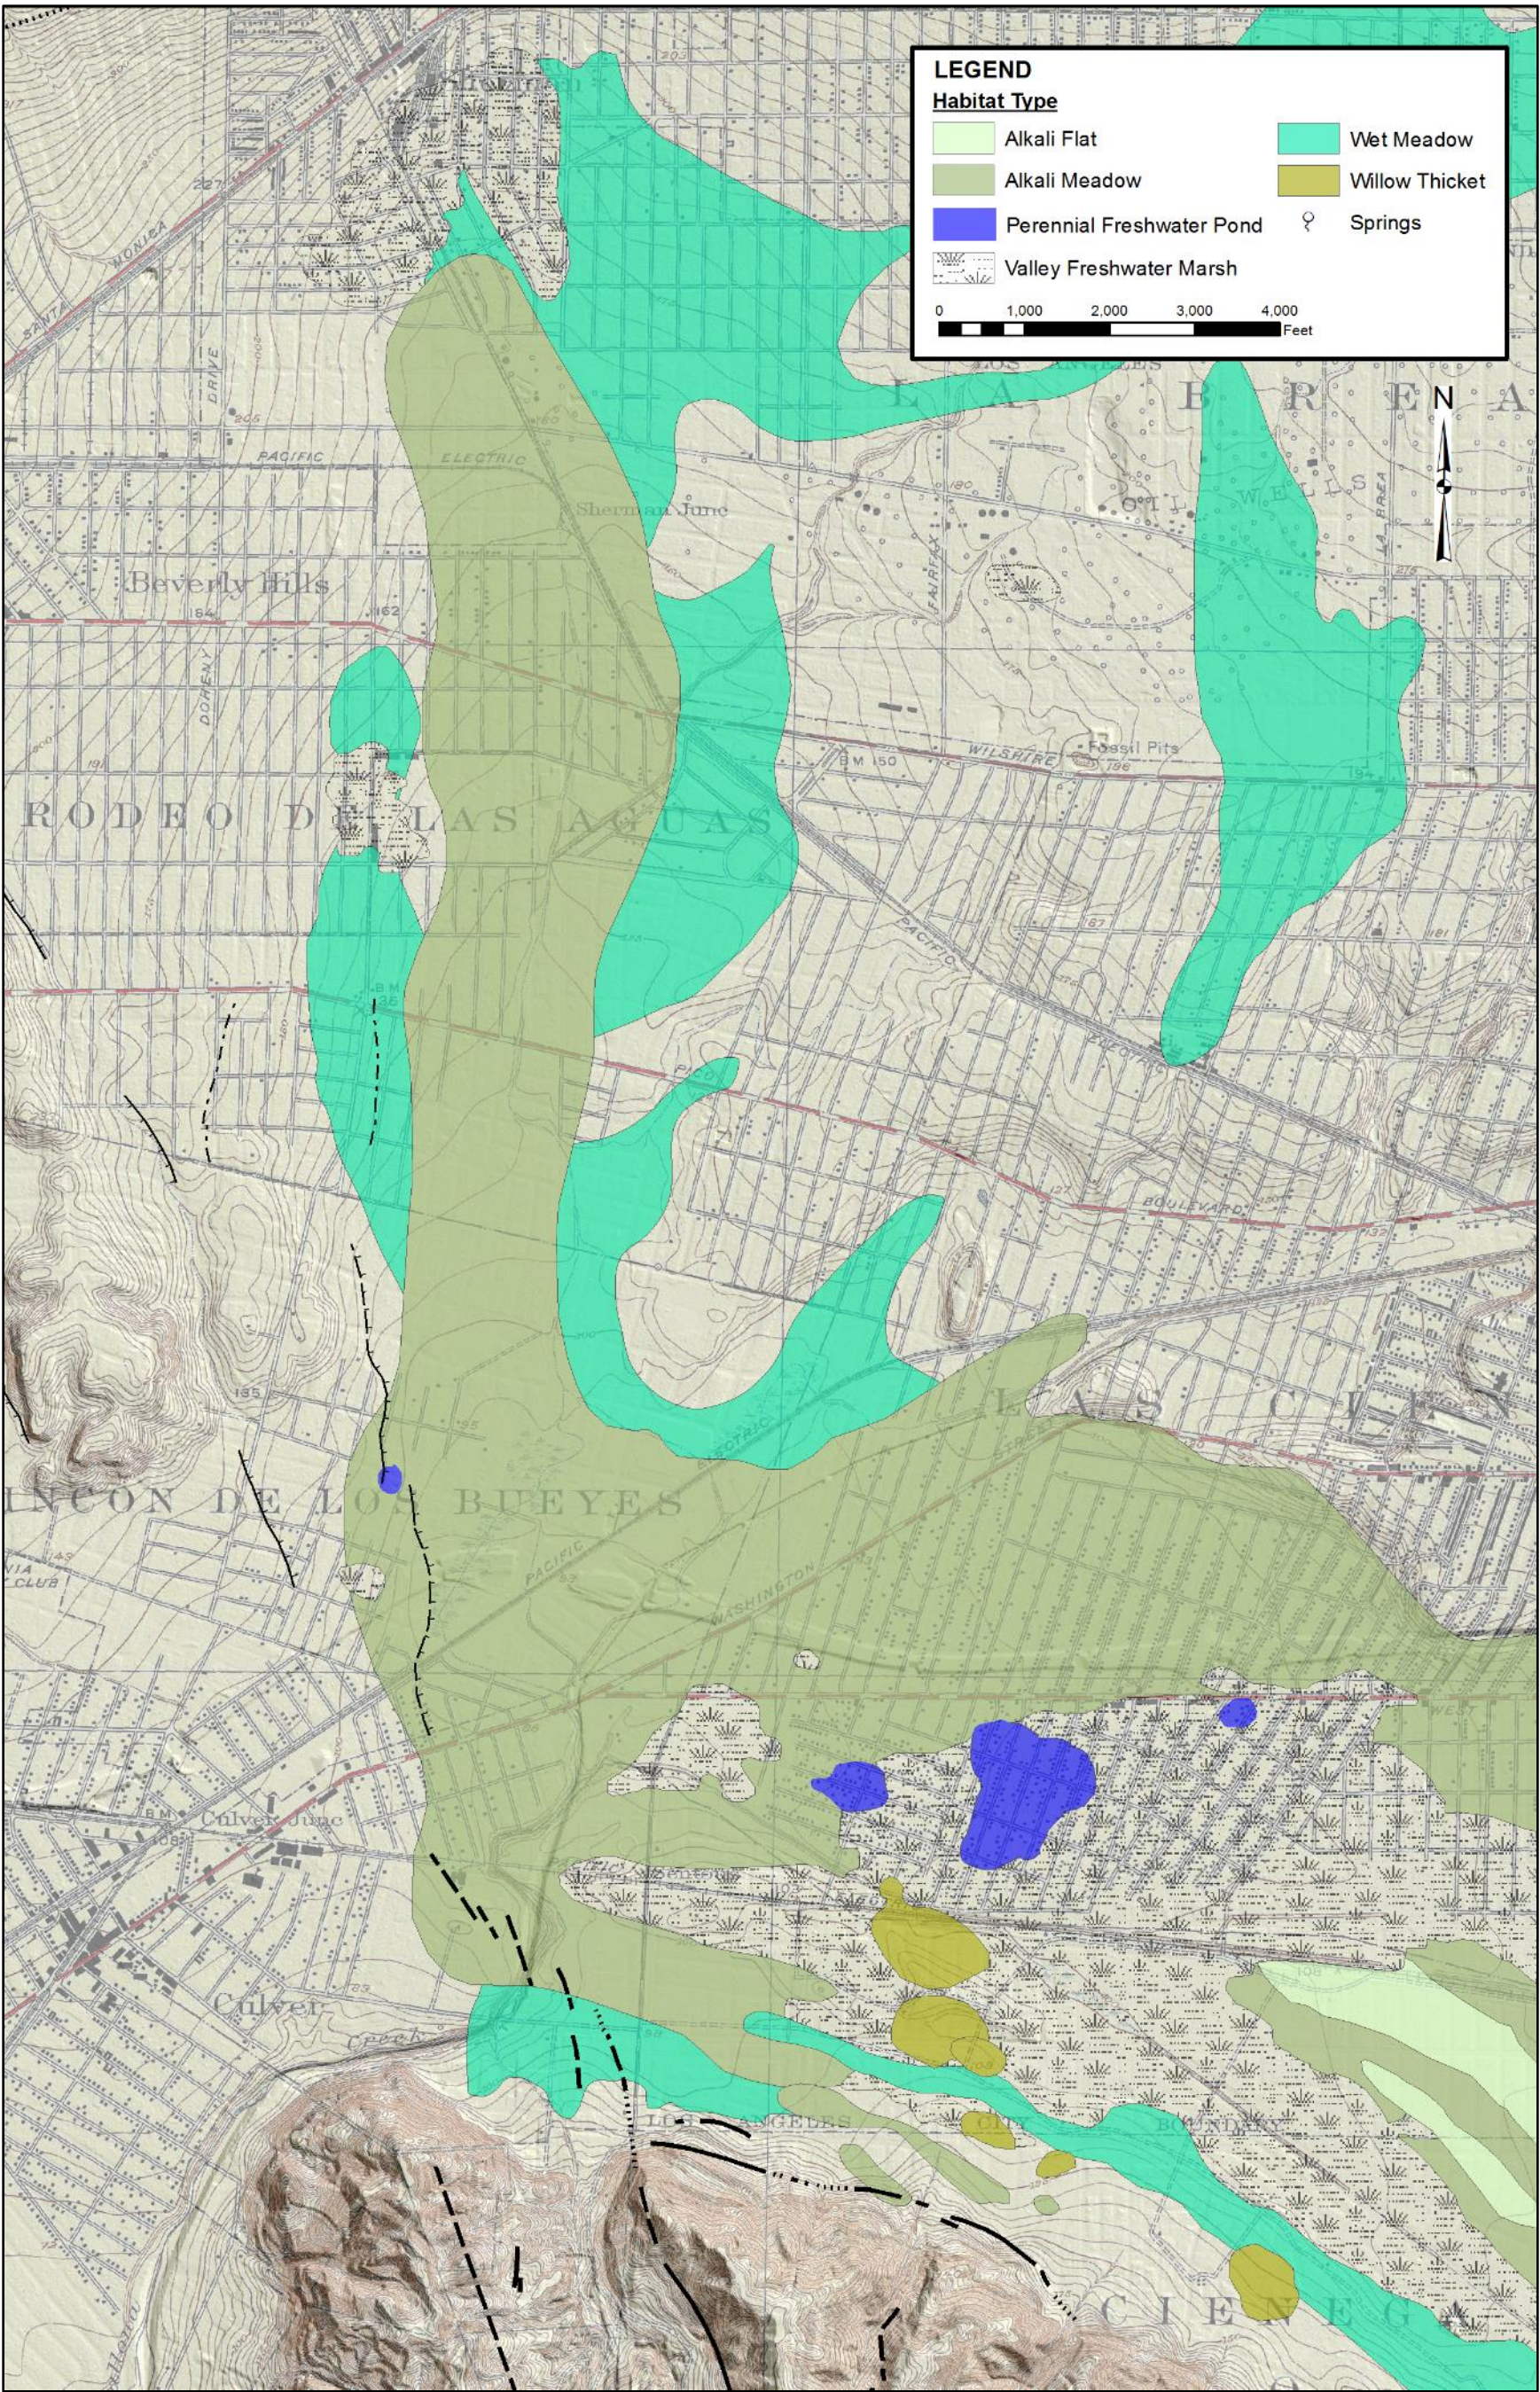
Figure 25 - Reconstructed wetlands environments by Dark *et al.* (2001) in the Ballona Gap region. Dark black lines are faults previously zoned by Bryant (1985); thin black lines with tick marks are topographic scarps; thin dashed black lines are notable breaks in slope.

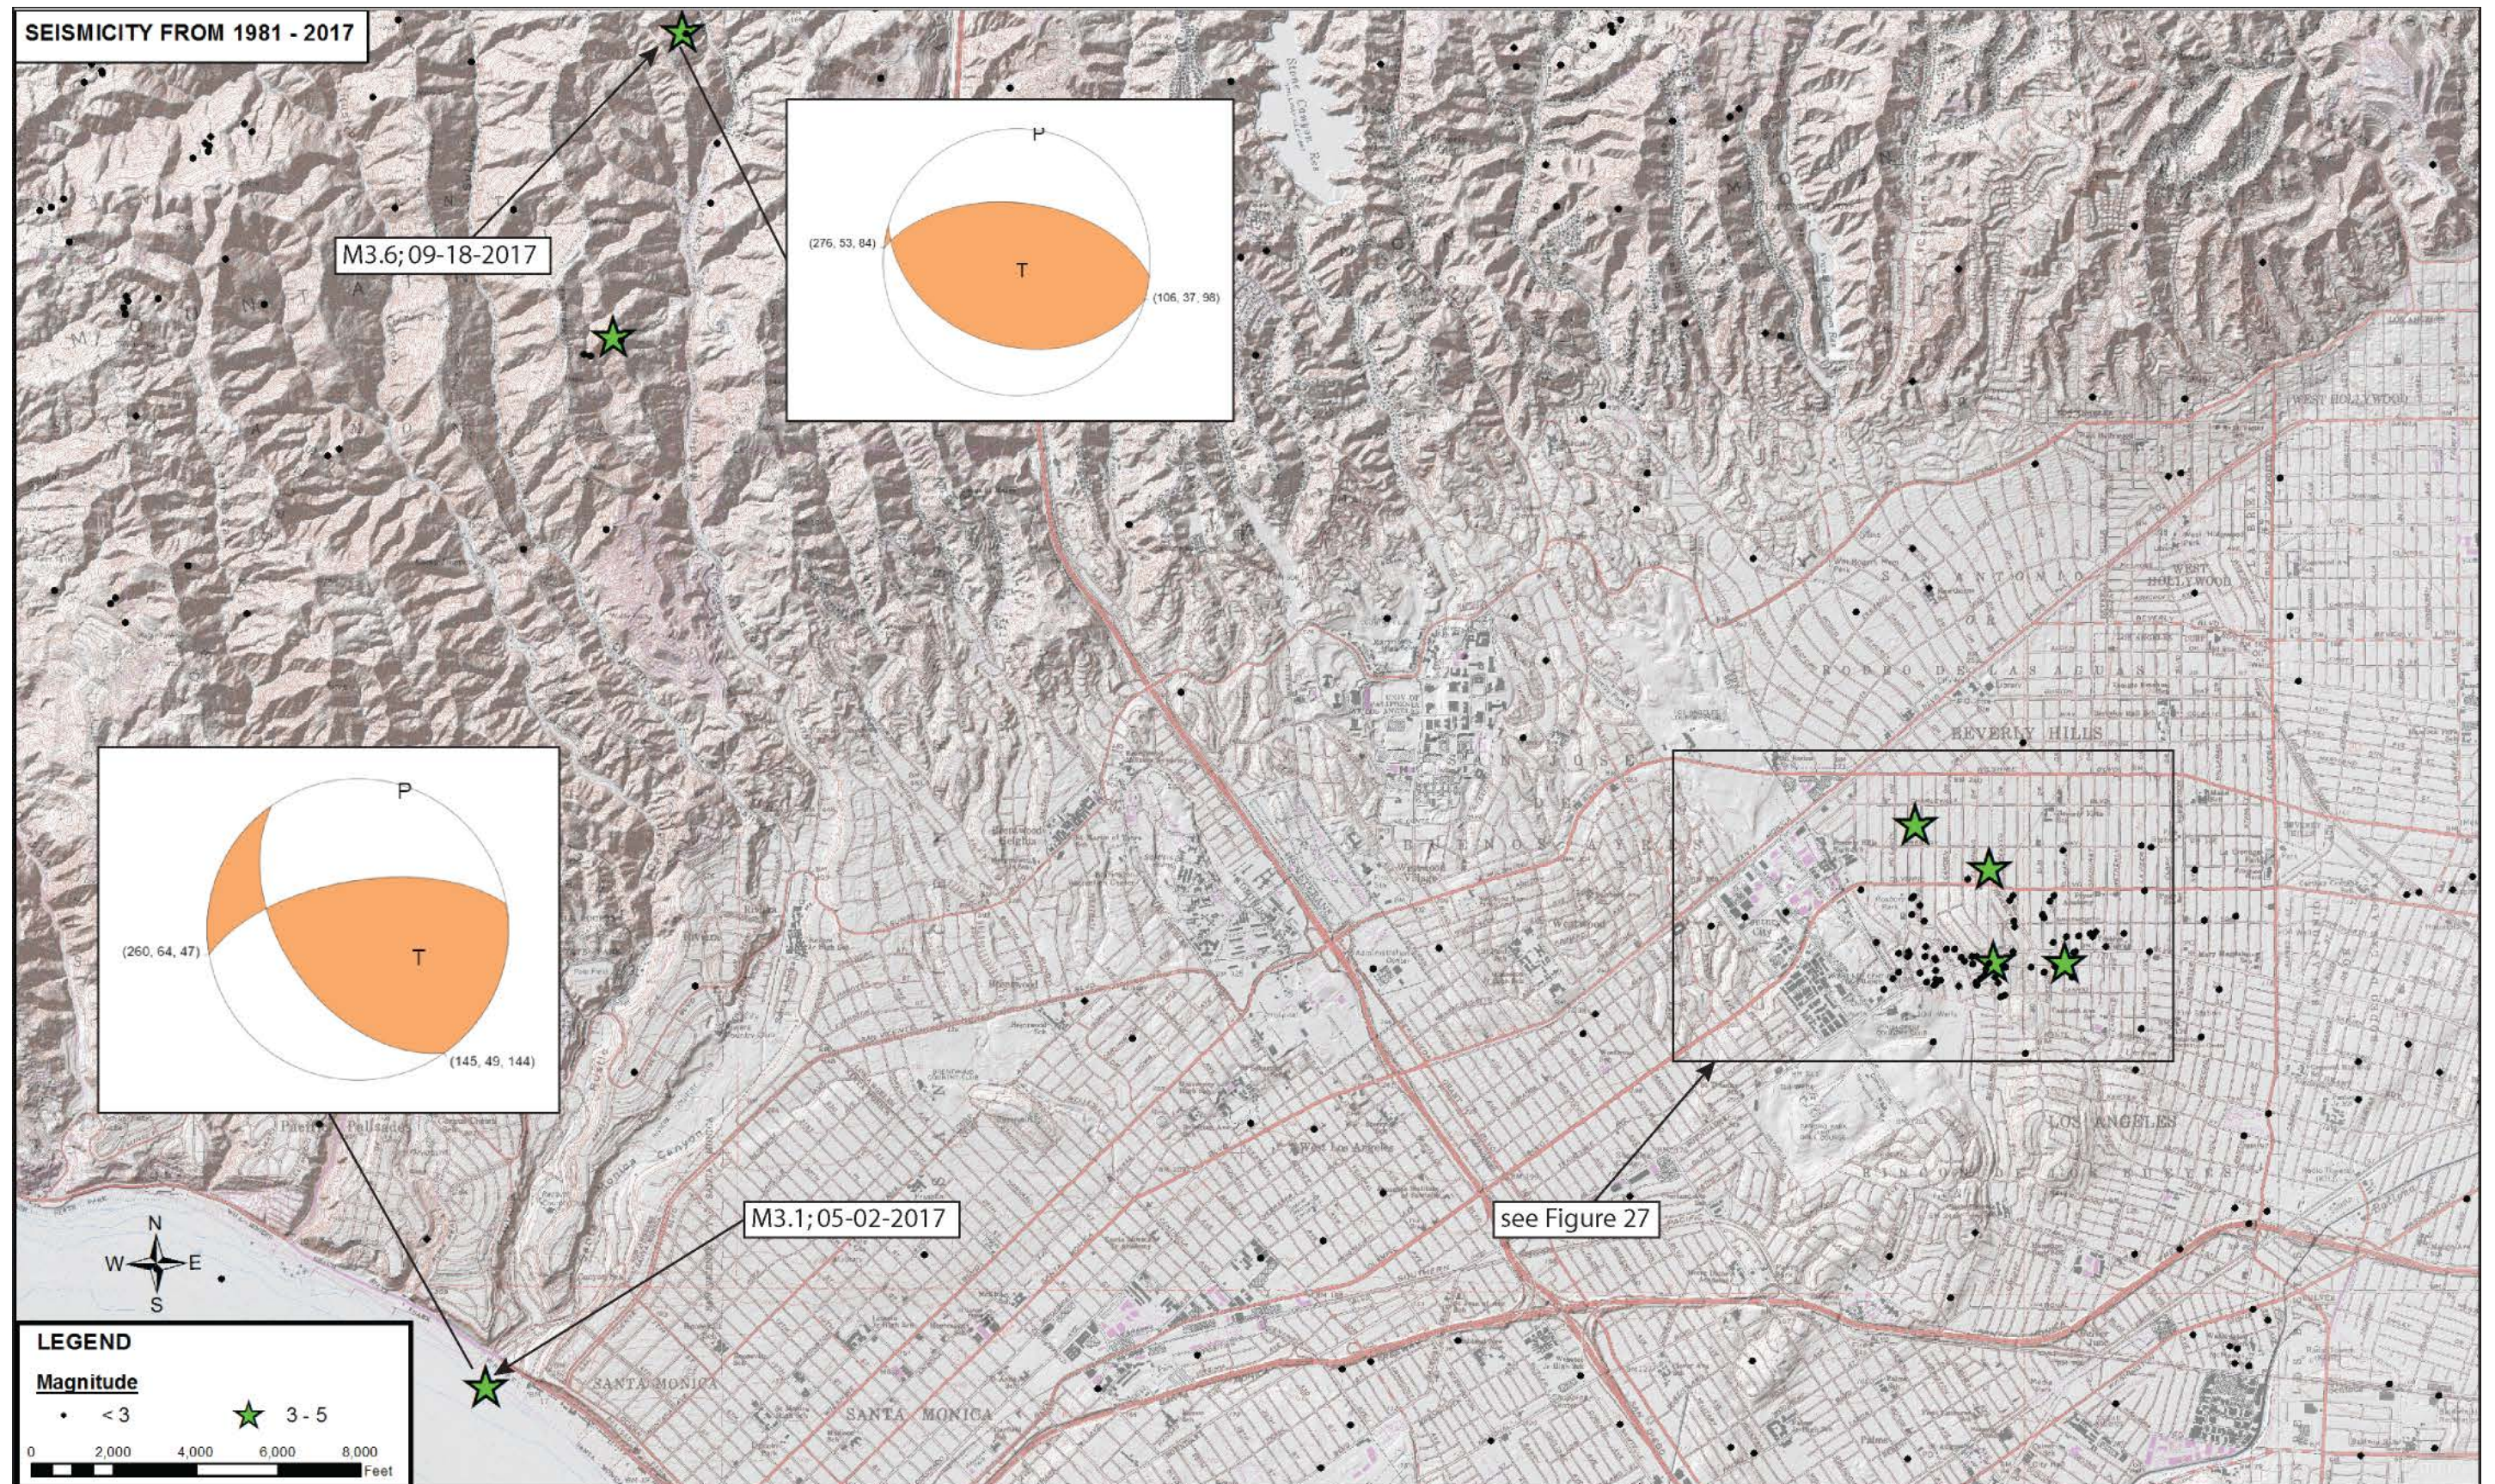
Figure 26 - Regional seismicity from 1981-2016 for western Los Angeles Basin, including epicenter and focal mechanisms of M3.1 and M3.6 earthquakes that occurred within the study area 2017. Inset box indicates area of interest depicted in Figure 27. [epicenter locations from Hauksson *et al.* (2011); 2017 epicenter location and focal mechanism data from SCEDC (2013)]

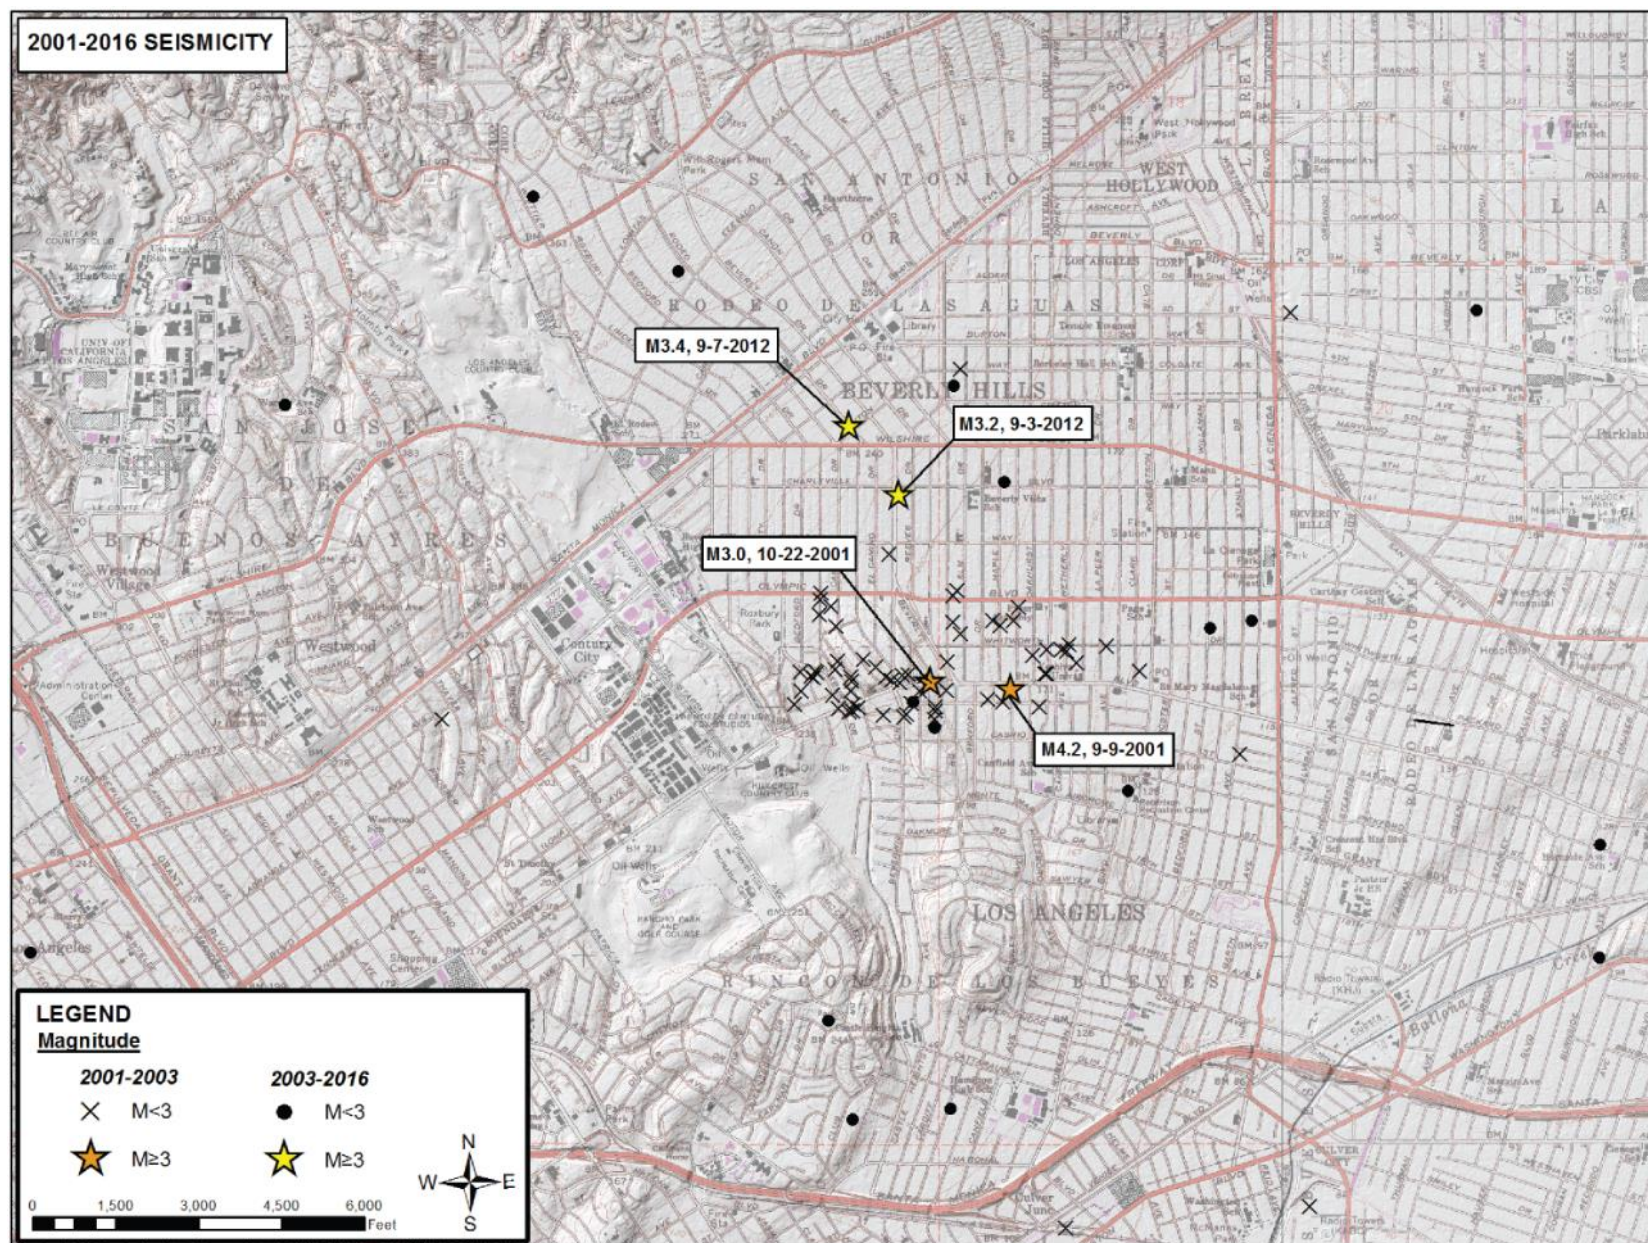
Figure 27 - Locations of earthquakes in the Cheviot Hills area between 2001 and 2016, including the epicenters from the 2001-2003 earthquake series. Stars are larger earthquakes referred to in the text.

Subsequent to the 2001-2003 sequence, two moderate earthquakes of magnitude M3.2 and M3.4 occurred in September 2012 north of the previous cluster (Figure 27). These events do not have nodal plane solutions so it is not clear whether they might be associated with the Santa Monica Fault or potential strands of the Newport-Inglewood Fault Zone; however, their northwest-southeast alignment might suggest they are related to a potential strand of the northern NIFZ.

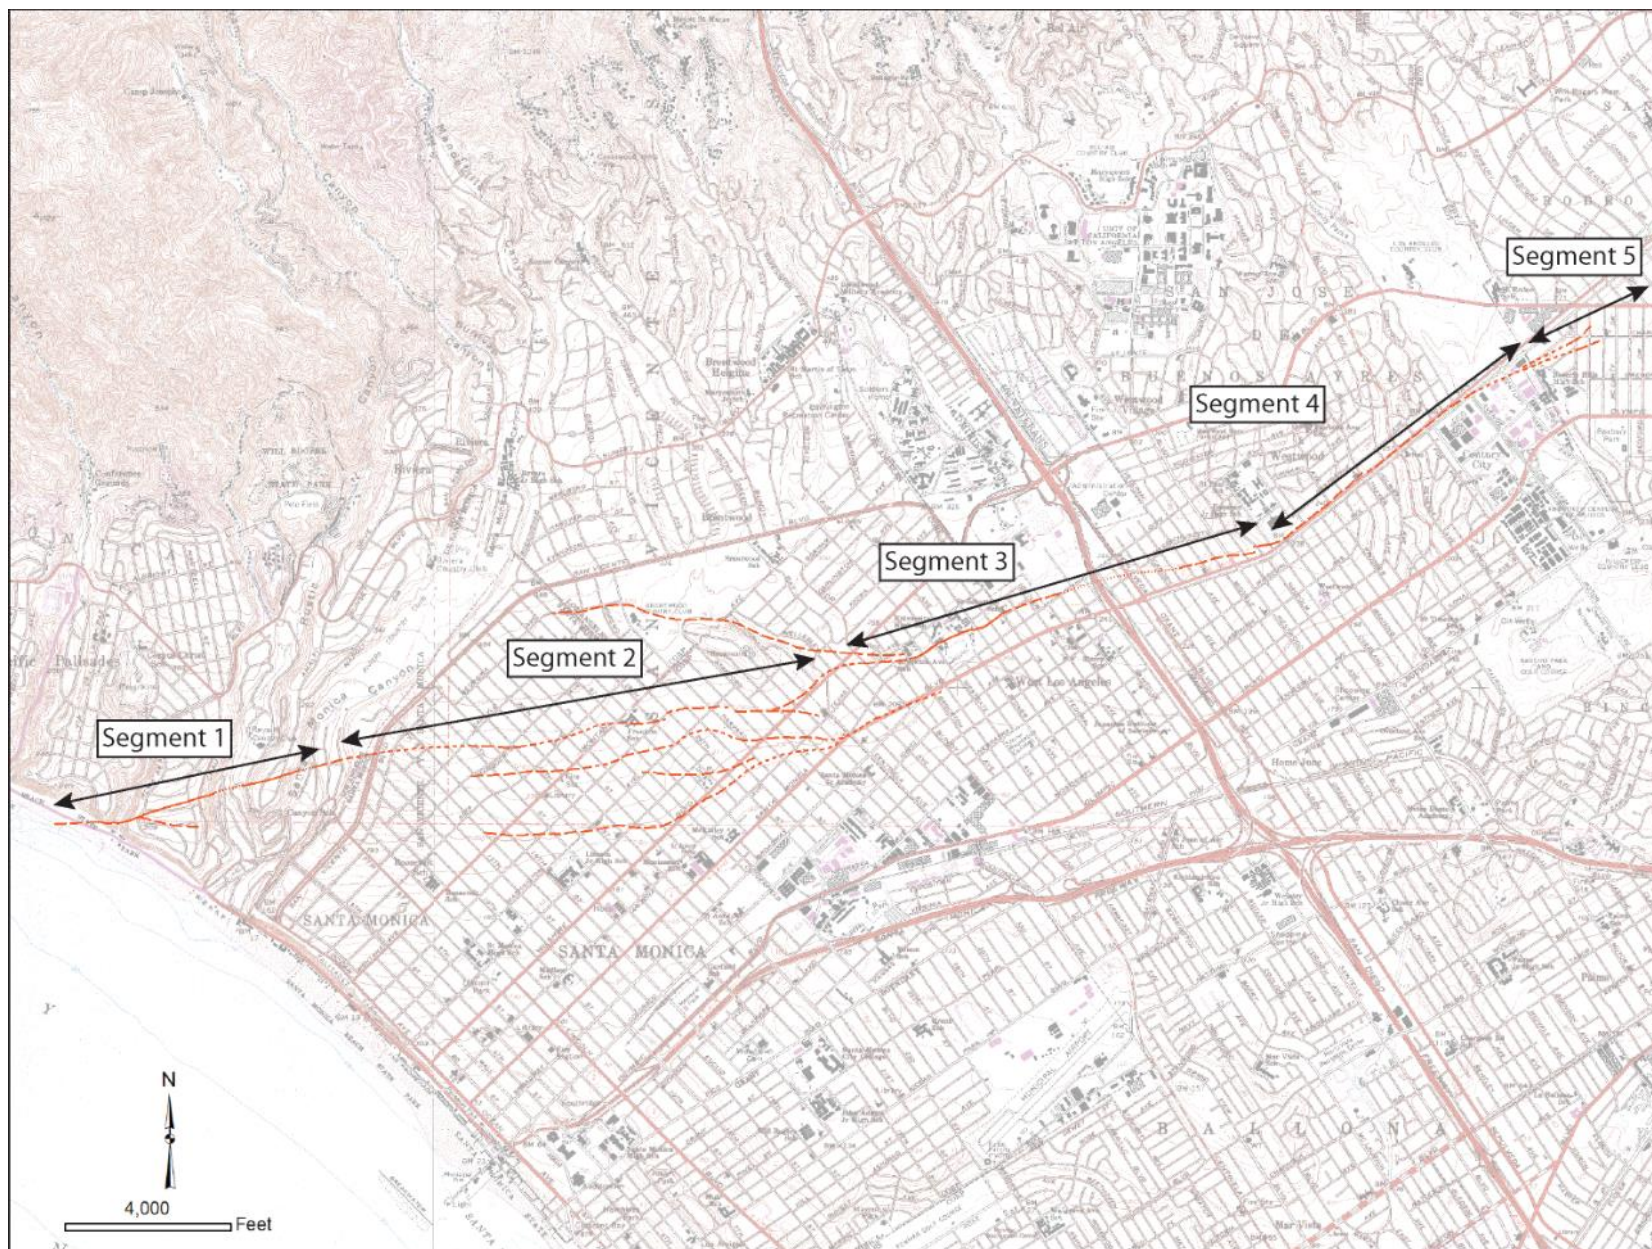
Figure 28 - Index map to Santa Monica Fault Zone segments discussed in text. Red lines are faults identified for zoning.

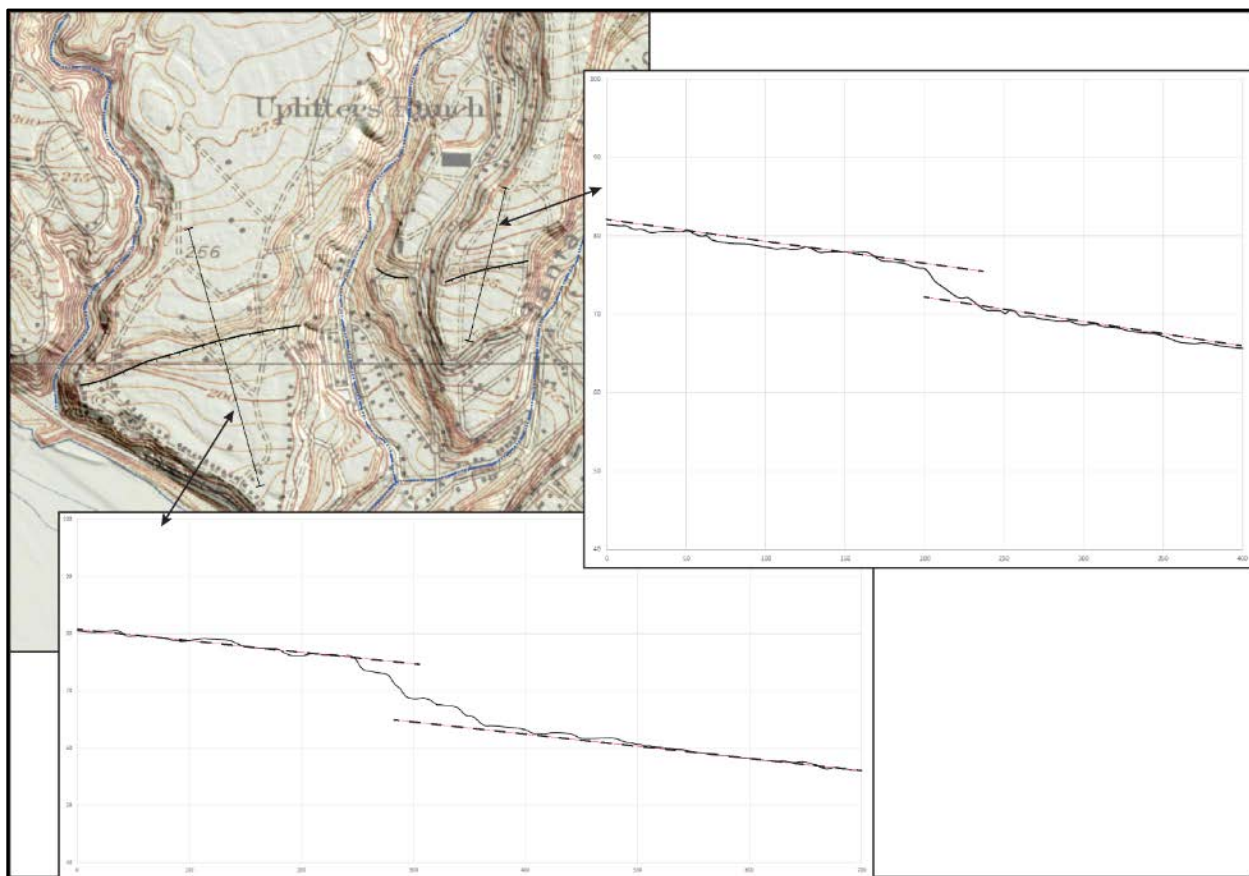
Figure 29 - Topographic profiles across two southeast-facing scarps in the marine terrace surface at Pacific Palisades. Scarp on the west is ~3 m, scarp on the east is ~1.5 m (5x vertically exaggerated). Base imagery is LA County lidar hillshade with 45° illumination angle; topographic base map is 1925 USGS 6' Topanga Canyon quadrangle map.

and range in height from 4 to 9 meters (Figure 29). The only subsurface investigation of this segment of the SMFZ was performed by Johnson (1932) and included studies of the uplifted terrace surfaces east of Potrero Canyon for geomorphic indicators of fault movement, stream gradient changes in the adjacent canyons, and two different types of geophysical surveys in an effort to map out the near-surface trend of the fault. He concluded the data collected indicated this segment was active. A secondary east-trending break in slope immediately south of the northeast-trending scarp is visible in the vintage topographic map of this area. KGS (2016) postulates this feature is fault-related (Plate 1), describing it as a Quaternary fault with unknown Holocene activity.

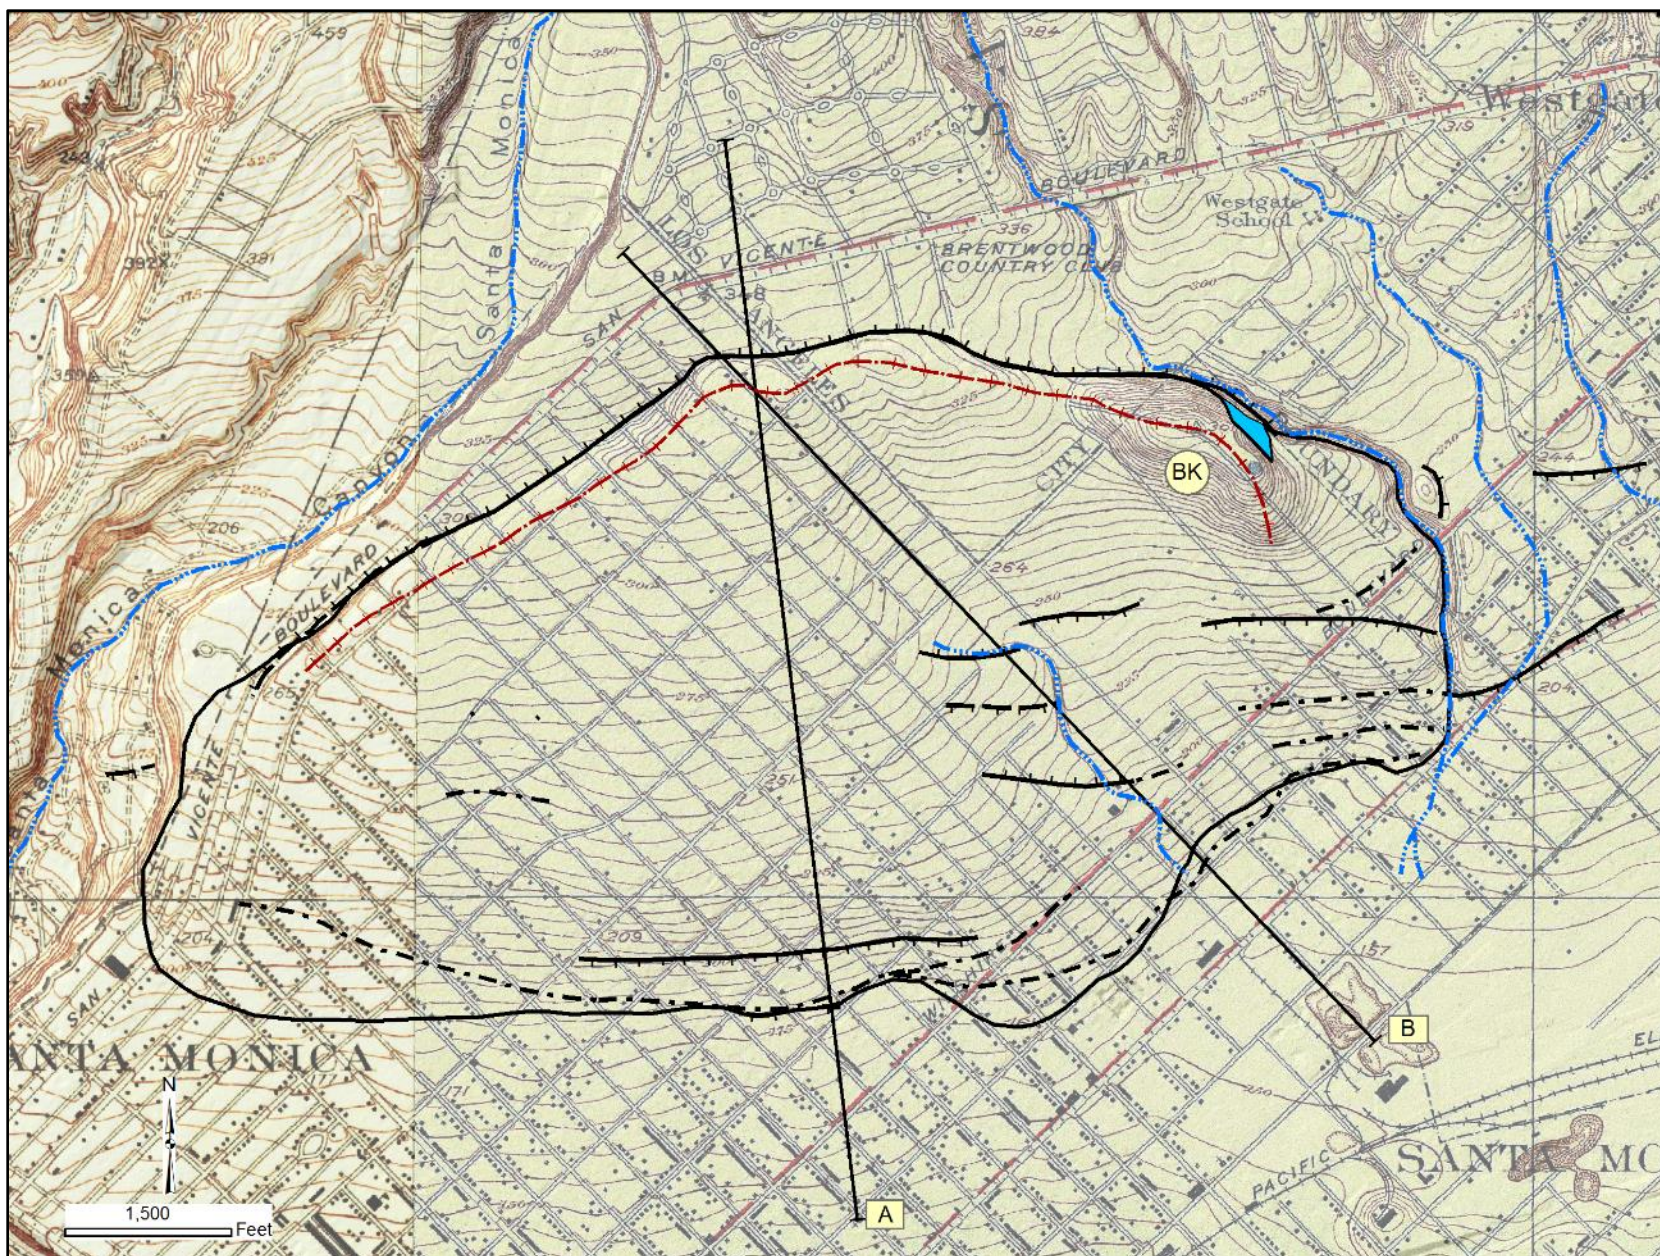
Figure 30 - Uplifted "Brentwood fan" showing breaks-in-slope (long-short dashed lines), scarps (black line with tick marks), scarp along northern margin (red line), stream drainages (blue lines), area of exposed Pliocene sedimentary bedrock (light blue shaded area), and topographic profile lines. Light gray oval shows uplifted intra-fan surface. BK – Brentwood Knoll topographic profiles are depicted on Figure 31. [Topographic base map: Sawtelle 6-min. (1925) and Topanga Canyon 6-minute quadrangles (1928)]

Extending east from Bundy Drive the fault is expressed geomorphically as a prominent south-facing linear scarp up to 12 meters high, about 3 to 4 km south of the mountain front (Figures 30-32; Plate 2). Between this scarp and the mountain front is a piedmont foreland consisting of uplifted and dissected older alluvial fans. Modern fan deposition is occurring downstream of the scarp, not at the range front, suggesting the most recent uplift is taking place at the scarp.
