**CALIFORNIA GEOLOGICAL SURVEY
FAULT EVALUATION REPORT FER 259**

**THE HOLLYWOOD, SANTA MONICA and NEWPORT-INGLEWOOD FAULTS
in the Beverly Hills and Topanga 7.5' Quadrangles
Los Angeles County, California**

by
Brian P.E. Olson
Engineering Geologist
January 5, 2018 (revised)

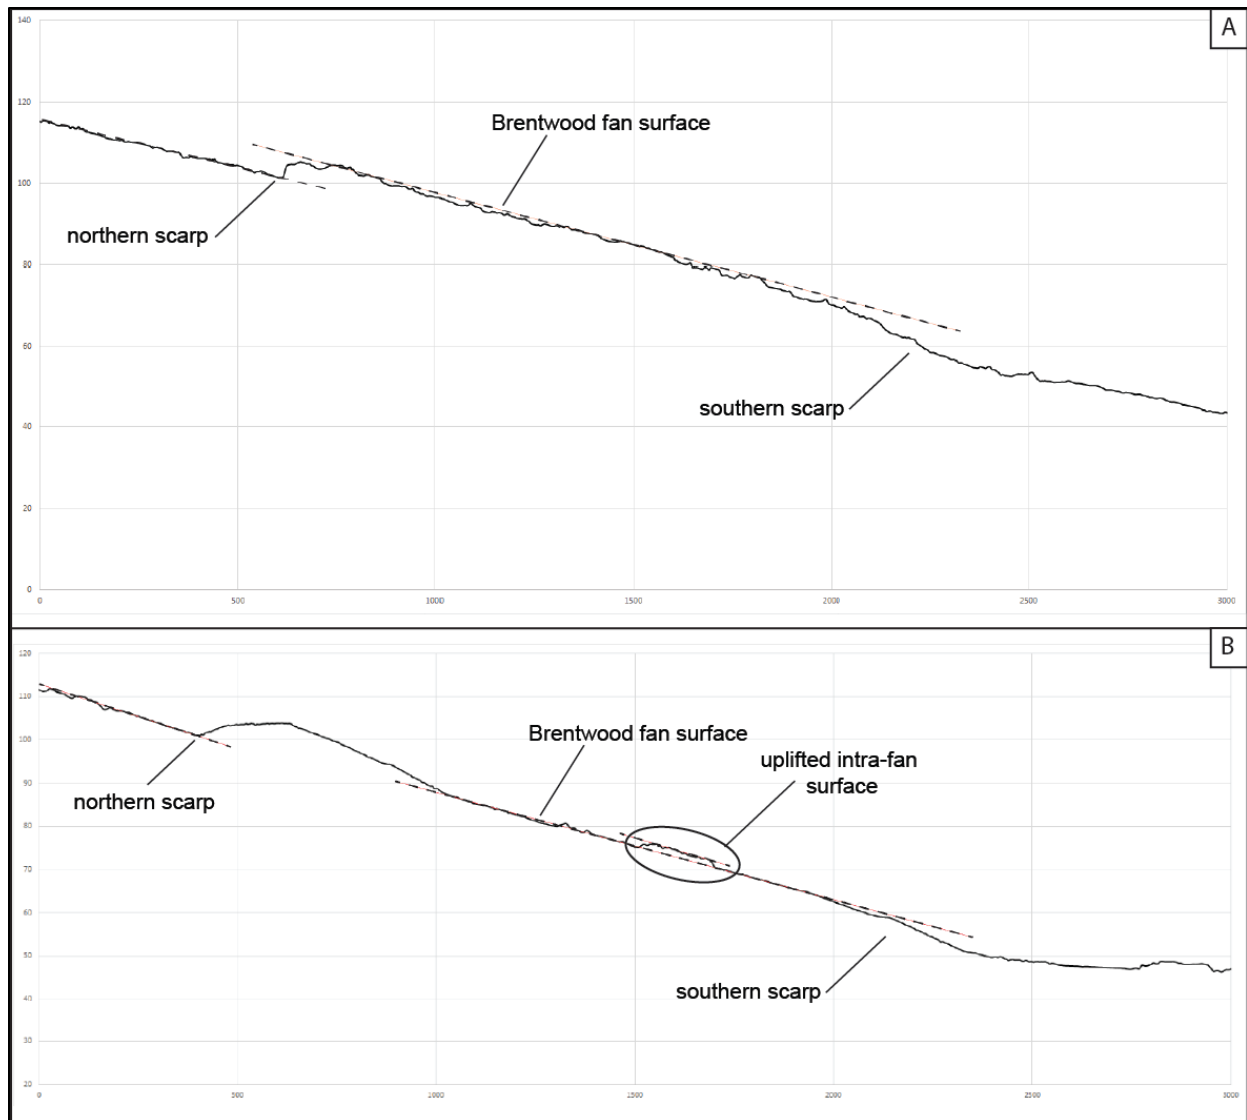
Figure 31 - Topographic profiles through the Brentwood fan. A) Profile showing north-facing scarp and Brentwood fan surface uplifted approximately 6 meters; B) Profile showing uplifted intra-fan surface uplifted approximately 1.5 m (10x vertically exaggerated)

its formation (Figure 31a). The low ridge extending northwesterly from Brentwood Knoll forms a north-facing scarp, until it reaches a saddle at the northern apex of the Brentwood fan. At this point, it transitions into a more flat-topped scarp in the western half of the fan where it is more linear and subparallel to the adjacent Santa Monica Canyon drainage. The height of the scarp also diminishes to the west suggesting the northwestern edge of the Brentwood fan is possibly related to erosion, not faulting. However, in the eastern half of the Brentwood fan the northern scarp trend is relatively steep, slightly irregular, and aligned obliquely to the regional stream gradient suggesting it may, at least in part, be fault-related. Faulting is also suggested by the presence of the anomalous Brentwood Knoll, which rises up to 25 meters above the surrounding alluvial fan surface. A small exposure of Pliocene bedrock mapped by Hoots (1931) and Castle (1960a) along the northeastern margin of the hill, approximately 3 km out from the mountain front, lends plausibility to a fault origin for this feature. Also, in this eastern portion of the fan there is a broadly incised drainage swale and numerous subparallel linear slope breaks and scarps that roughly align with, and project toward, the Segment 1 fault trace. A stream drainage depicted on the 1925 topographic map is noticeably deflected around an uplifted portion of the fan bounded by two of these subparallel scarps (Figure 30 and 31b). KGS (2016) mapped a fault north of Brentwood Knoll and along the northern scarp that connects with the Segment 3 strand of the SMFZ (Plate 1). They noted the more northwesterly trend of the fault as it bends around Brentwood Knoll forms a local restraining bend, which would explain the upthrown bedrock and the uplifted and disrupted topography of the eastern Brentwood fan. The subparallel intra-fan faults then likely represent a positive flower structure caused by the resultant transpressional stress. Continuous scarps and breaks in slope, as well as a fold scarp by Dolan *et al.* (2000a) that broadens significantly to the west, were mapped along the southern edge of the Brentwood fan (Plates 1 and 2). These geomorphic features likely represent either additional high-angle faults in the hanging wall associated with the flower structure or the surface expression of the underlying blind reverse fault in the shallow subsurface.

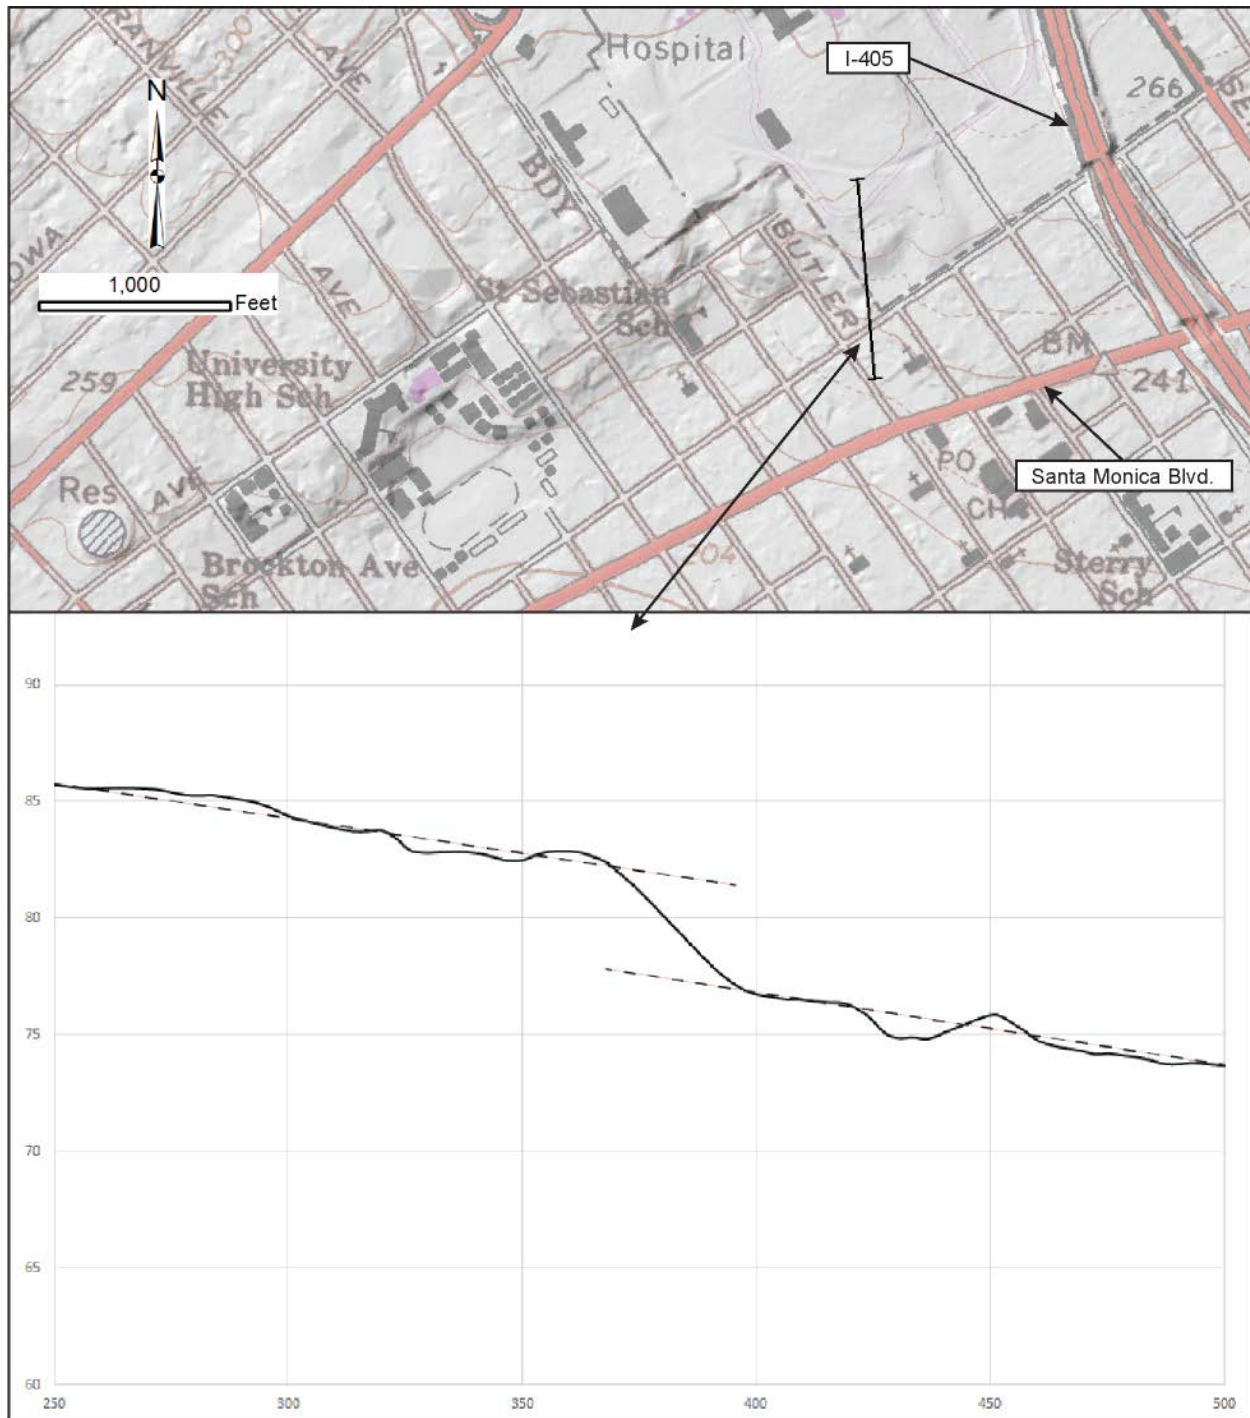
Figure 32 - Topographic profile across scarp at the Veteran's Administration Hospital. Scarp is ~1.5 m (5x vertically exaggerated). Topographic base map is modern USGS 7.5' Beverly Hills quadrangle topographic map draped over the LA County lidar hillshade with a 315° illumination angle.

Extending east from Bundy Drive the fault is expressed geomorphically as a prominent south-facing linear scarp up to 12 meters high, about 3 to 4 km south of the mountain front (Figures 30-32; Plate 2). Between this scarp and the mountain front is a piedmont foreland consisting of uplifted and dissected older alluvial fans. Modern fan deposition is occurring downstream of the scarp, not at the range front, suggesting the most recent uplift is taking place at the scarp.

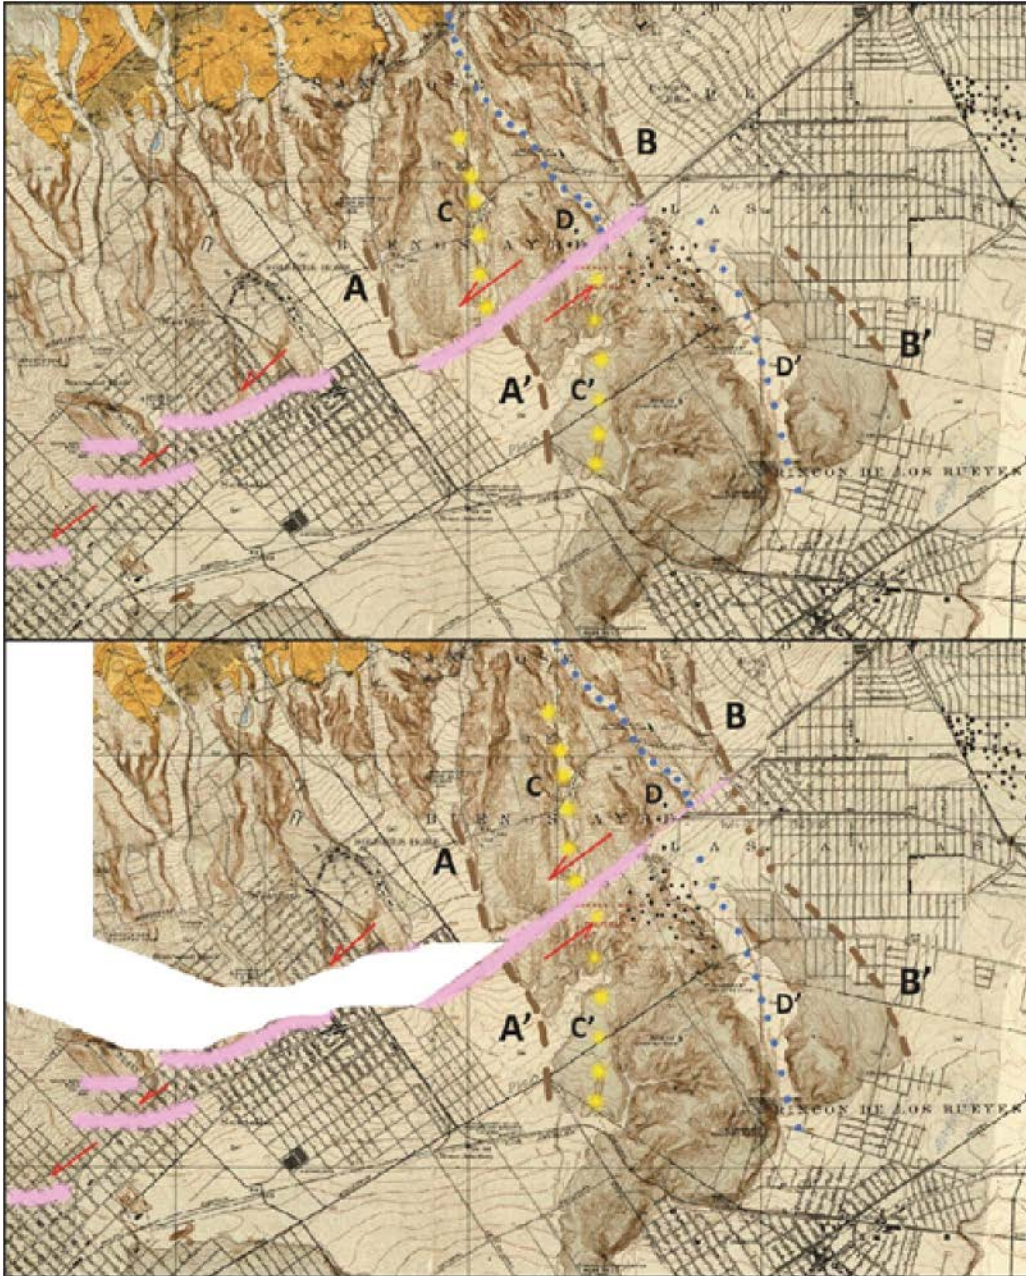
Figure 33 – Top: Geologic map (Hoots, 1931) with possible correlating alluvial drainages and margins; Bottom: Aligned alluvial drainages and margins after approximately 1.2 km of backslip along SMFZ. (figure prepared by J. Trieman)

the western and eastern lateral margins, along with some of the major canyon drainages, it appears plausible the Cheviot Hills are left-laterally offset by the SMFZ. By moving the northern block approximately 1,200 meters northeast relative to the southern block, these features appear to line up (Figure 33).

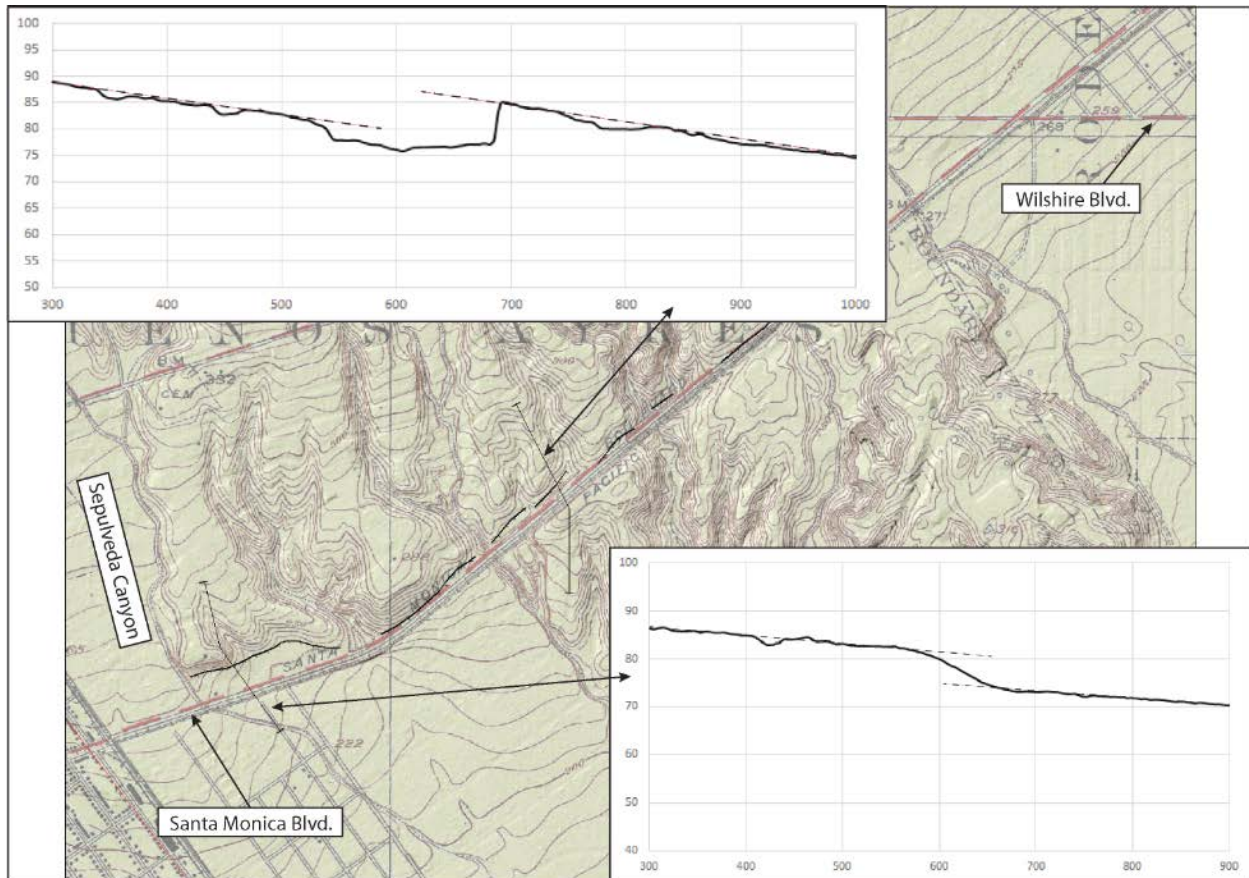
Figure 34 - Topographic profiles looking east across two different scarps along Santa Monica Blvd. in the Cheviot Hills. Scarp on the west is south-facing and ~2 m high. Scarp to the east is ~2.5 m high and north-facing. Profiles are 5x vertically exaggerated. Black lines with tick marks are geomorphic scarps. Base imagery is the LA County lidar hillshade with a 315° illumination angle; topographic base map is 1925 USGS 6' Sawtelle quadrangle map.

Scarp heights range from 5 to 15 meters, but are not consistently south-facing like those to the west. Figure 34 depicts a topographic profile drawn across the main scarp near Sepulveda Canyon and a second profile drawn across the Santa Monica Boulevard scarp in the Cheviot Hills. The western profile shows a south-facing scarp typical for Segments 1 and 3, while the eastern

profile depicts what appears to be an anomalous north-facing scarp. This inconsistency is plausibly explained by left-lateral offset of the highly dissected older alluvium, which transports alluvial surfaces of different elevations laterally along the fault. Similarly, lateral motion of a terrain with a dense drainage network like the Cheviot Hills will produce offset streams that appear both left- and right-deflected. The Santa Monica Boulevard scarp appears to be affected by erosion at its easternmost end, where it changes orientation again and trends roughly N25°E at the southern end of the Los Angeles Country Club. This northern scarp may represent a splay of the main SMFZ in this area. Several studies documented inactive faults in the vicinity of, and subparallel to, this northern scarp suggesting the erosion may in part be fault-controlled. Moving east the northern scarp appears to be truncated along the eastern margin of the Cheviot Hills (i.e. the WBHL) near El Rodeo School (Locality 18 on Figure 14); however, to the south the Moreno Creek channel is deflected at the eastward projection of the main Santa Monica Boulevard scarp into the Beverly Hills alluvial plain (Plate 2).

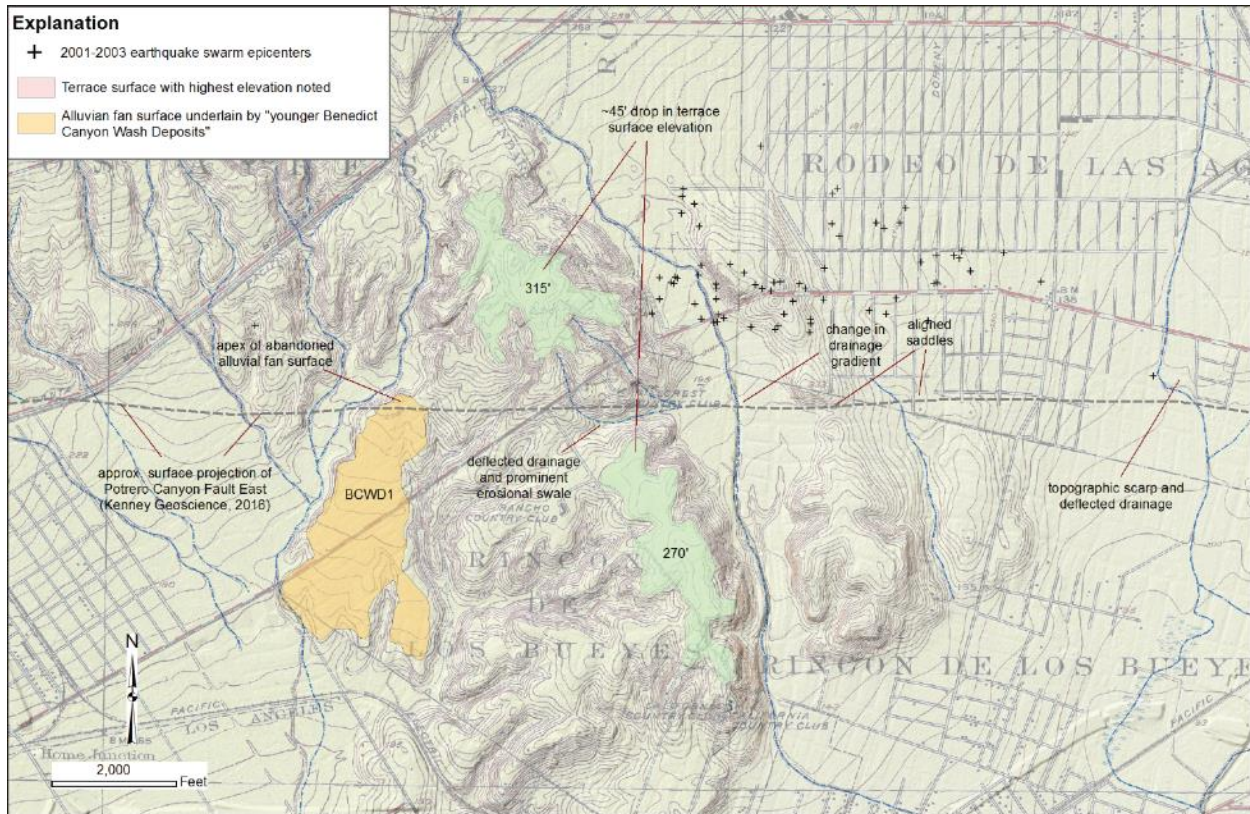
Figure 35 - Potential geomorphic evidence supporting the postulated Potrero Canyon Fault East of Kenney Geoscience (2016) through the Cheviot Hills. Topographic base map is 1925 Sawtelle and 1926 Hollywood 6' quadrangles. Contour interval is 5 feet.

As part of his regional tectonic evaluation of the study area, KGS (2016) postulated that a youthful left-lateral strike-slip fault is developing in the southern Cheviot Hills, which they referred to as the Potrero Canyon Fault East (PCFE). They note evidence for the existence of this fault includes a weakly defined alignment of saddles and swales that appear to coincide with drainage gradient changes, the fan apex location of the younger BCWD unit on the western side of the Cheviot Hills, and a significant drop in terrace elevations to the south across the alignment (Figure 35). KGS additionally observed the trend of these geomorphic features is generally aligned with the overall trend and location of the 2001-2003 seismicity sequence (Figure 26). On their 2016 map, KGS classifies the PCFE as an active fault; however, Miles Kenney concludes the fault, particularly in the east, has not likely ruptured to the surface (M. Kenney, pers. comm., 2016).

The evidence presented for the existence of this fault is sparse and not wholly supported. For example, the postulated existence of the fault through the Cheviot Hills is based on the difference in elevations between two terrace surfaces; however, no data is yet provided to demonstrate these terraces are the same age and were once continuous. Based on this model, the PCFE may exist, and may indeed be active, but additional data is needed to confirm this model. Should additional data become available supporting the existence and activity of the PCFE, it should be evaluated to determine if it poses a surface rupture hazard.

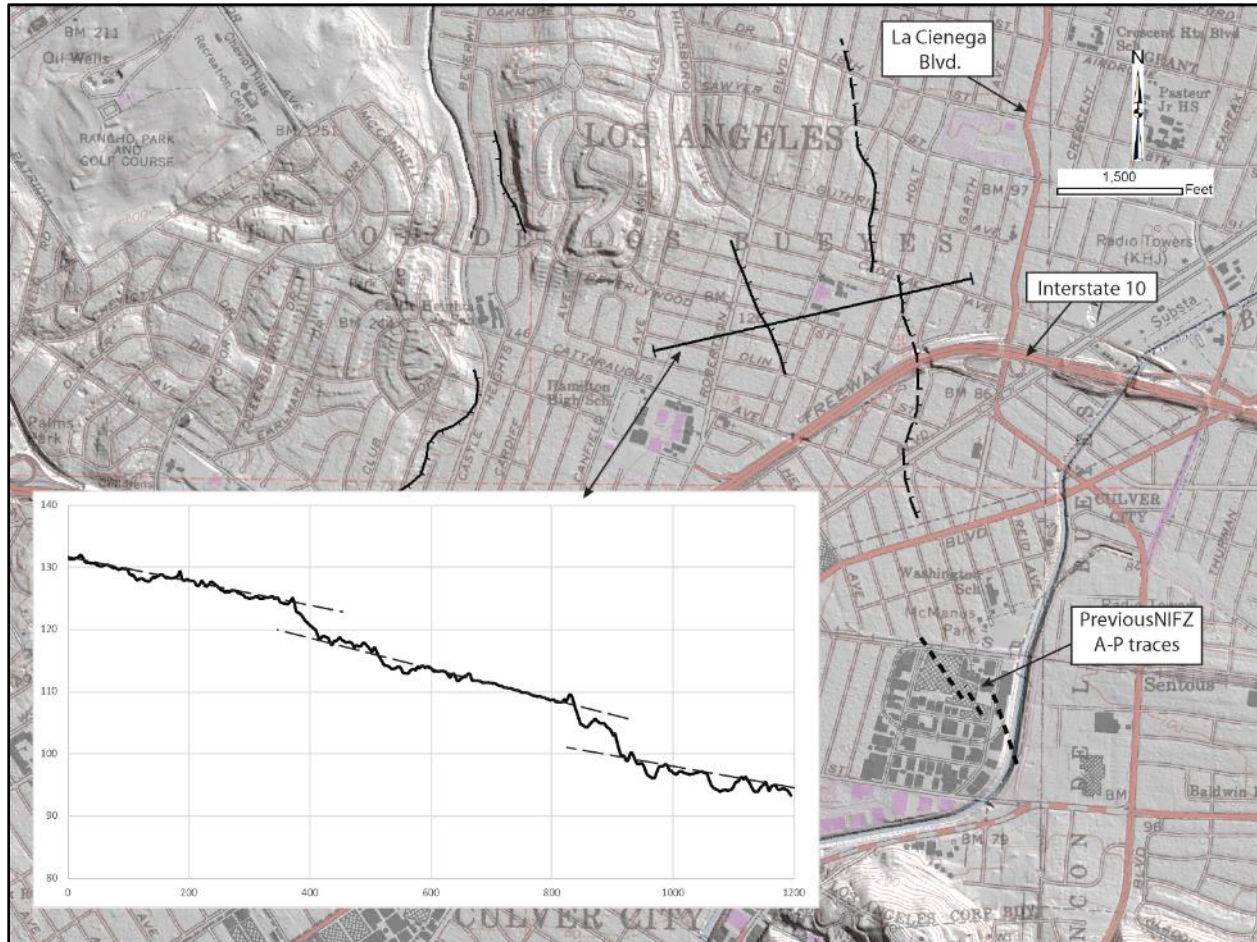
Figure 36 - Topographic profile across two east-facing scarps in the Ballona Gap. Scarp on the west is ~1.5 m and scarp on the east is ~2 m. Profile is 10x vertically exaggerated. Base imagery is LA County lidar hillshade with 45° illumination angle; topographic base map is modern USGS 7.5' Beverly Hills quadrangle map.

Bryant (1985) mapped a series of active fault strands trending northwesterly through the Baldwin Hills and extending just over 1 km into the alluvium of Ballona Gap (Plate 1). North of, and in-line with, these faults are two subparallel east-facing scarps observed in the Los Angeles County 3-meter lidar hillshade (LARIAC, 2006) ranging from 1.5 meters (western) to over 2.5 meters high (eastern) (Figure 36). These scarps appear to roughly coincide with the western boundary of the historic Ballona wetland habitat (Figure 25) suggesting they are associated with the Newport-Inglewood Fault Zone, which forms a fault-related groundwater barrier causing elevated groundwater levels to the east. They also approximately correspond with the "Inglewood Fault" and "West Pico Fault" of Erickson and Spaulding (1975) (Plate 1). Of the two subparallel slope breaks noted on Plate 2, the easternmost is more directly aligned with the eastern Ballona Gap scarp and also coincides with the historic boundary of the Ballona wetlands. Therefore, it was inferred to represent a continuation of the NIFZ fault zone to the south. Because the western slope break is more oblique to the western Ballona scarp and does not appear to be associated with any marked changes in groundwater levels, it is not interpreted to be associated with active faulting.
